Rietvlei Catchment Pics

HGM 1.1

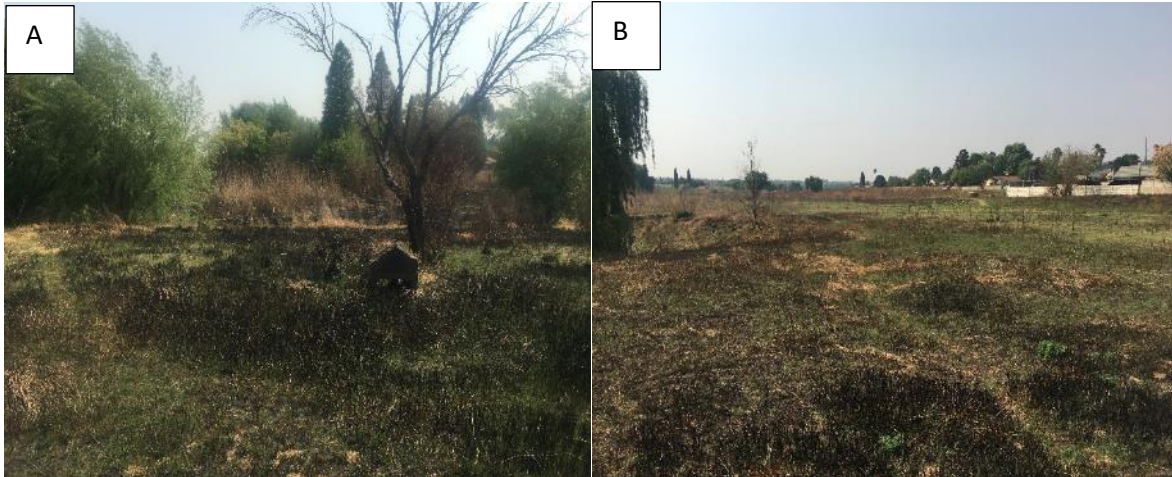
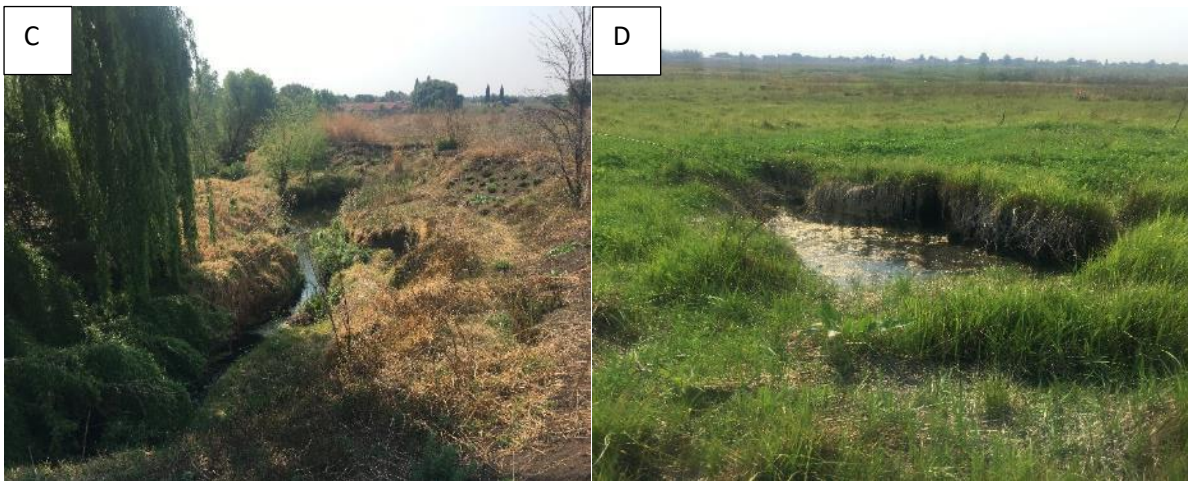
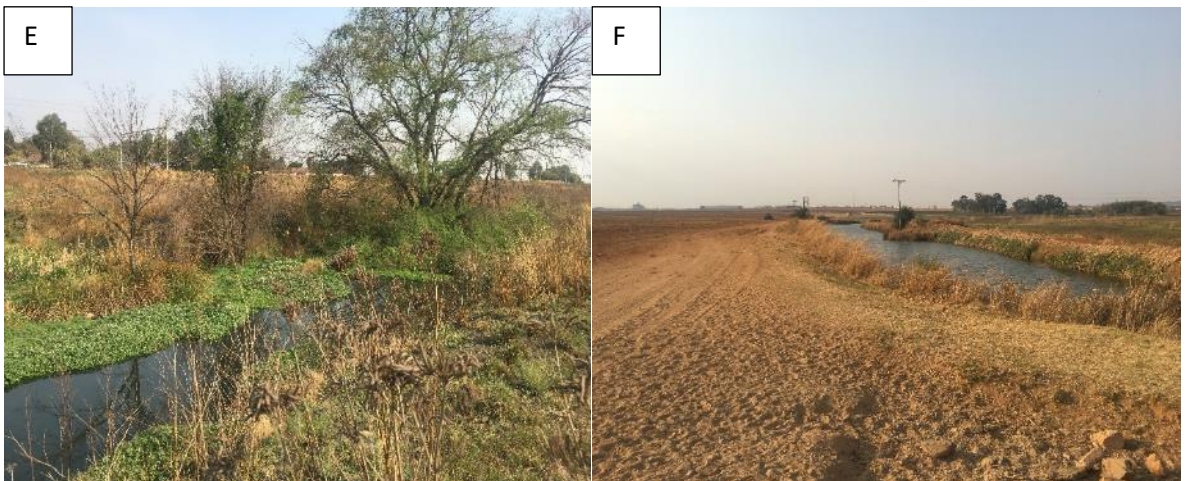
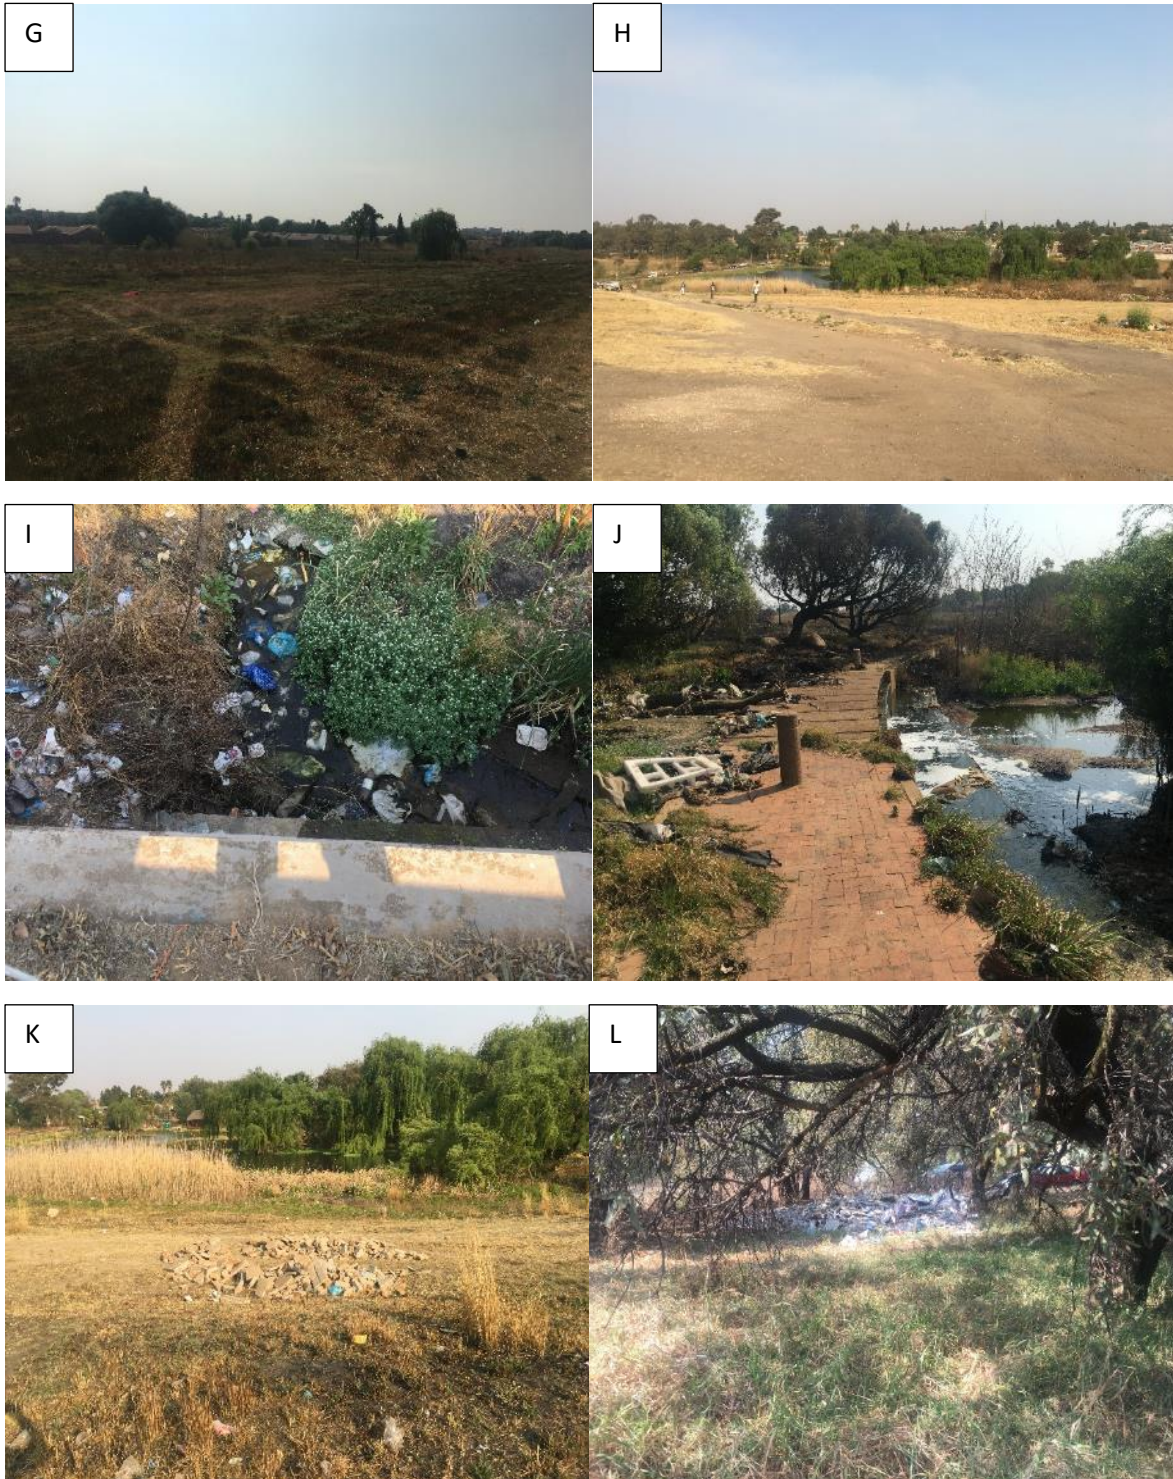
Figure 2: Photographs indicating impacts recorded (informal crossings, burnt grass, erosion, water weeds /hyacinth, agriculture activities, walk/driveways, litter dumping, debris dumping)

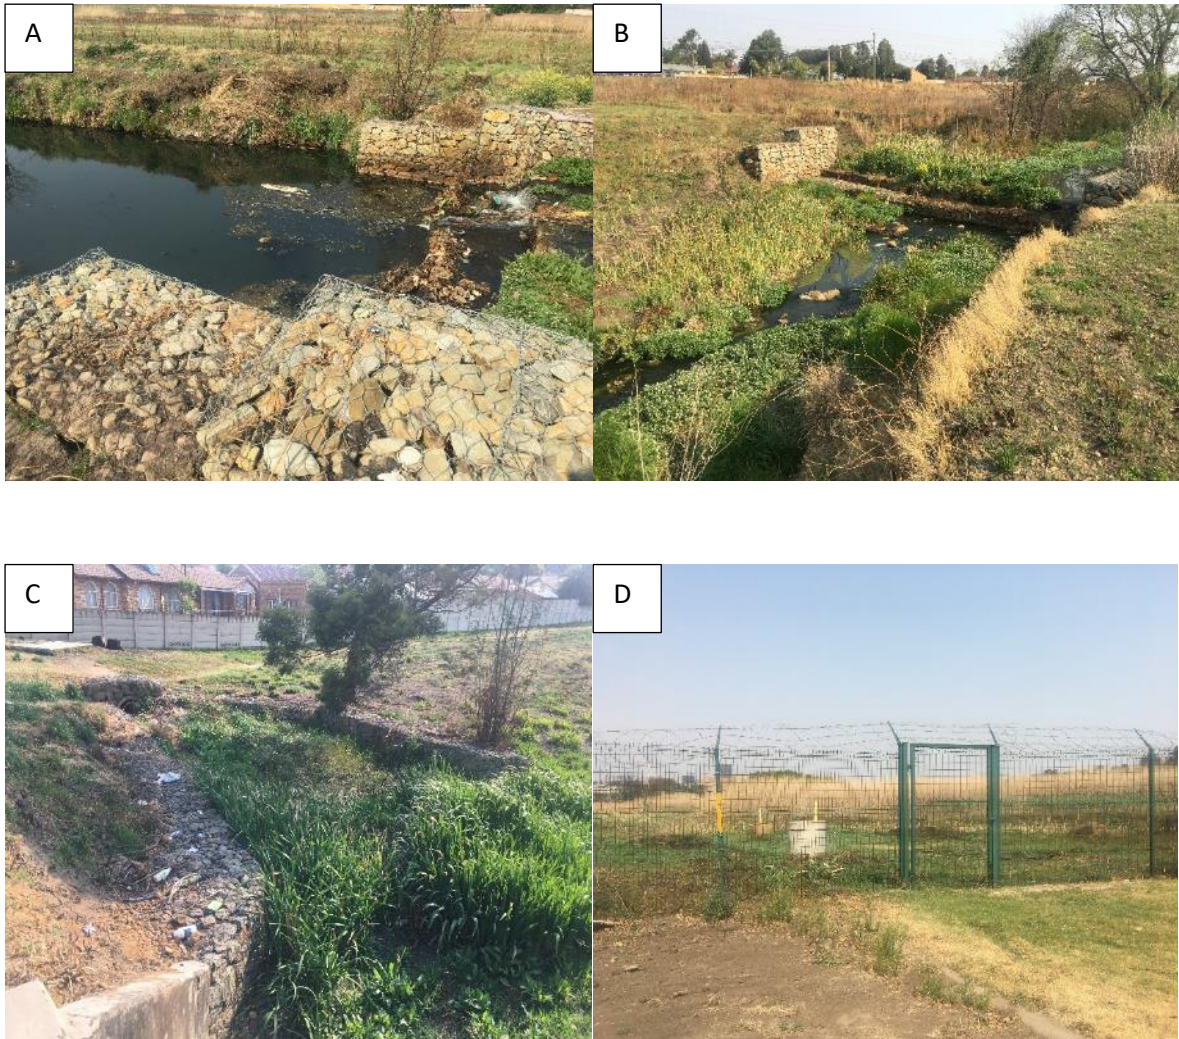
Figure 3: Photographs indicating existing wetland rehabilitation interventions (gabions, fencing off)

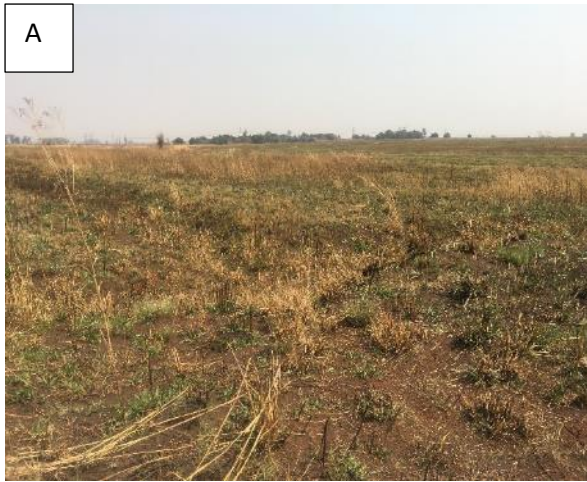
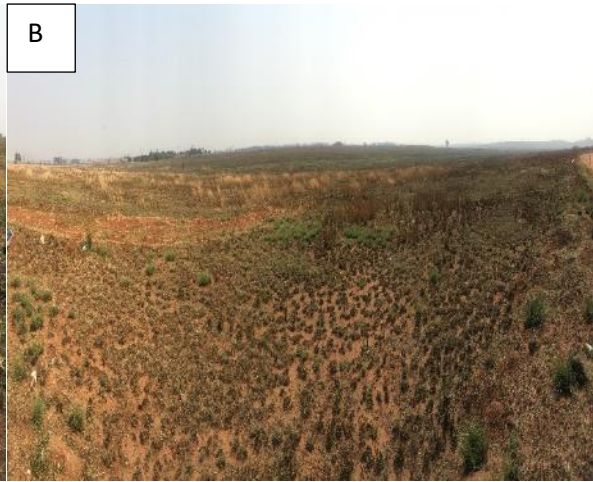
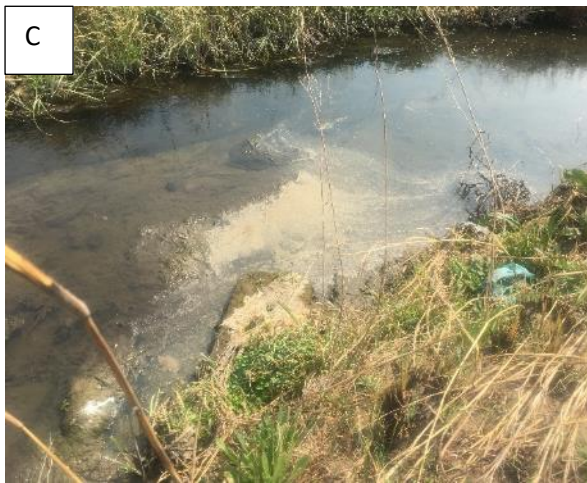
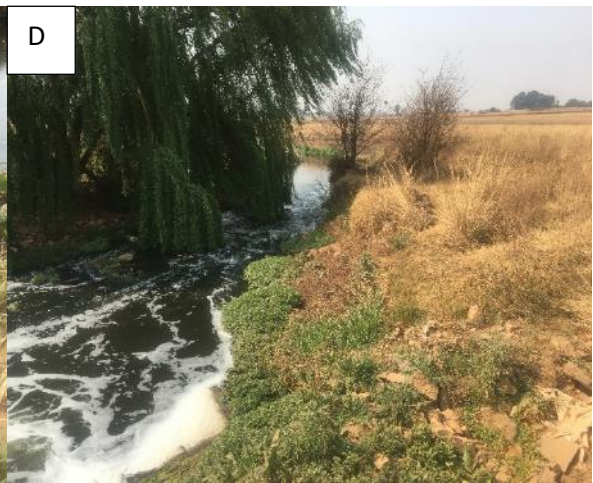
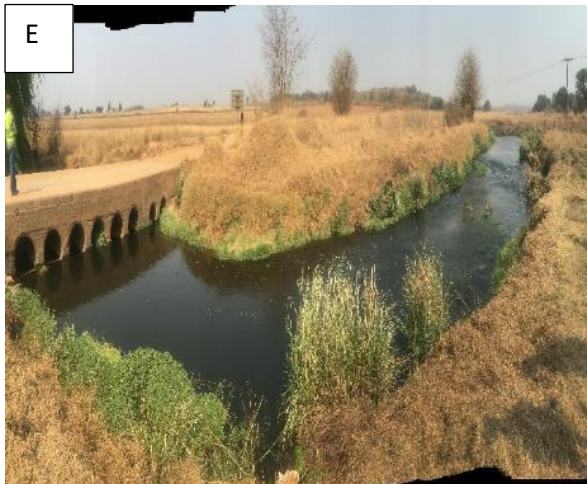
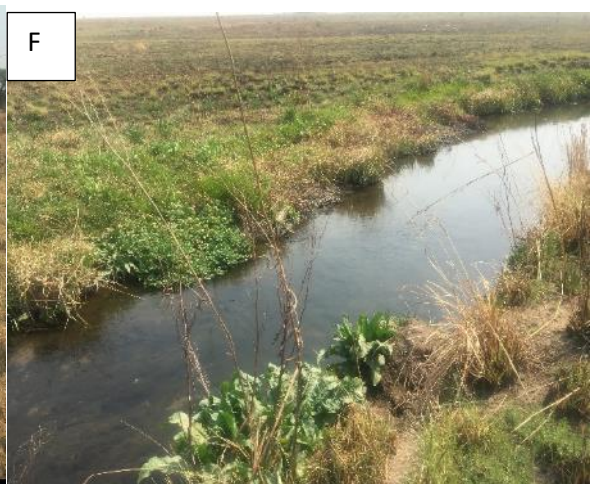
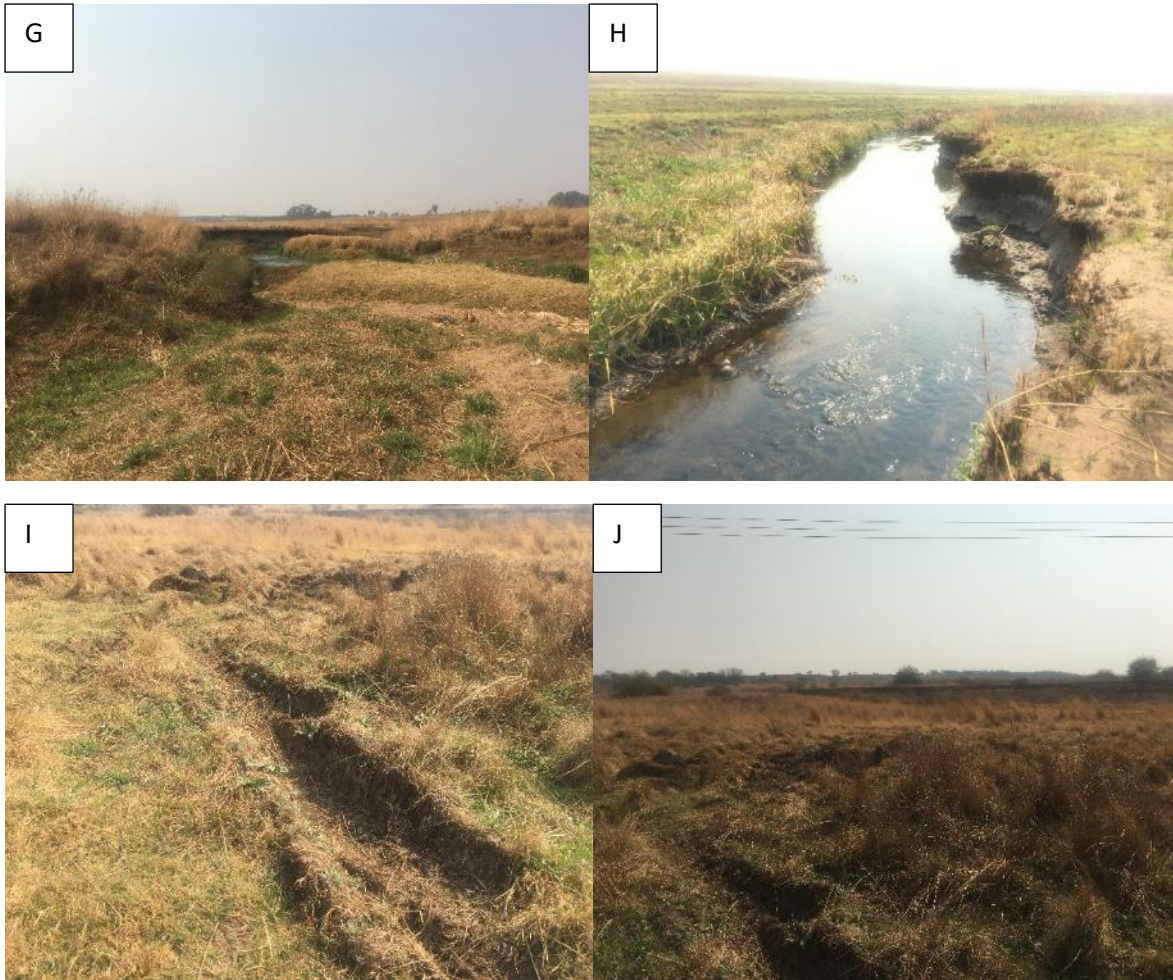
Figure 5: Photographs indicating impacts observed (veld fire, traces of sewerage, water hyacinth, erosion, informal crossings or vehicle driving)

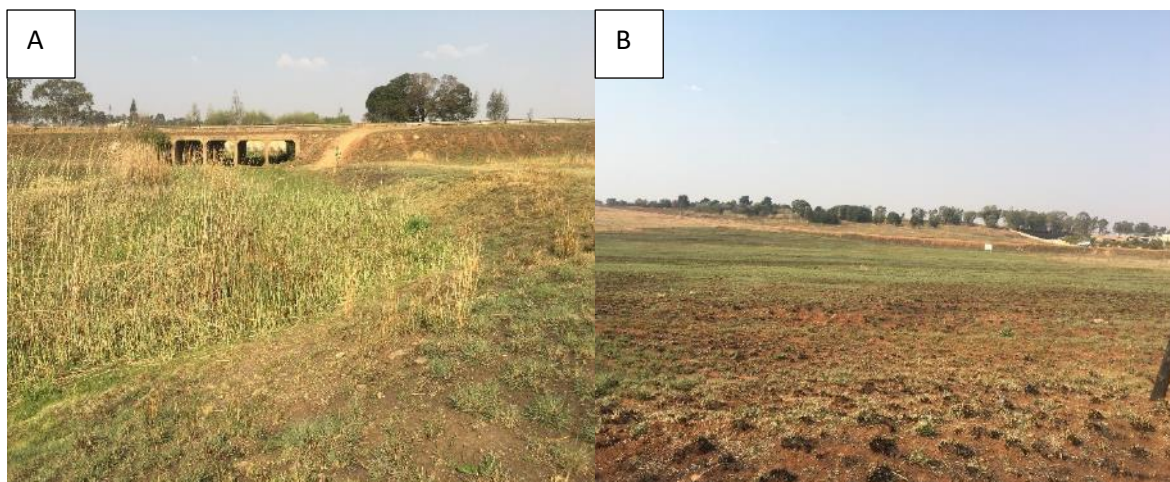
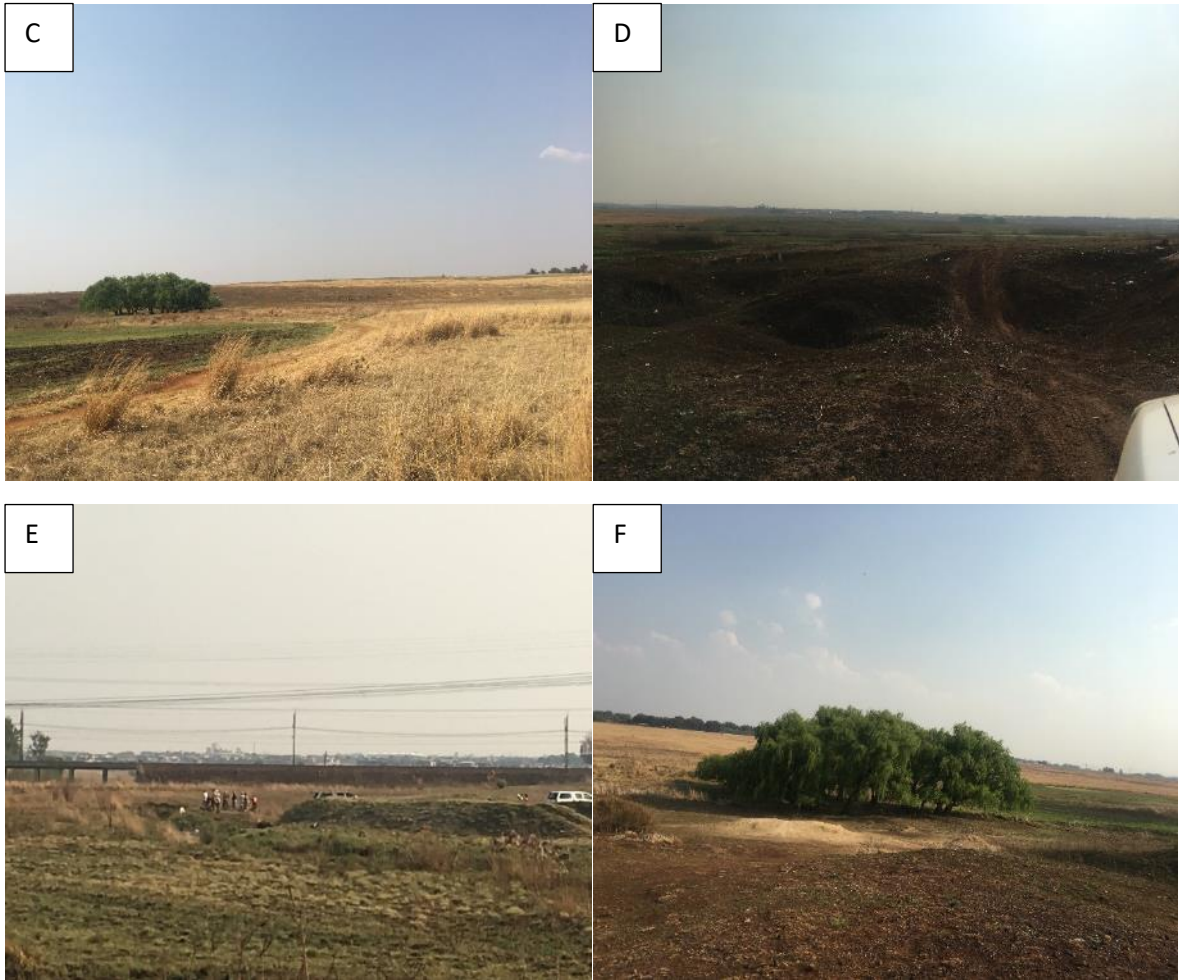
Figure 7: Photographs of impacts observed onsite (veld fires, vehicles tracks, litter dumping, religious activities, sand /building material abstraction)

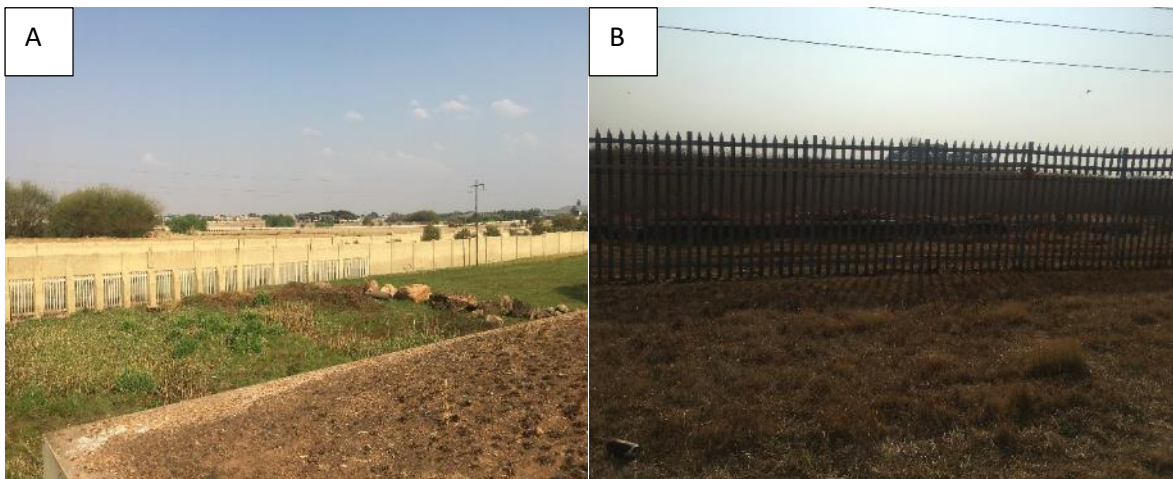
Figure 8: Photographs of existing wetland rehabilitation interventions (surrounding /fencing of the area)

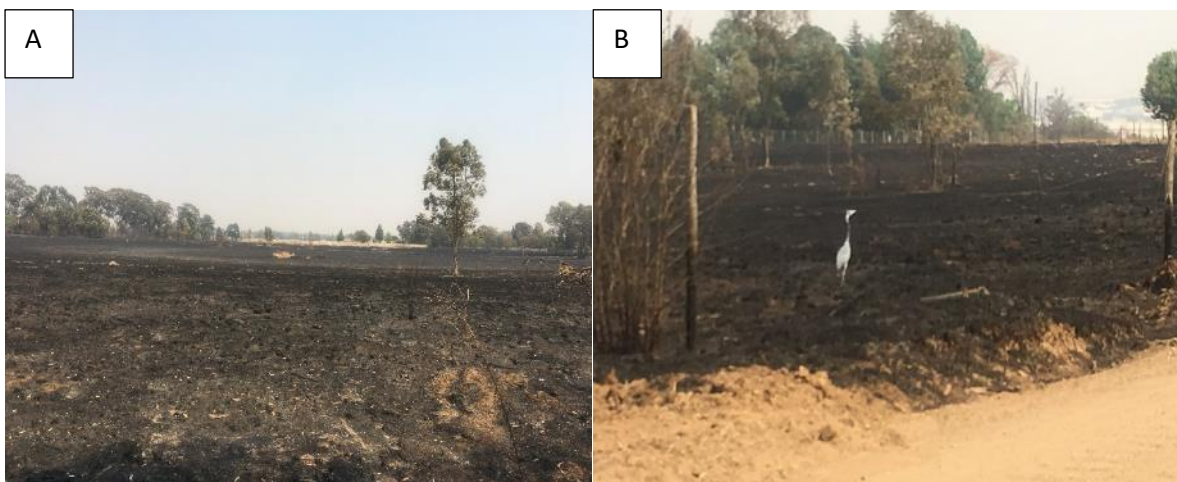
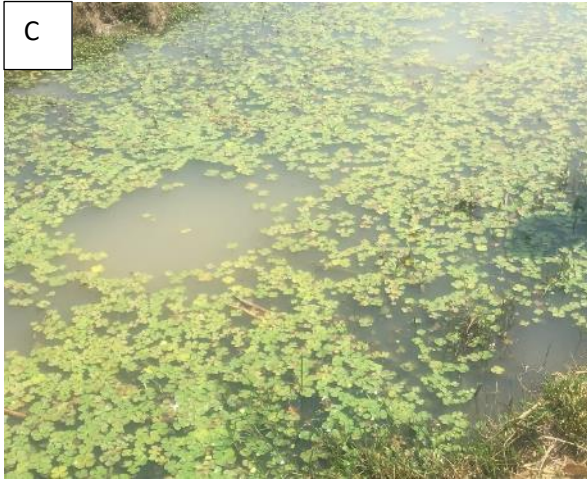
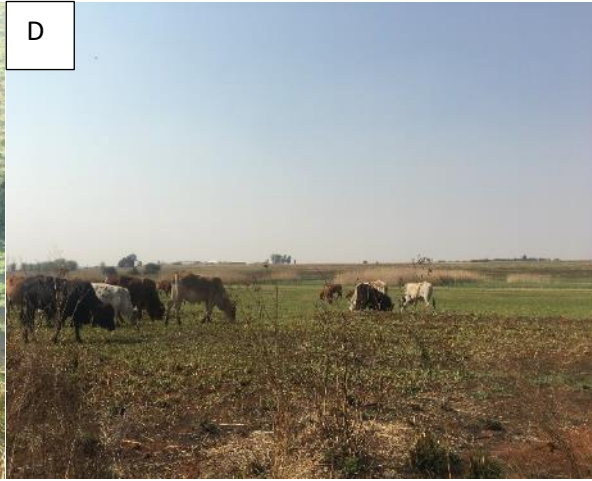
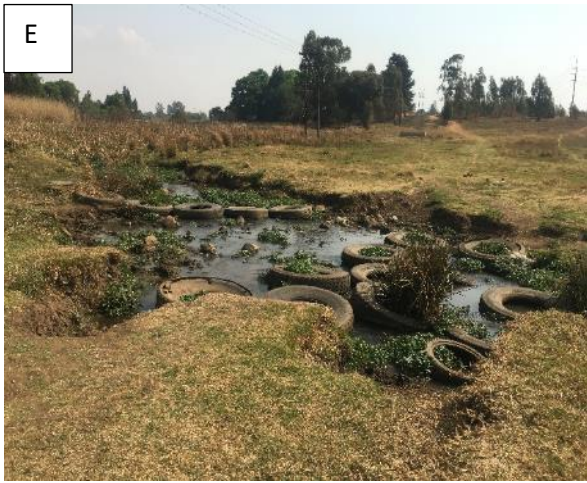
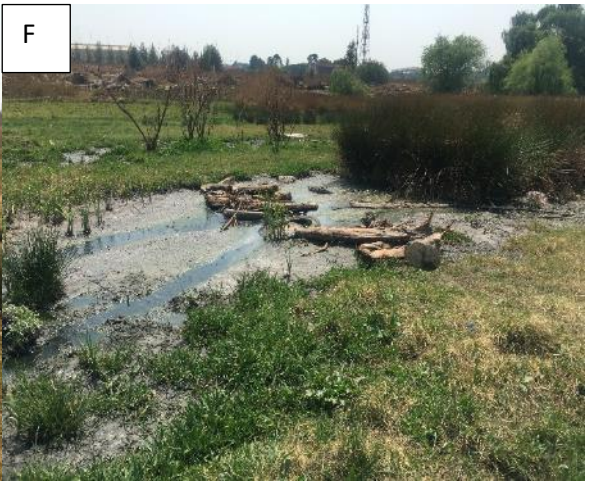
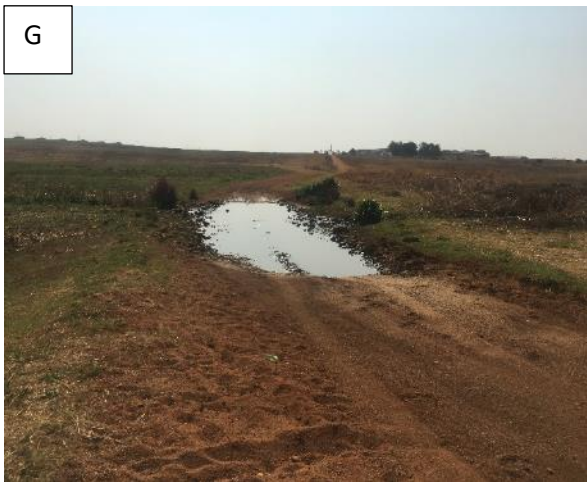
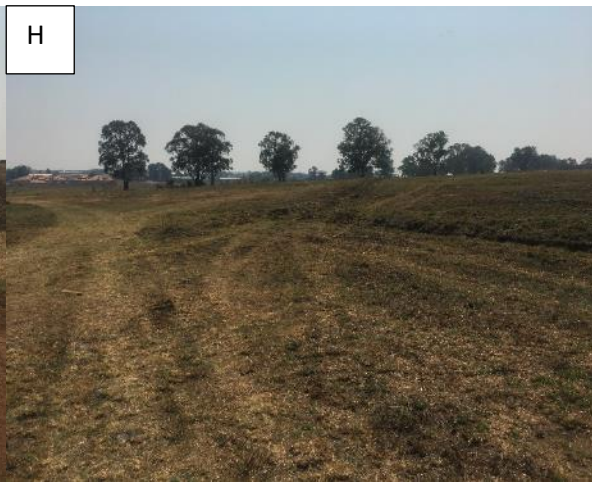
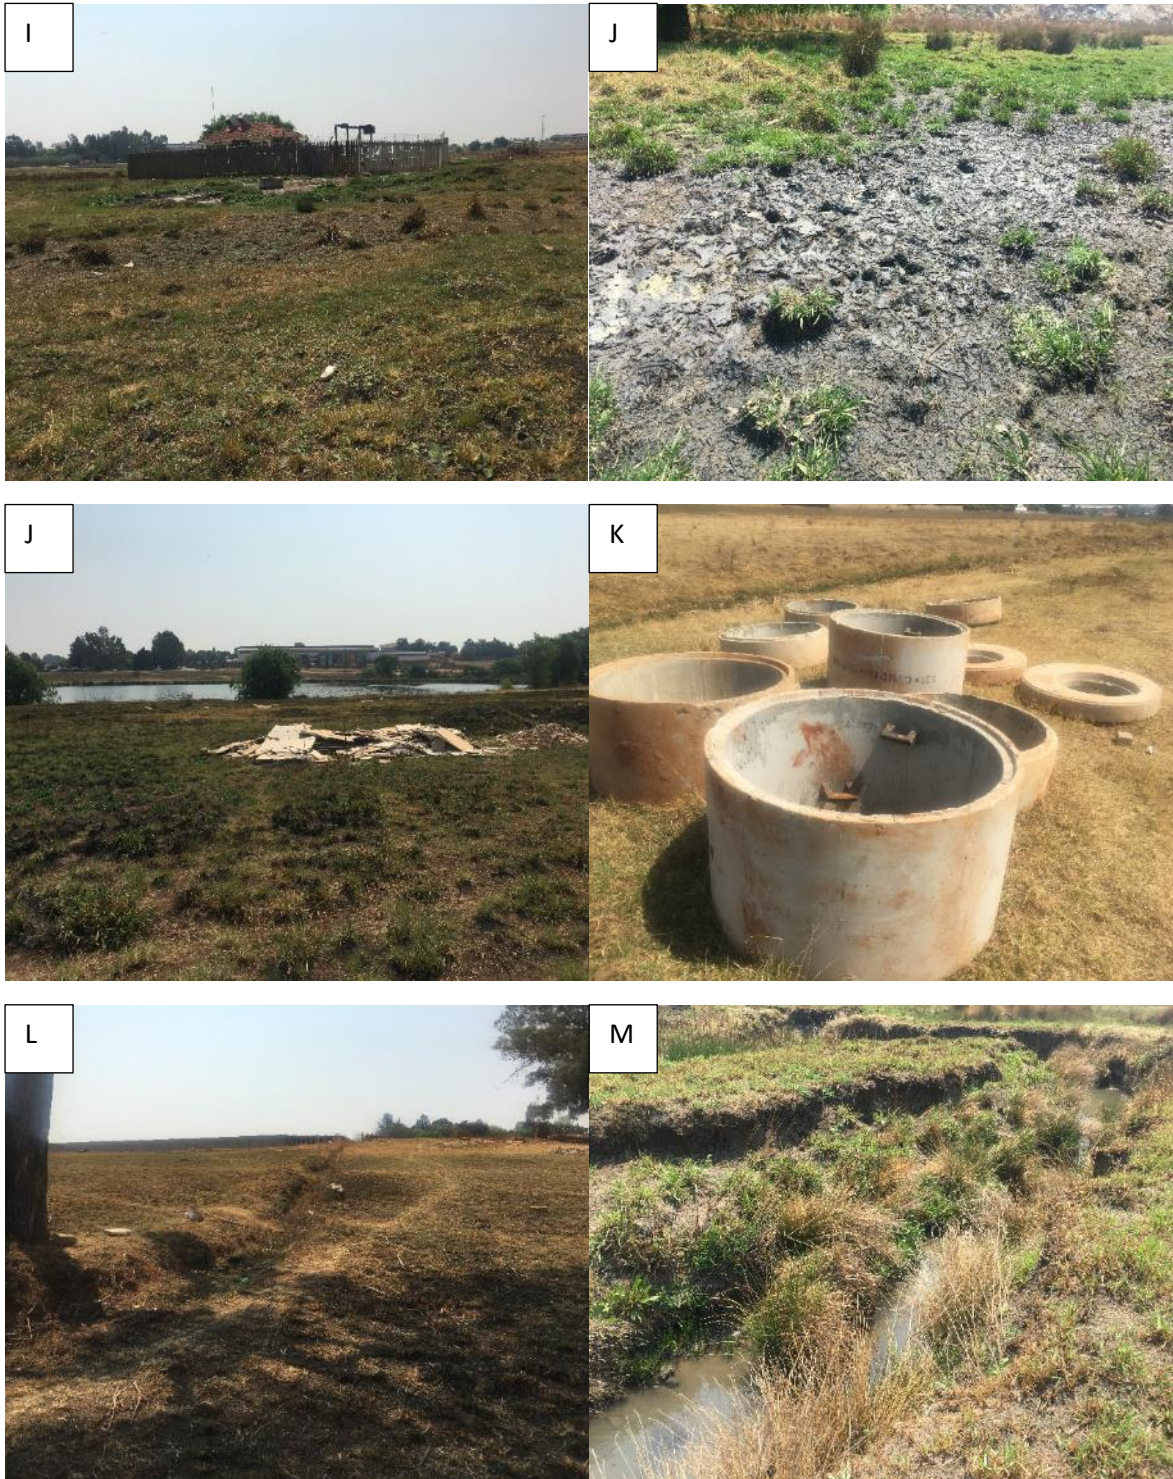
Figure 10: Photographs of impacts observed (veld fires, water weeds, livestock grazing, informal crossings/vehicle tracks, sewage from sewer pump house, rubble /building material mounts, trench and erosion)

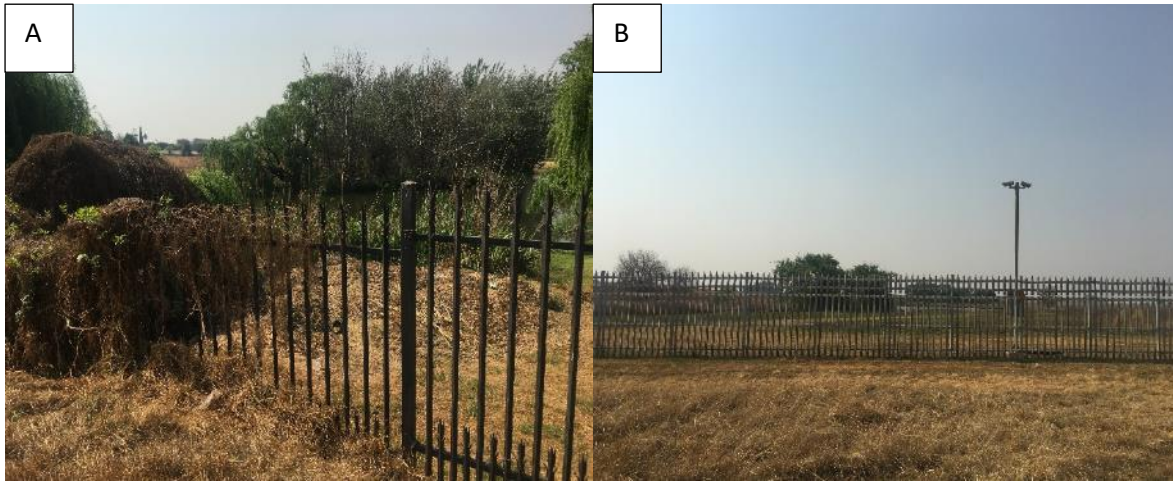
Figure 11: Photographs of existing wetland rehabilitation interventions (fencing off)

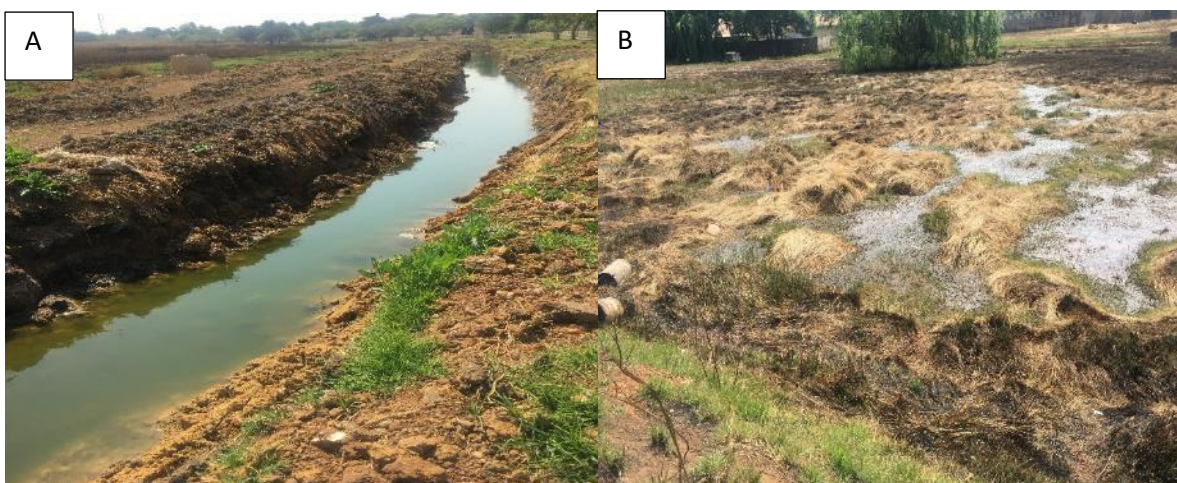
Figure 13: Photographs of impacts observed (informal crossings, veld fires)
