FINAL ENVIRONMENTAL MANAGEMENT PROGRAMME PERFORMANCE ASSESSMENT – 2018

HARMONY ST HELENA 10 SHAFT

REFERENCE NUMBER: FS/30/5/1/2/2/86 MR

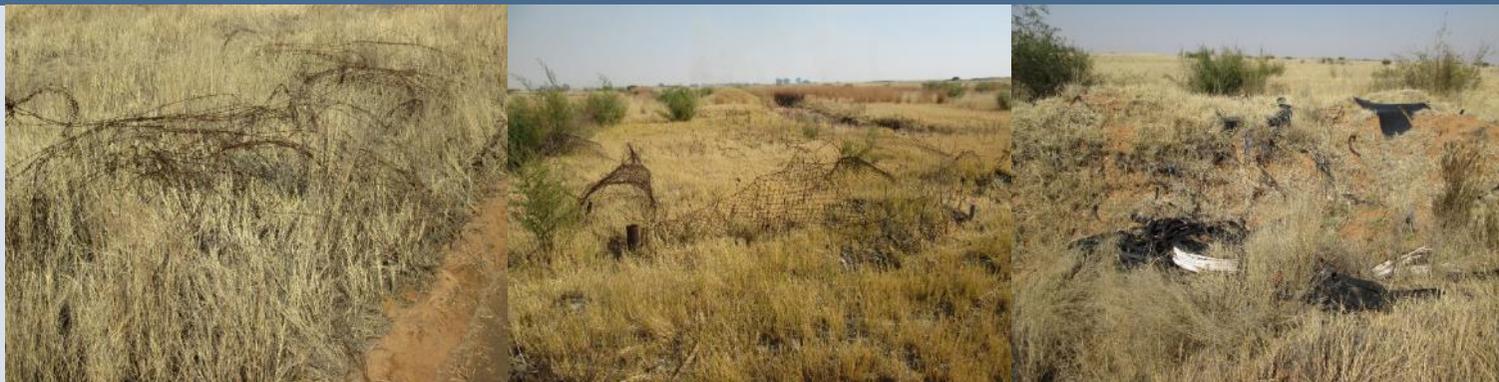
Finding Ref. #	Finding
Waste Management	
1	Some abandoned waste was noted that was not removed during the initial decommissioning of St Helena 10 Shaft. These include waste cables adjacent to the access road and historic bank area as well as dismantled fence material.
Additional Access Roads	
2	Evidence of additional access roads that were created for the use of the vehicles removing the waste rock from the St Helena 10 Shaft site was noted.
Infrastructure Removal	
3	<p>The reclamation and rehabilitation process were ongoing at the time of the audit and not yet completed. Most of the infrastructure was removed or buried at the St Helena 10 Shaft site. Instances were however noted where infrastructure was not removed. These include:</p> <ol style="list-style-type: none"> 1. A number of concrete slabs/foundations. 2. Brick storm water drain structures. 3. A concrete built oil-water separator facility. 4. An unused gravel access road that surrounded the sub-station. 5. An unused concrete culvert structure.

Figure 3: Dismantled fence material and waste cables.

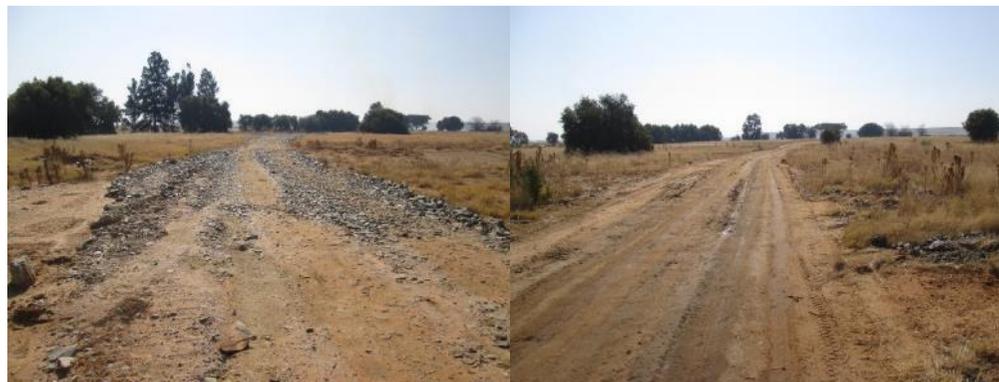
2	4.7.2.13	1. Vehicles may only drive on designated roads.	Evidence of additional access roads that were created for the use of the vehicles removing the waste rock from the St Helena 10 Shaft site was noted. These roads should be removed as soon as possible during the rehabilitation process and no additional roads should be created.
---	----------	---	--

Figure 4: Additional access roads created for use during removal of waste rock material.

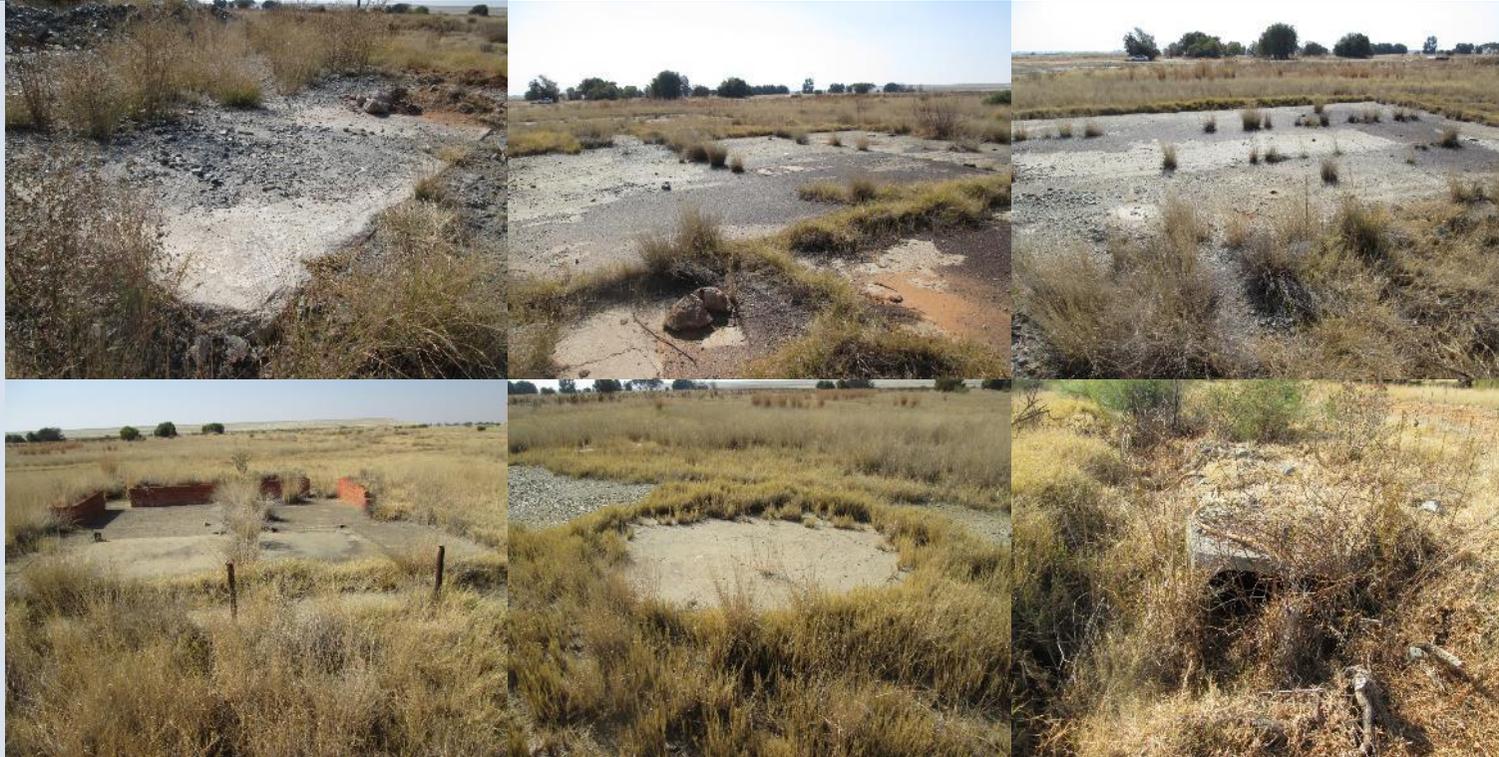
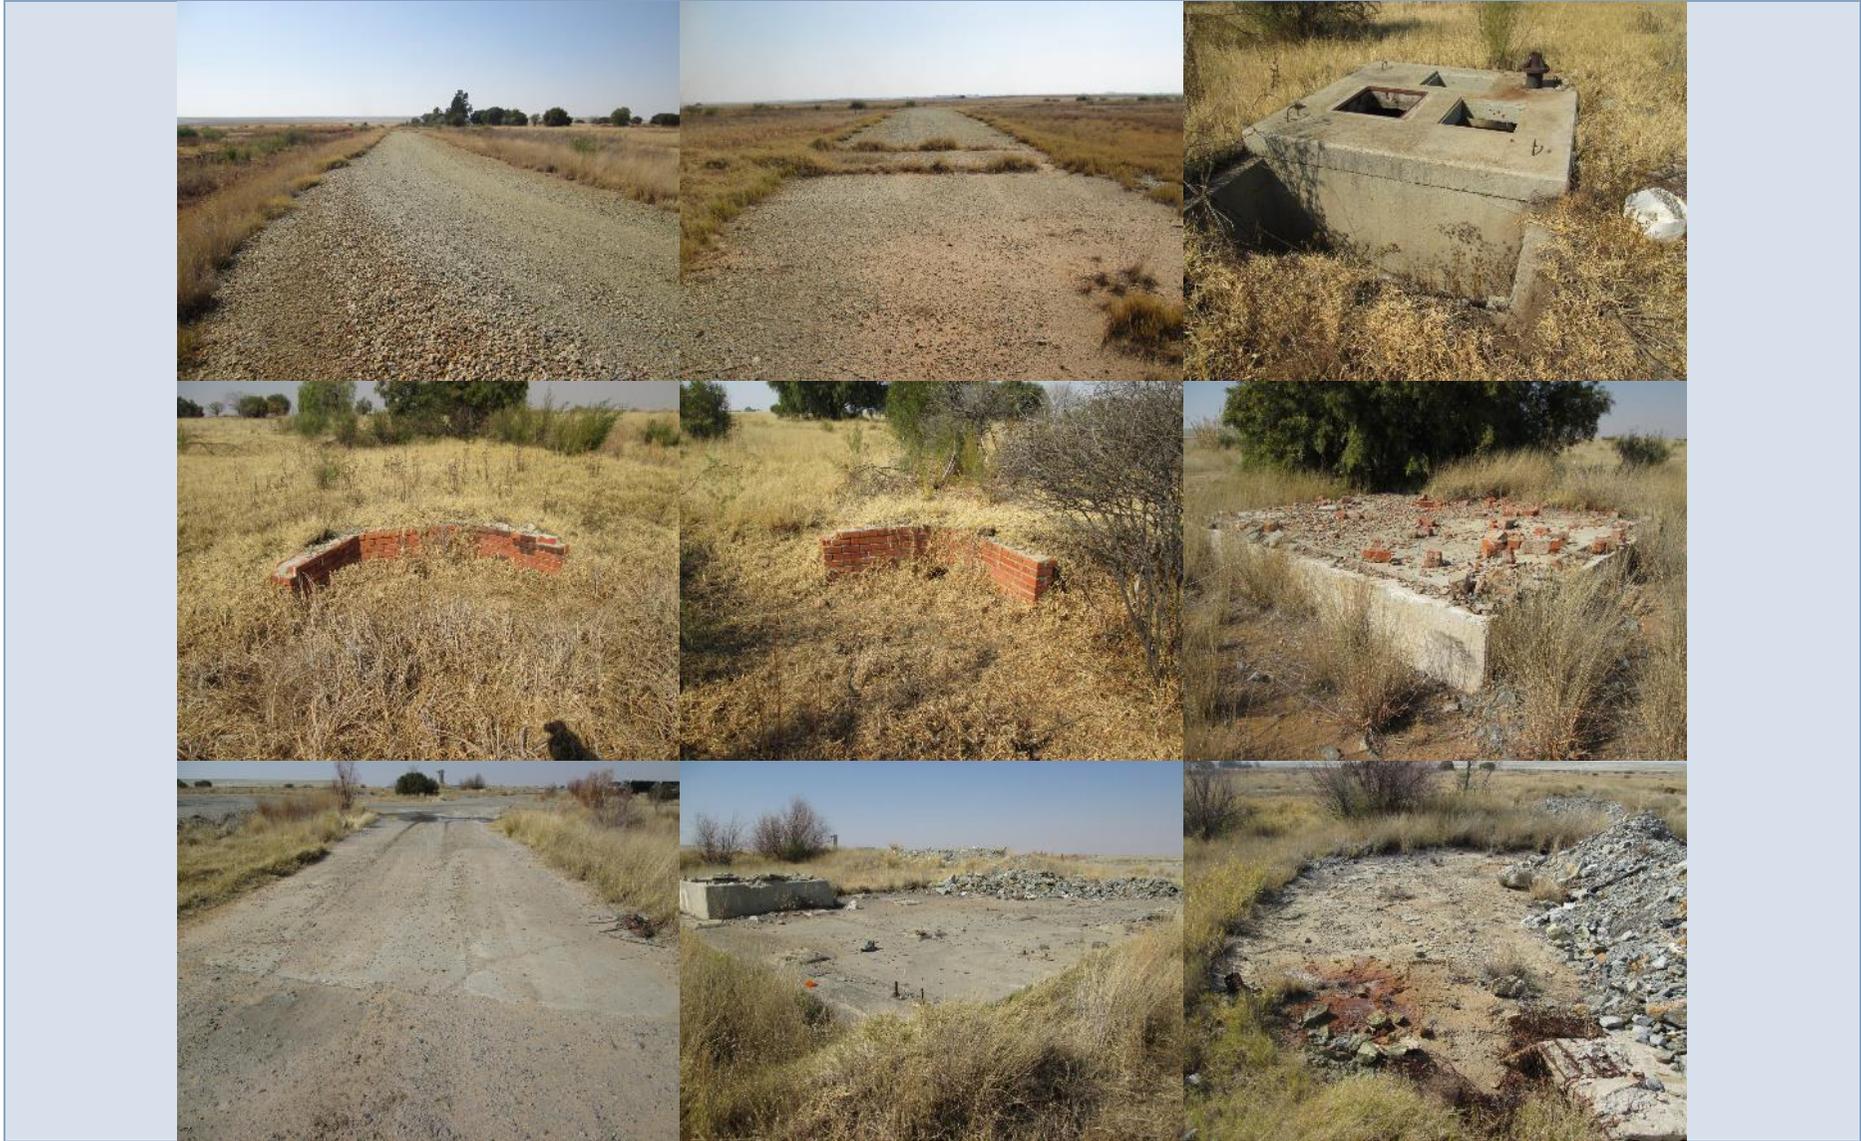
EMPR Ref #	Condition	Compliance Rating	Comments/ Verification
	<ol style="list-style-type: none"> To reduce the visual impact of the altered topography by a process of reclamation and rehabilitation. To dispose of all saleable assets. 	!	The reclamation and rehabilitation process were ongoing at the time of the audit and not yet completed. Some concrete structures were still in place. These include concrete bases, foundations, culverts and sumps.

Figure 5: Indication of infrastructure not yet removed during rehabilitation.

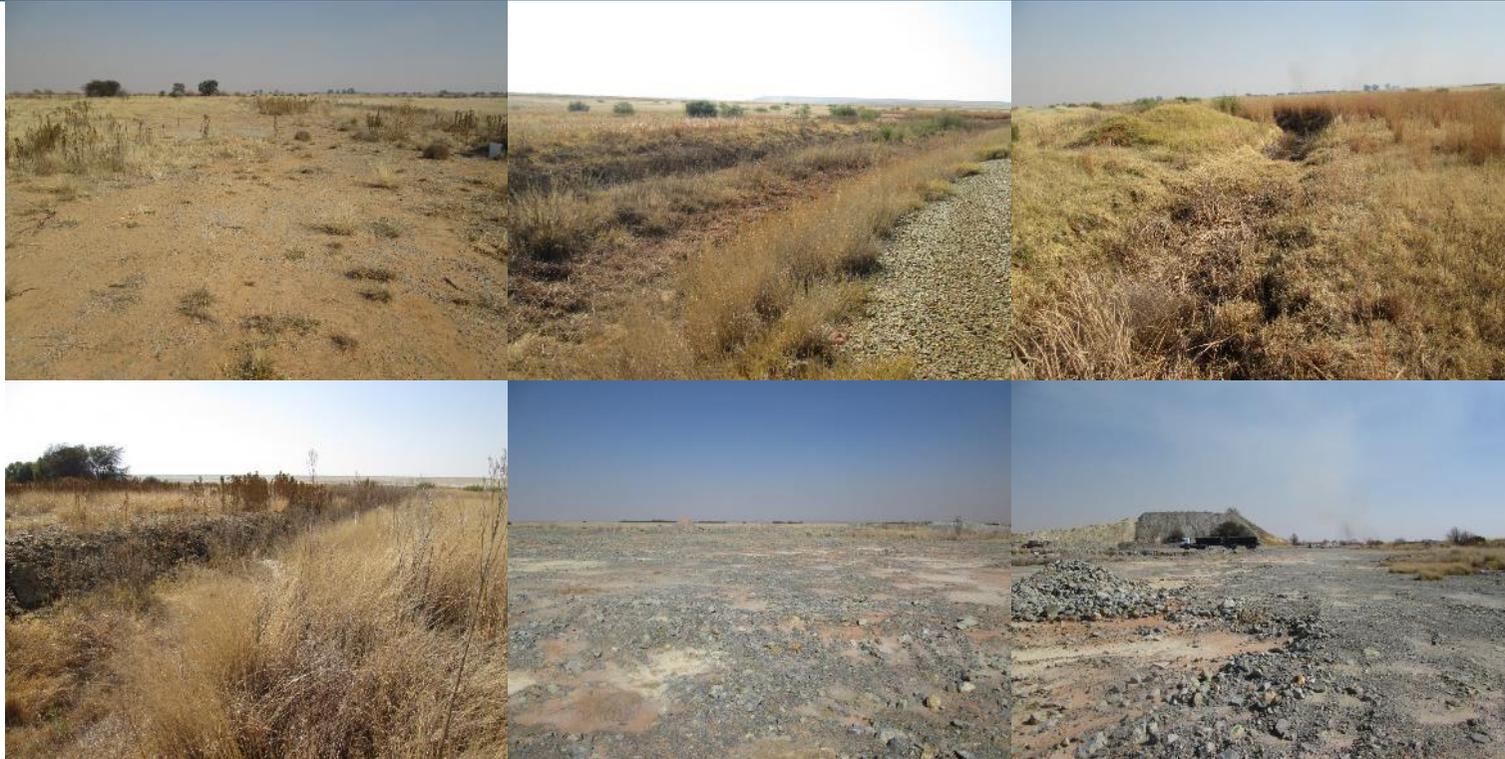
EMPR Ref #	Condition	Compliance Rating	Comments/ Verification
	1. To achieve self sustaining vegetation on the mining area excluding the slimes dams.	!	Self sustaining vegetation has not yet been established in all the disturbed mining areas.

Figure 6: Indication of the areas where additional rehabilitation measures should be implemented.

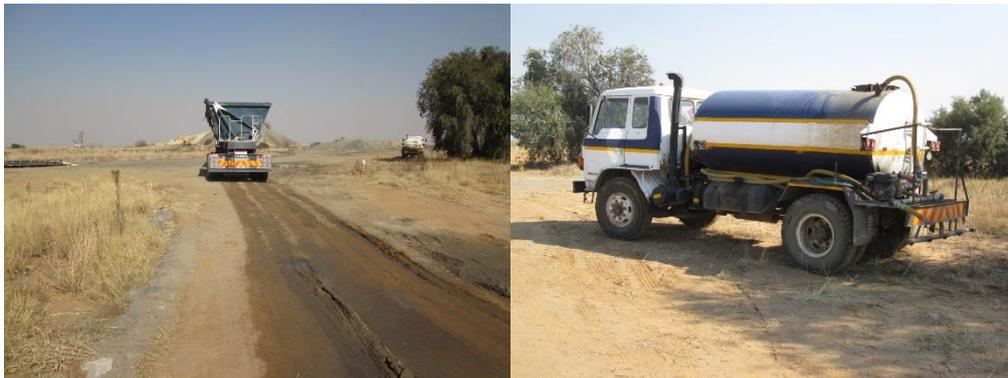
Figure 7: Dust suppression on access roads.

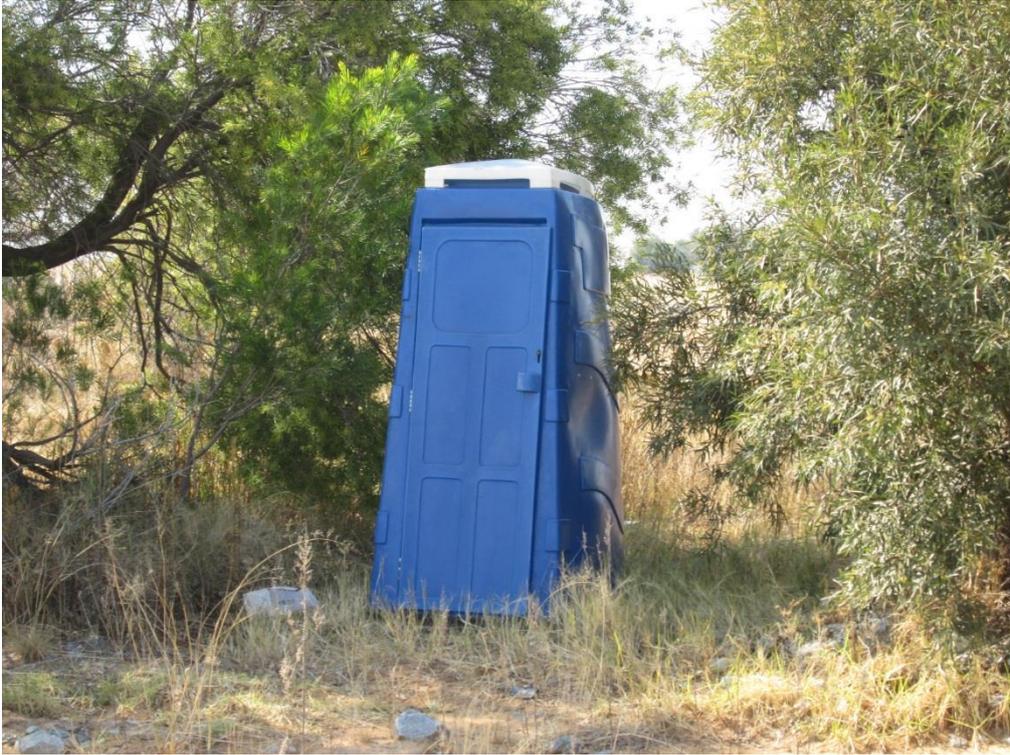
Figure 8: Available ablution facilities.

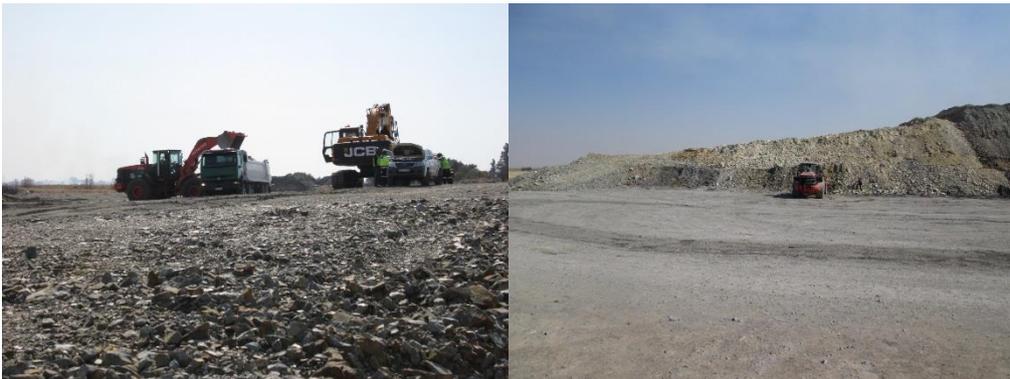
Figure 9: Removal of waste rock dump.

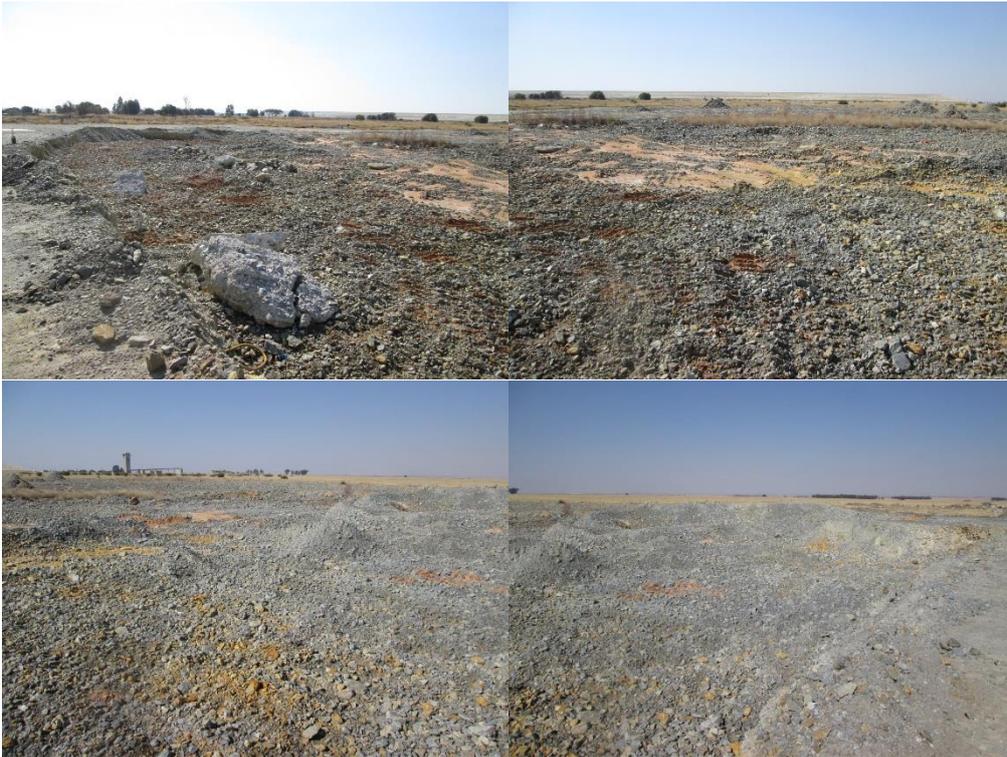
Figure 10: Area where waste rock dump has been removed.

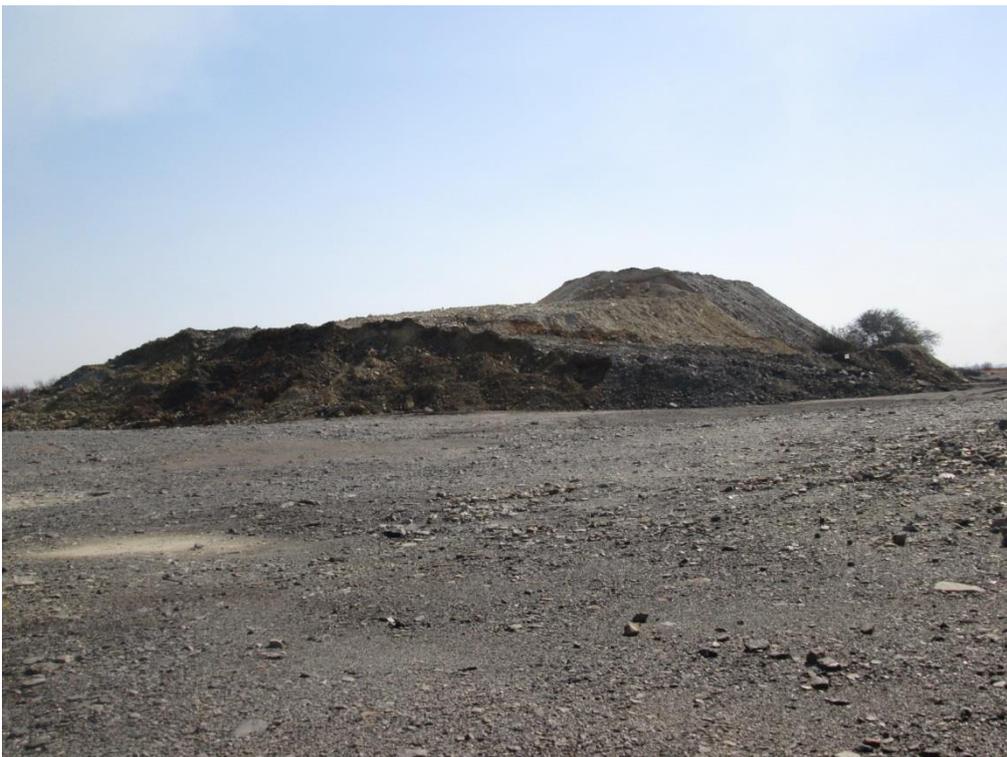
Figure 11: Remaining waste rock dump.

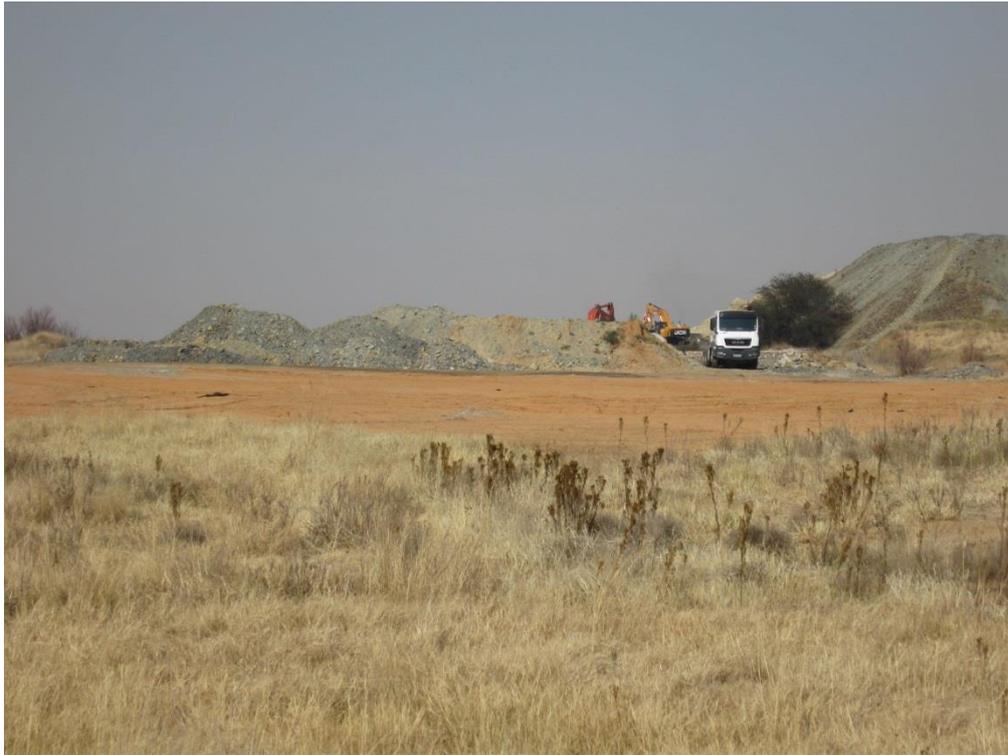
Figure 12: Disposal of waste rock into the shaft.
