Closure Cost Assessment Report

Closure Cost Report FS30/5/1/2/2/86MR

HAR5113

Harmony Gold Mining Company Limited

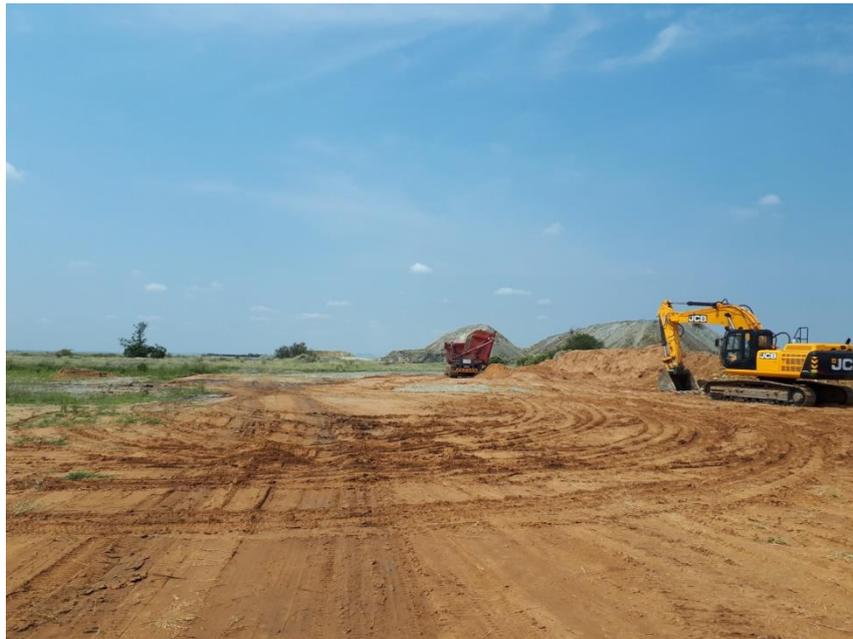
Figure 7-1: St Helena 10 shaft

All infrastructures have been demolished on site. The shafts are currently being filled to surface and will then be plugged based on the approved engineering design.

Sealing of vertical and incline shafts is set to minimise risks associated with these shafts. The shaft must first be filled with building rubble of demolished infrastructure nearby. This is followed by a mass concrete cap (1 000 mm thick) built on top to seal the shaft (DME, 2005).
