EXTERNAL NEMA EA AUDIT REPORT 2018

MOOPLAATS COLLIERY

REFERENCE NUMBERS: 17/2/1/15 MP 29, 17/2/3 GS-58, 17/2/4/G
(GS)-36

EIMS REFERENCE: 1284
DOCUMENT TITLE: Mooiplaats Colliery External NEMA EA Audit Report- 2018

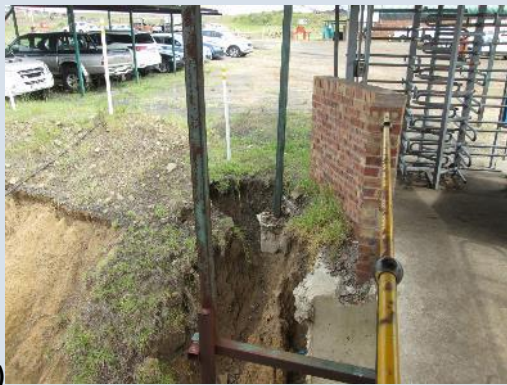
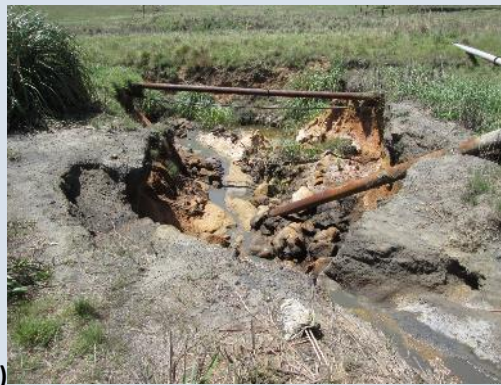
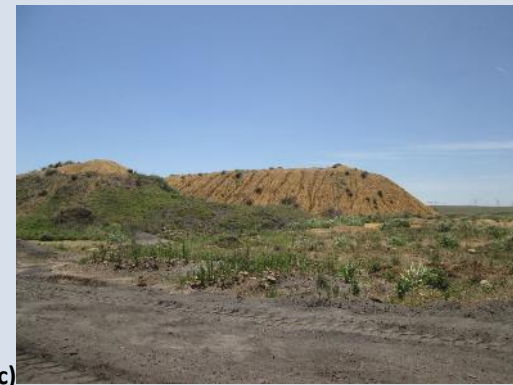
3.16	Measures must be taken to prevent and to reduce erosion.	2	Measures were implemented to prevent and manage soil erosion in most areas. Erosion concerns were however noted within the storm water drain to the south-east of the admin buildings, to the south and north of the incline shaft and on the subsoil stockpile.

3.3.4	Blocking of storm water drainage system must be prevented and storm water must be managed to prevent soil erosion.	2	Measures were implemented to manage storm water and prevent soil erosion in most areas. Erosion concerns were however noted within the storm water drain to the south-east of the admin buildings, to the south and north of the incline shaft and on the subsoil stockpile.

3.3.8	The soil stockpiles must be shaped to reduce soil compaction and must be managed properly to avert any wash down to nearby water courses.	2	Evidence of erosion of the subsoil stockpile located to the west of the shaft was noted. Silt wash from the stockpile could potentially reach the nearby watercourse.

Figure 3: Erosion at the storm water drain to the east of the offices (a), north of the shaft (b) and on the subsoil stockpile (c).

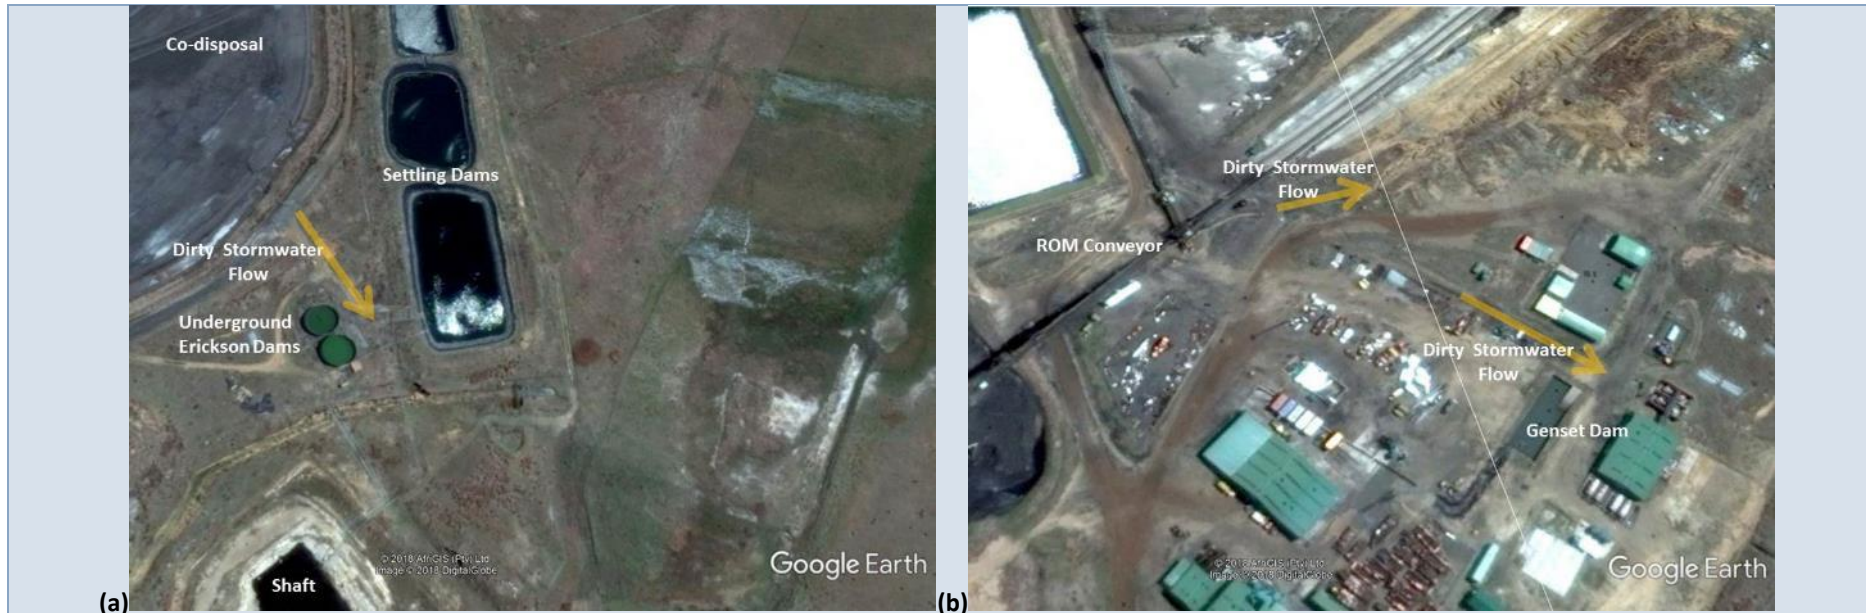
Figure 4: Uncontained dirty storm water from the co-disposal facility (a), ROM conveyor, workshops and laydown area (b).

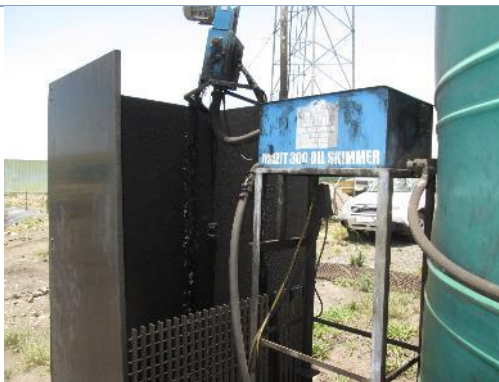
3.3.12	Any spilled product must be directed towards a separator pit where fuel should be removed and disposed of in a hazardous waste treatment facility.	2	An oil-water separator was present at the workshop area, but it was not functional at the time of the audit.

Figure 5: Oil-skimmer at oil-water separator system at the workshop.

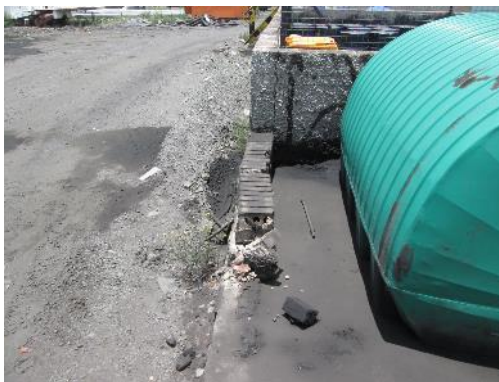
3.3.13	Fuel, lubricants and hydrocarbons must be stored in bunded facilities.	2	Most of the fuel, lubricants and hydrocarbons are stored in bunded areas. It was noted that the bunded area used for the storage of hydrocarbons were broken within the laydown area.

9	3.3.13	Fuel, lubricants and hydrocarbons must be stored in bunded facilities.	It was noted that the bunded area used for the storage of lubricants and hydrocarbons were broken within the laydown area.
---	--------	--	--

Figure 6: Broken bund wall at the laydown area.

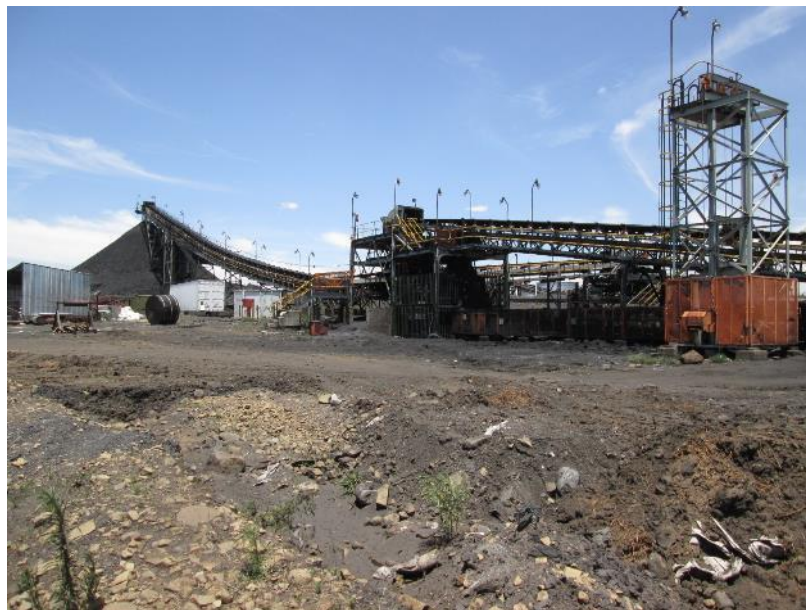
3.3.14	The conveyor must incorporate turnovers to minimize spillage during normal operation. Should spillages occur due to malfunctioning of the conveyor or any other reason, clean-up of all the spillages must be undertaken as soon as possible.	2	It was reported that spillages from the conveyors are undertaken regularly. Spillages from the ROM conveyor were however noted at the time of the audit.

10	3.3.14	The conveyor must incorporate turnovers to minimize spillage during normal operation. Should spillages occur due to malfunctioning of the conveyor or any other reason, clean-up of all the spillages must be undertaken as soon as possible.	Spillages from the ROM conveyor were noted at the time of the audit.
----	--------	---	--

Figure 7: Spills from the ROM conveyor.

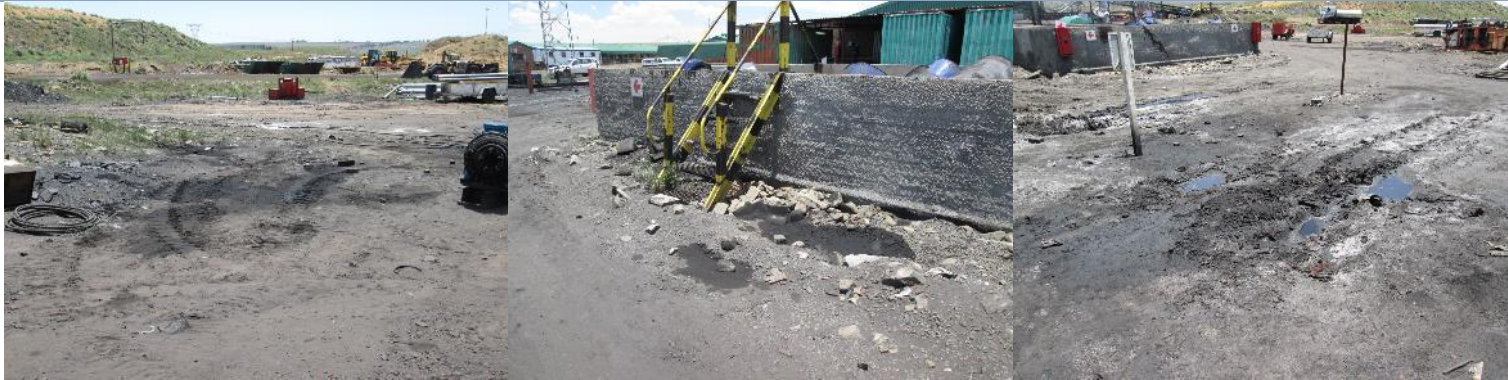
11	3.3.15	All equipment is subjected to noise specification that will reduce the overall noise at the closest receiving environment and ensure that the noise level do not exceed the legal limits.	No noise monitoring reports were available to confirm that the noise limits do not exceed the legal limits.
12	3.3.19	An authorisation in terms of the National Water Act, of 1998 (Act No. 36 of 1998) obtainable from the Department of Water Affairs must be obtained for the operation of all activities that triggers a Water Use License.	Certain of the water uses were not licenced as part of the Water Use Licence. These activities include the Genset Dam and the activities undertaken within and near of the watercourse/ wetland.
13	3.3.26	In the event of an accidental spillage, clean-up of the spillages must be undertaken within 48 hours.	Evidence of hydrocarbon spillages were noted in numerous areas on the mine.

Figure 8:Hydrocarbon spillages noted during the audit.

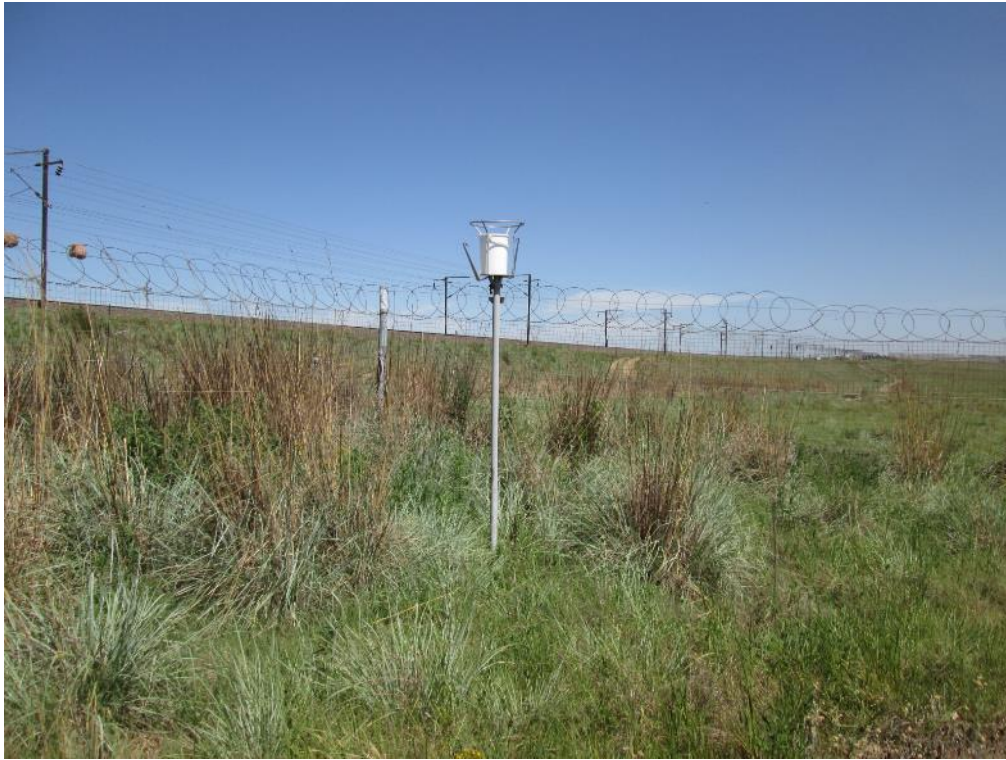
Figure 9: Dust bucket to the north-west of the mining activities.

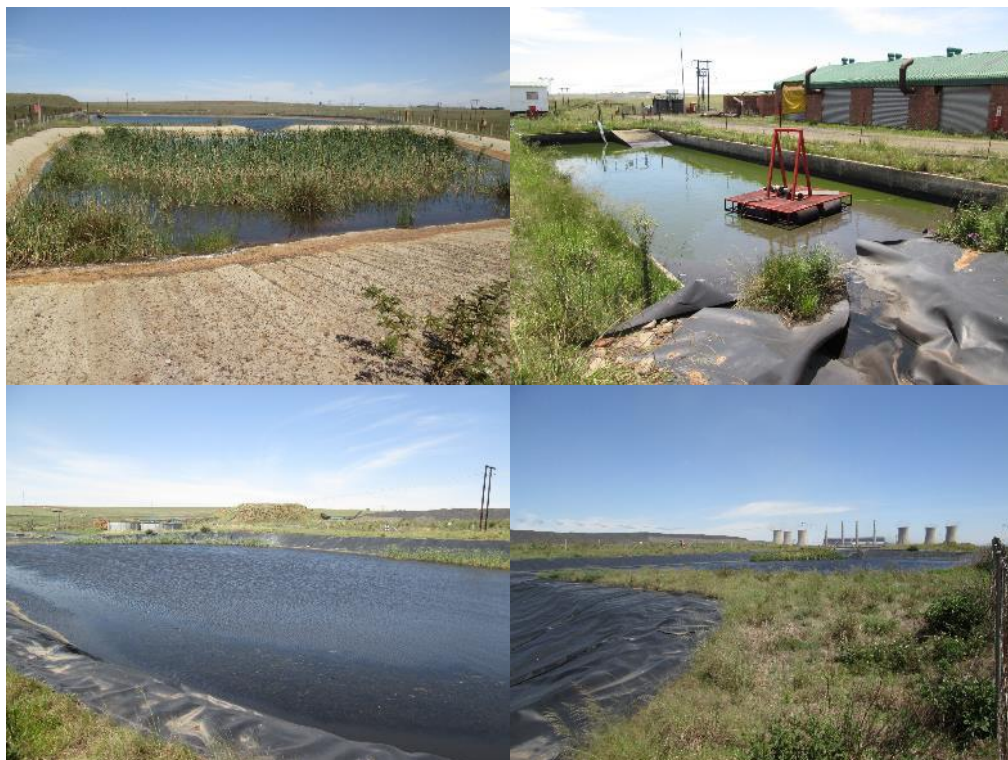
Figure 10: Levels of the PCDs.

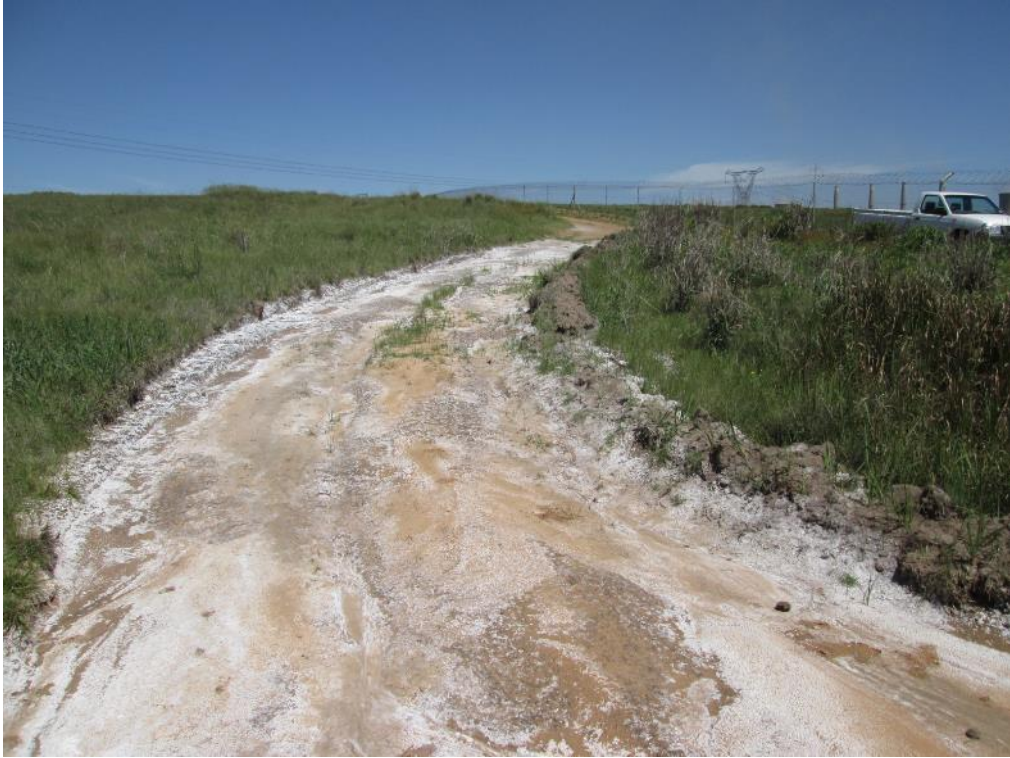
3.3.2	No service roads should be constructed across the valley bottom wetlands and floodplains.	2	Service roads were historically constructed across wetlands as indicted within the updated Mining Right EMPr, dated February 2012. As per the EMPr, these areas should be rehabilitated. No recent construction of access roads within wetlands was noted during the audit.

Figure 11: Access road within the wetland boundary to the north-east of the mining area.

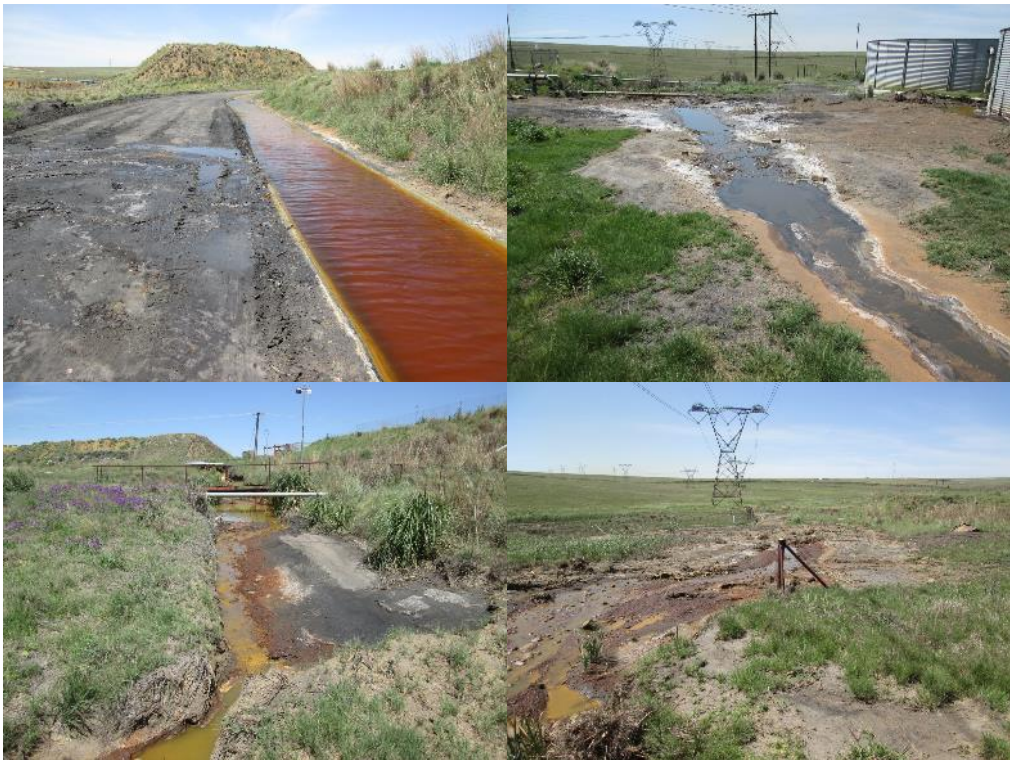
Figure 12: Concrete trench around the co-disposal overflowing towards the watercourse to the south-east of the mining area.

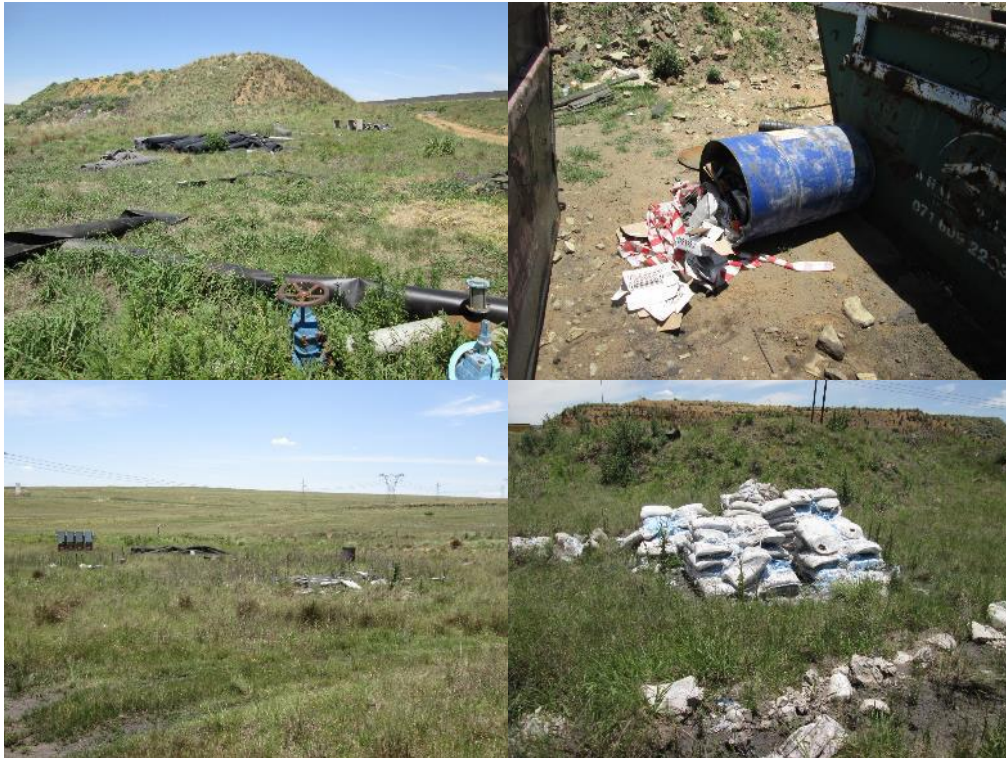
Figure 13: Housekeeping concerns at Mooiplaats Colliery.

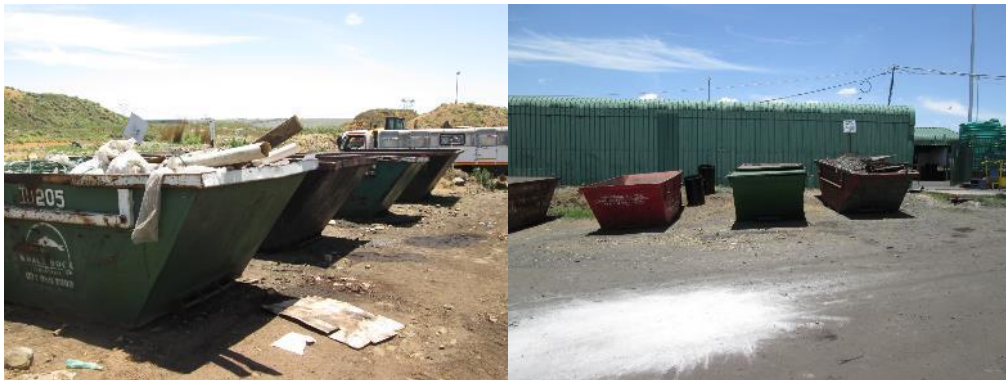
Figure 14: Waste storage areas.

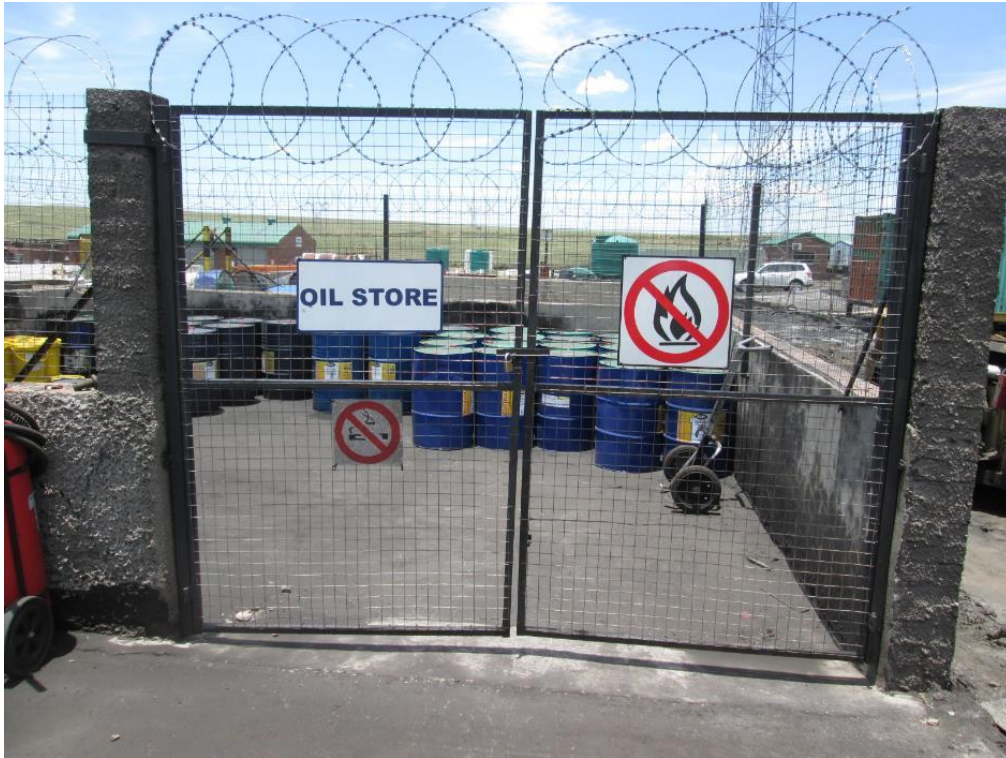
Figure 15: Designated hazardous storage area that was lined, access controlled and signposted.

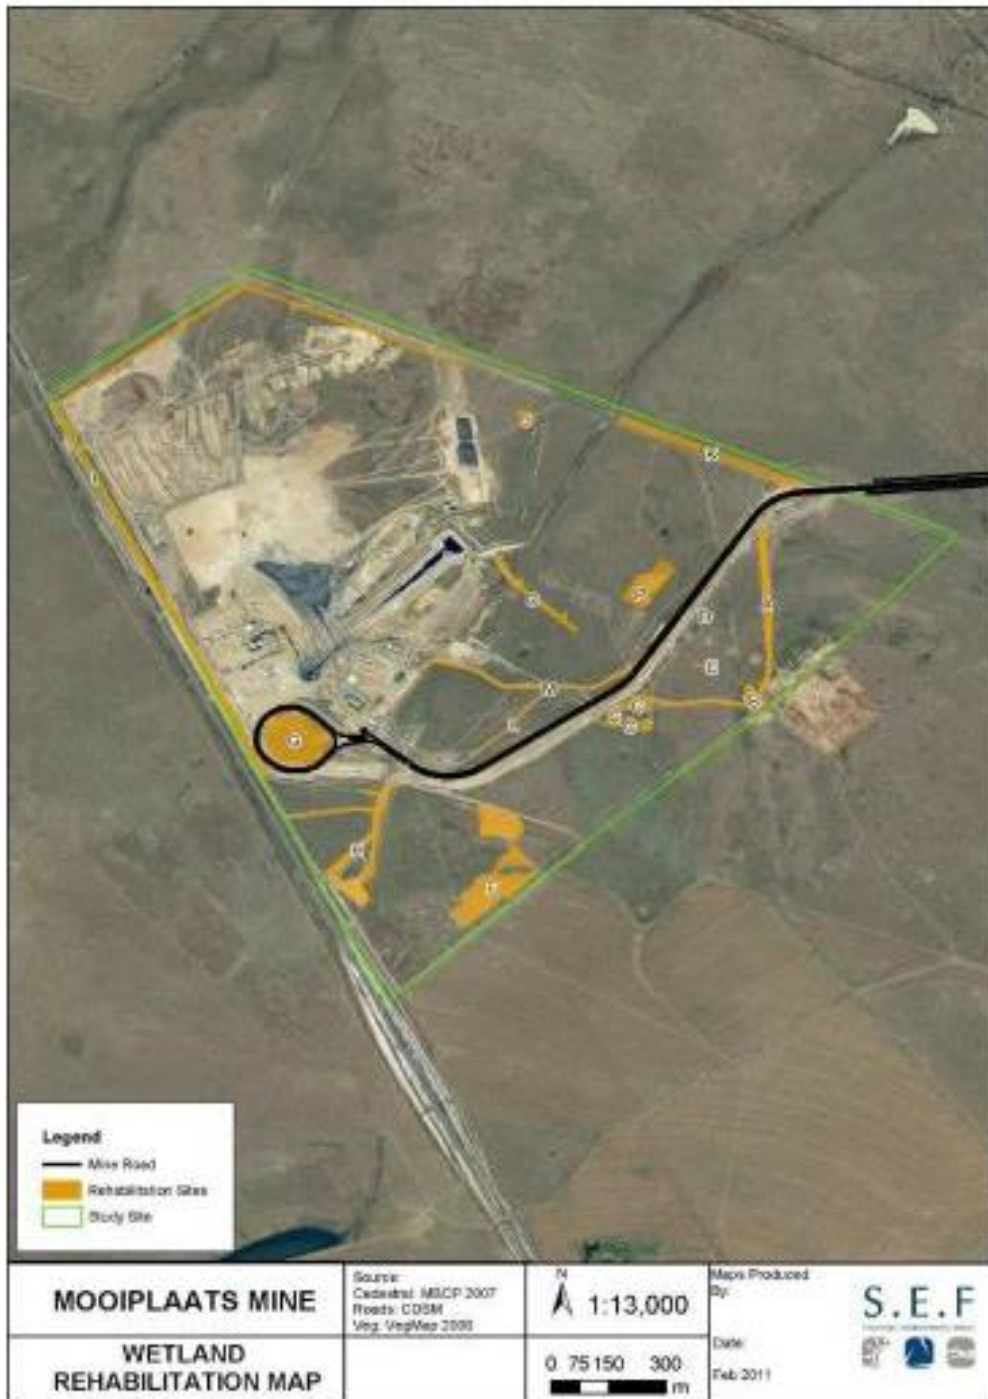
Figure 16: Access roads, stockpiles and general disturbance requiring rehabilitation within wetlands. (Courtesy of the Mining Right EMPr, prepared by Cabanga in 2012.)
