NEMA EMPR AUDIT 2019

ELANDSFONTEIN COLLIERY

ELANDSFONTEIN COLLIERY (PTY) LTD

DECEMBER 2019

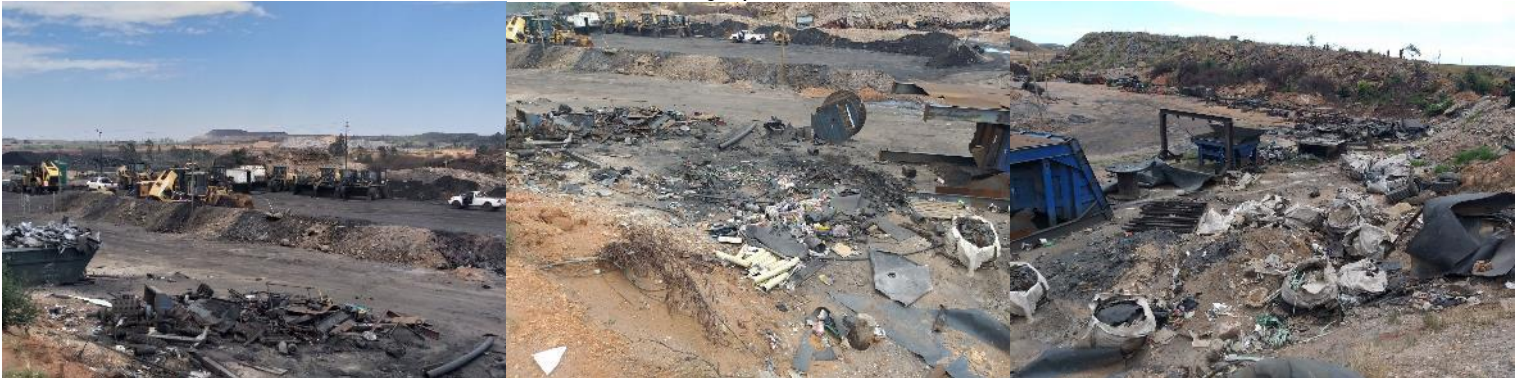
Finding Ref. #	EMPr Aspect	EMPR Requirement	Finding Description
Stormwater Management			
1	Soil, Land Use and Land Capability Surface Water	Ensure proper storm water management designs are in place. All dirty water channels must be constructed and placed within the dirty water infrastructure areas, such that all dirty water runoff emanating from these areas are captured and contained to a dirty water containment facility;	Inadequate stormwater management within the mining areas. Evidence of erosion and ponding in proximity of the wetland/watercourse. Inadequate containment of dirty water from the dirty water areas.
<p>Photographic Record:</p>   <p>Ponding and erosion near the water course and the old Western Opencast Pit.</p>			
Waste Management			
2	Surface Water	The management of general and other forms of waste must ensure collection and disposal into clearly marked skip bins that can be collected by approved contractors for disposal to the appropriate disposal sites;	Inadequate waste management at the salvage yard - limited waste skips were available - a substantial amount of waste was not placed within waste skips and consequently, left lying on the ground.

Inadequate waste management and disposal at the salvage yard.

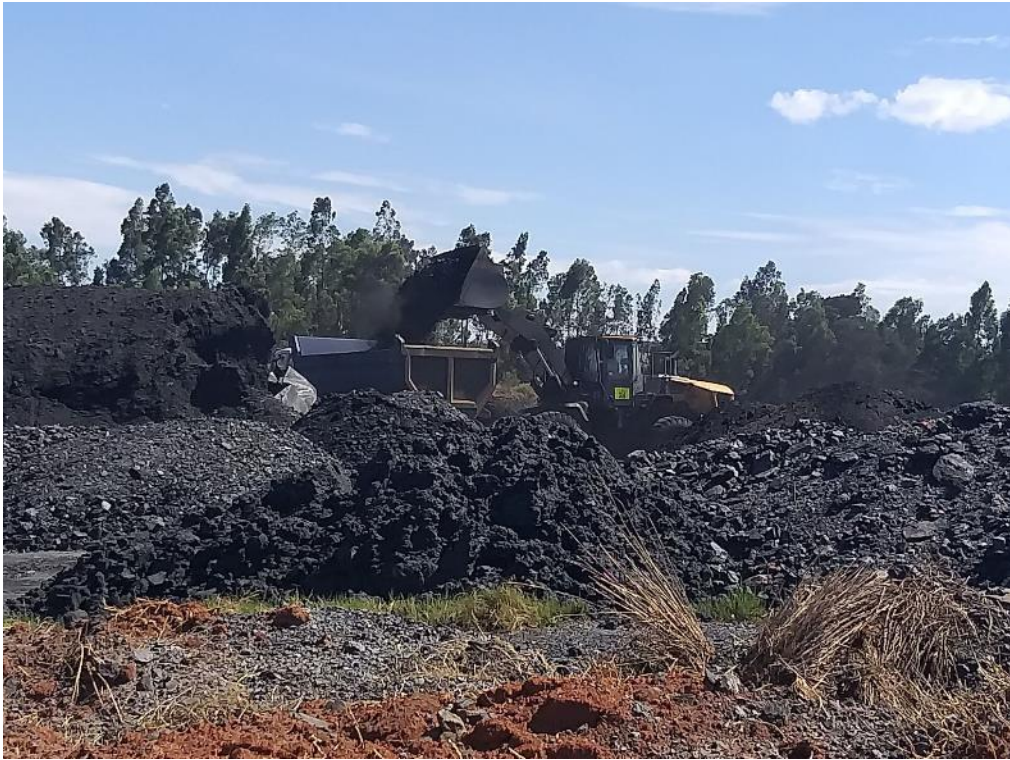
Figure 2: Removal and re-processing of the historically disposed discard within the pits in the northern section of the MR 314 MP Mining Right.

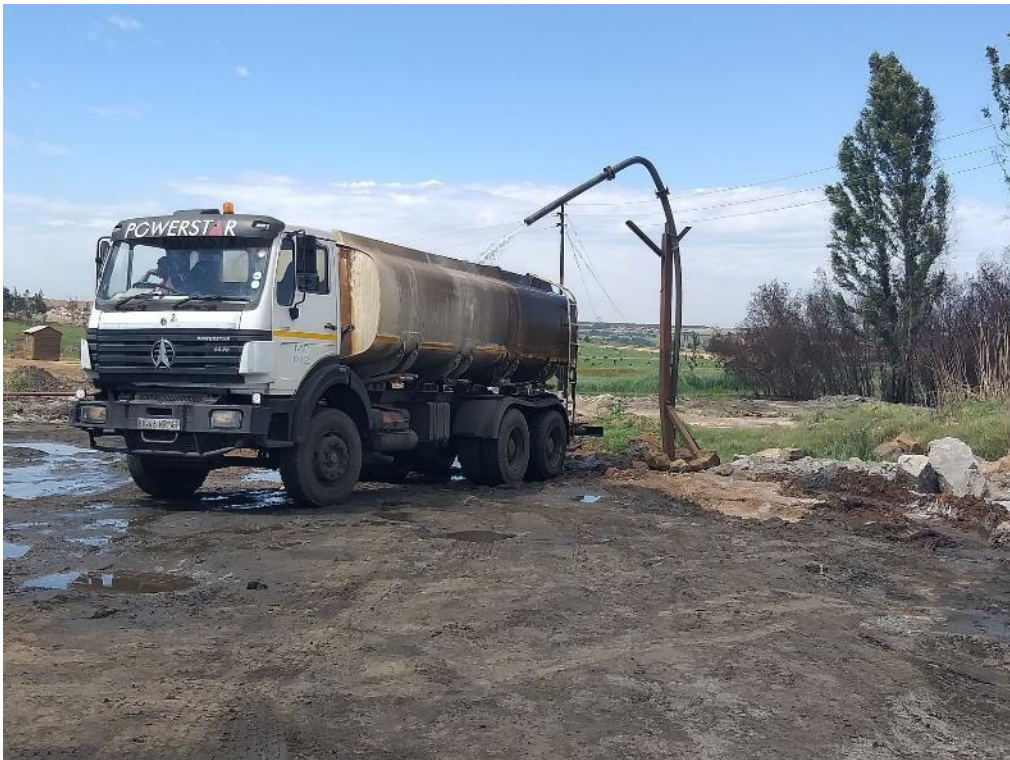
Figure 3: Use of water from PCD 3 for dust suppression.

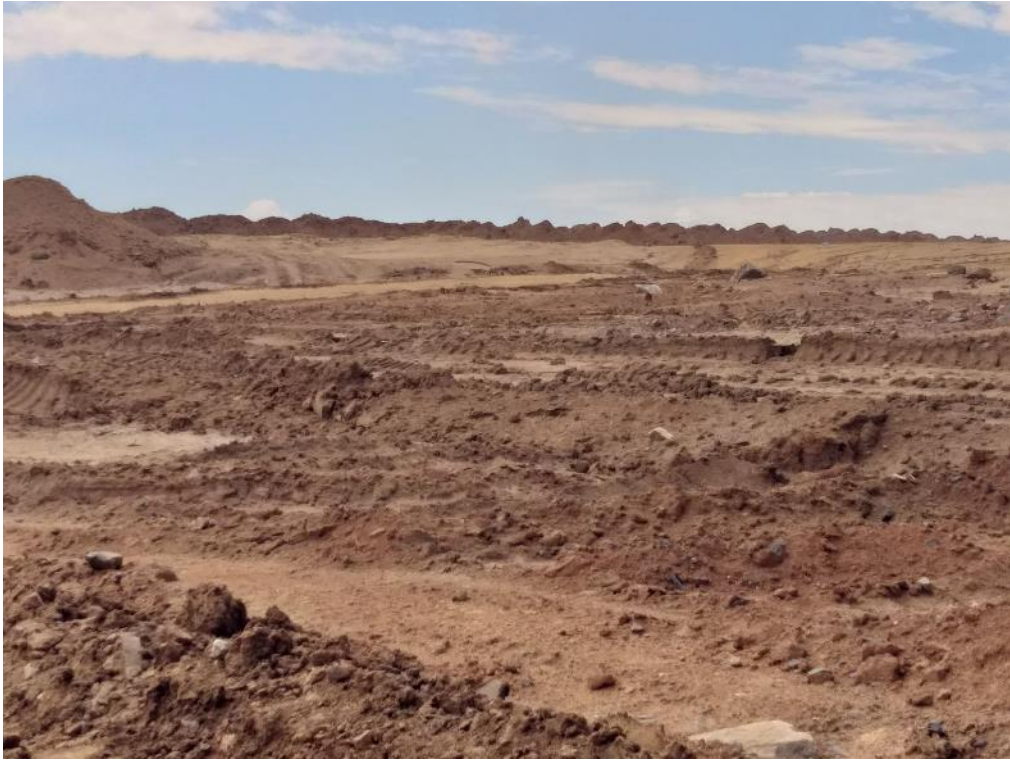
Figure 6: Progressive rehabilitation of recently mined areas.

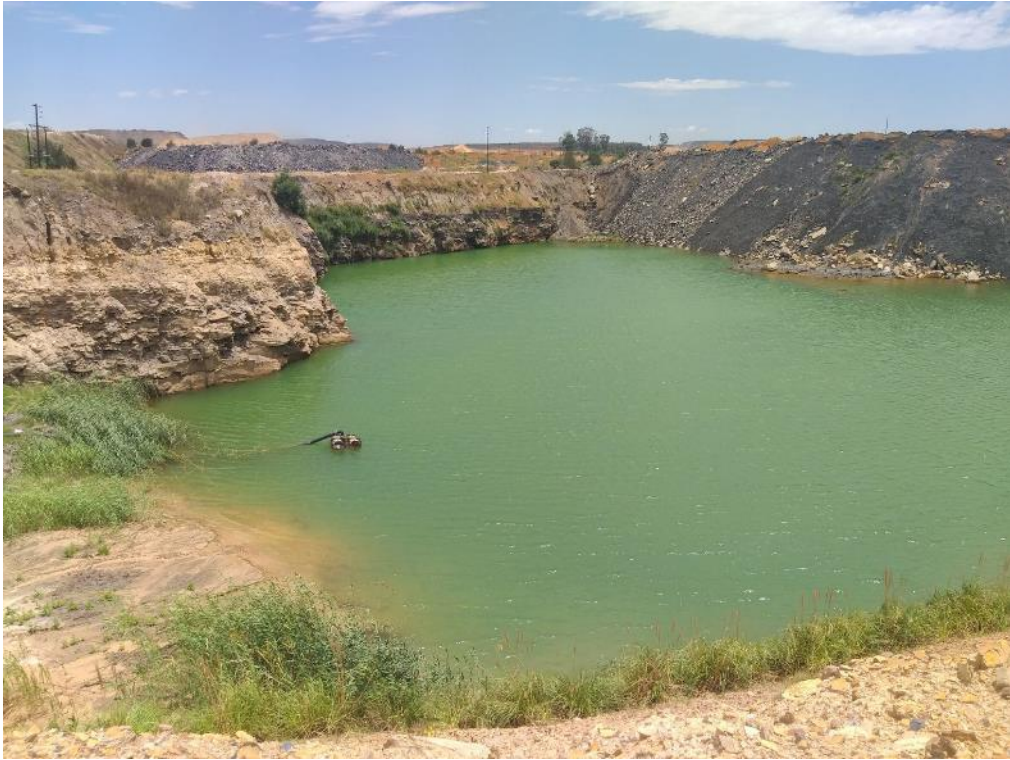
Figure 10: Western Opencast Pit used for containment of runoff water.

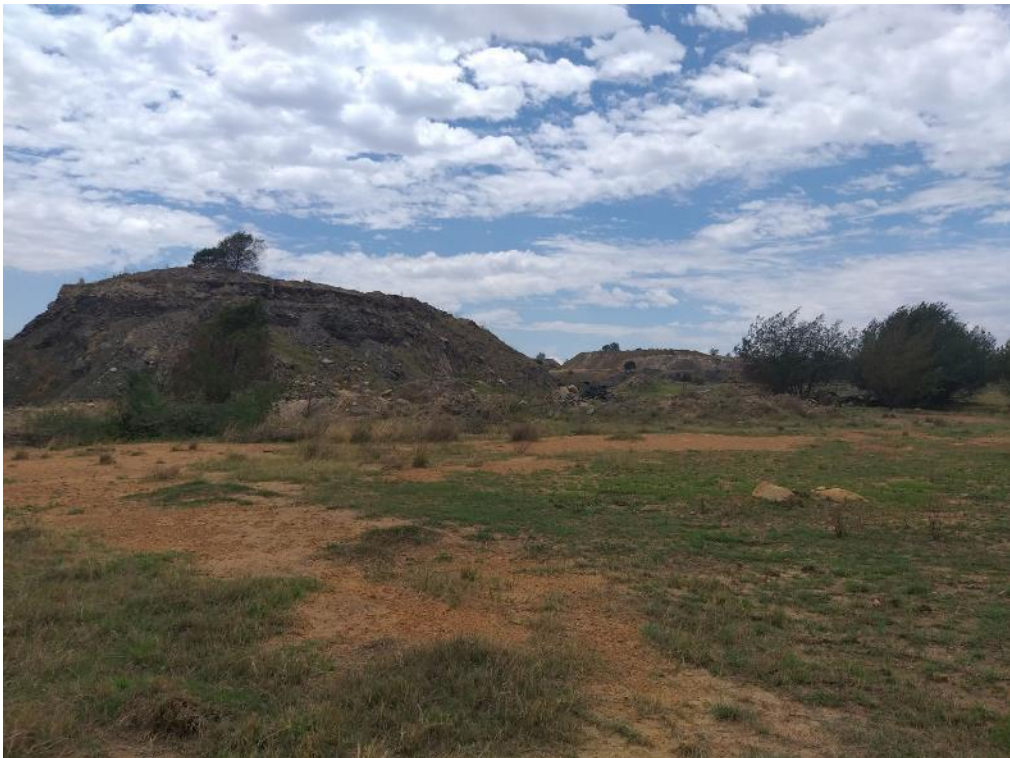
Figure 11: Unrehabilitated stockpiles on MR 63 MP.

3.8	All disturbed areas should be rehabilitated immediately as per the recommendations in the Rehabilitation Report (Digby Wells, 2017a).	2	Good, progressive rehabilitation of opencast mining areas however, several historically disturbed areas have not been rehabilitated.
