City of Ekurhuleni Wetland and Watercourse Rehabilitation Planning within the Kaalspruit Catchment

Situation Assessment Report

Wetland Consulting Services (Pty.) Ltd. in association with GreenGab Consulting (Pty) Ltd.

May 2018

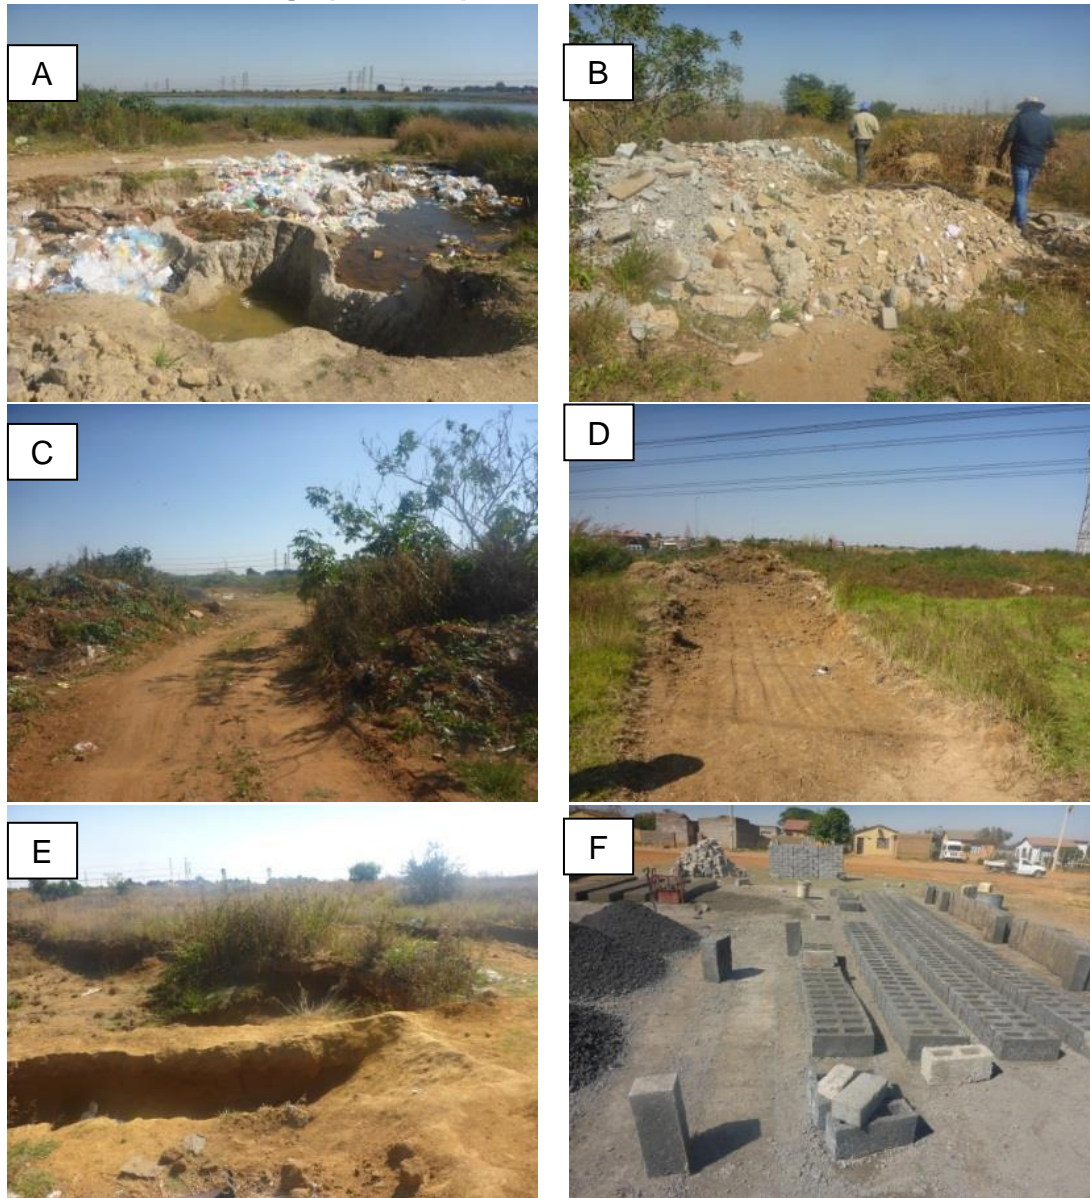
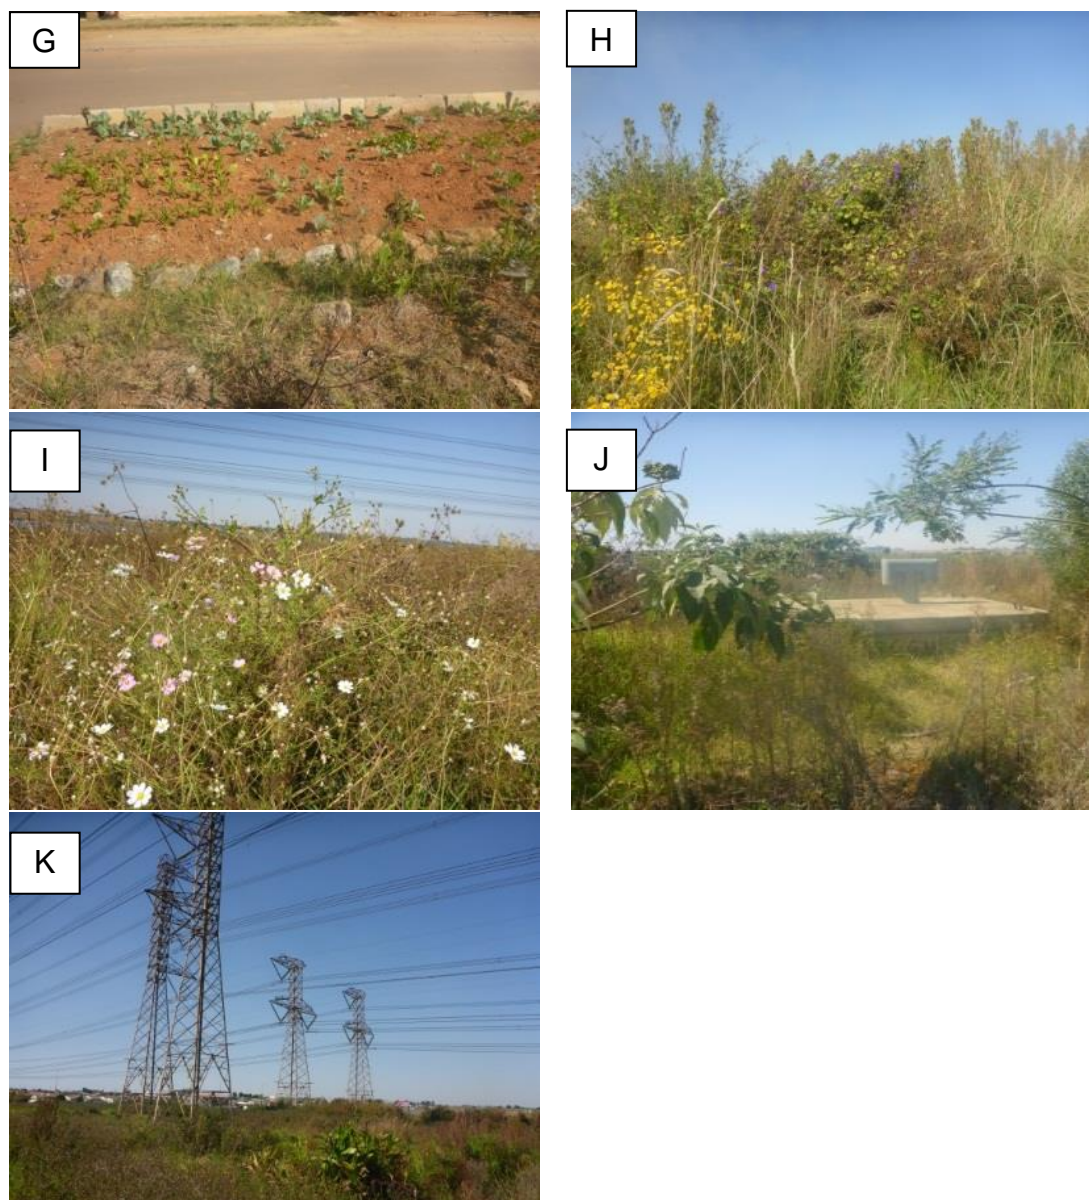
Figure 12: A. Litter (26° 1' 43.29"S 28° 14' 0.40"E); B. Dumping of building rubble (26° 1' 45.76"S 28° 13' 51.75"E); C. tracks and informal roads (26° 1' 49.37"S 28° 13' 53.48"E); D. Ground clearing/scrapping (26° 1' 30.73"S 28° 13' 49.86"E); E. Excavation for building material (26° 1' 51.42"S 28° 13' 50.7"E); F. Storage area for building material (26° 1' 47.35"S 28° 13' 55.33"E)

Figure 12: G. Cultivation for subsistence farming (26° 1' 52.26"S 28° 13' 37.82"E); H. Alien plant species (26° 1' 44.07"S 28° 13' 59.73"E); I. Concrete structures and abandoned concrete pipes (26° 1' 44.96"S 28° 13' 41.76"E); J. Power lines (26° 1' 38.68"S 28° 13' 39.94"E).

- *Erograstis plana*
 - *Eragrostis gummiflua*
 - *Eragrostis curvula*
 - *Agrostis lachnantha*
 - *Cynodon dactylon*
 - *Paspalum distichum*
- Create walkway around the pan basin and vegetate open spaces;

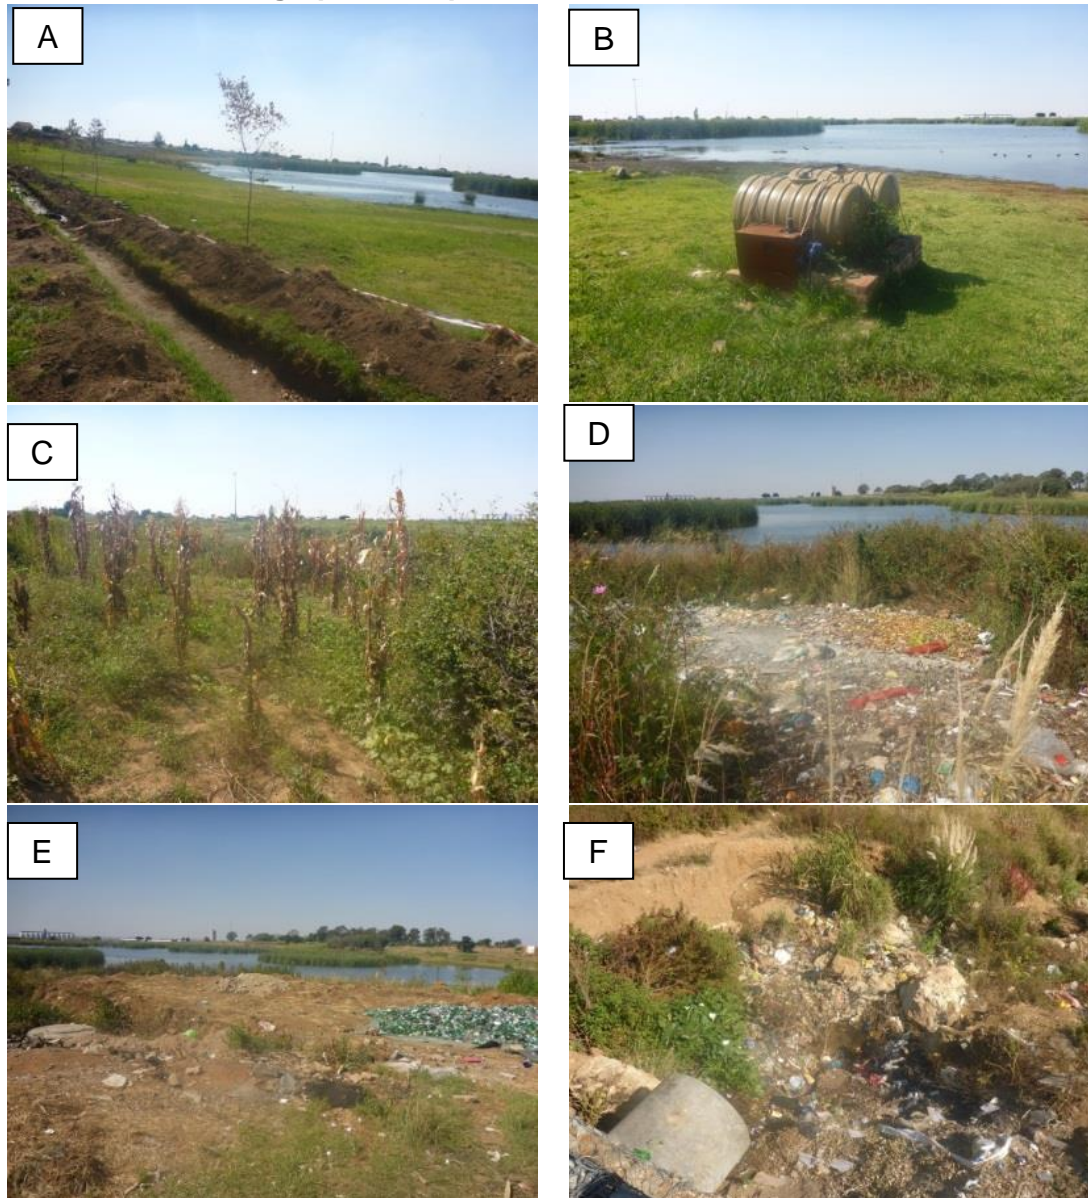
Figure 13: A. Trench close to where new trees have been planted (26° 1' 41.47"S 28° 14' 22.59"E); B. Water (JoJo) tanks for storing water (26° 1' 39.08"S 28° 14' 22.79"E); C. Cultivation for subsistence farming (26° 1' 36.79"S 28° 14' 22.59"E); D. Domestic litter dumping (26° 1' 37.56"S 28° 14' 22.78"E); E. Litter dumping and used bottles (26° 1' 37.32"S 28° 14' 21.38"E); F. Storm-water drainage and litter (26° 1' 37.6"S 28° 14' 21.38"E).

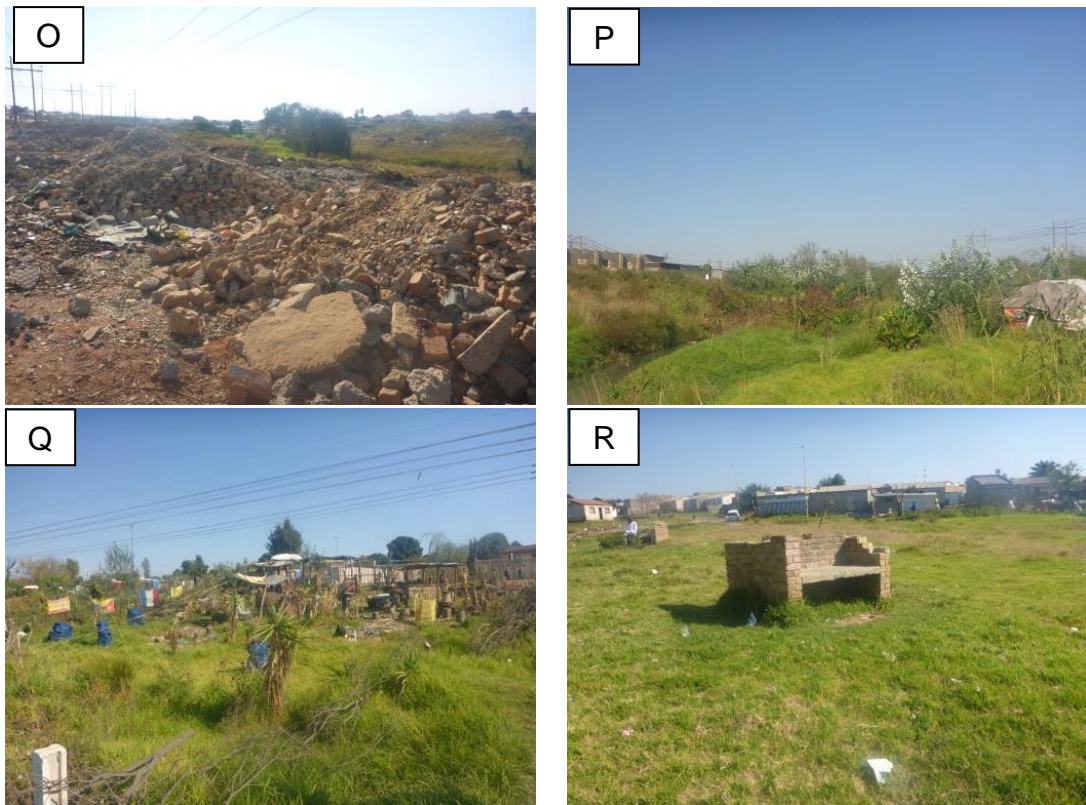
- Dumping of building rubble and litter;
- Sewage discharge and litter;
- Livestock (sheep) grazing in the wetland;
- Area used as a landfill in the valley bottom;
- Excavation and erosion gullies;
- Erosion on the sides of the valley bottom from adjacent housing;
- Tracks and informal roads;
- Cultivation - subsistence farming;
- Storm-water drainage from the road and houses;
- Surcharging manholes into watercourses and water quality deterioration,
- Informal recreational space;
- Concrete building, pipes and structures in the valley bottom;
- Informal human settlements in the valley bottom; and
- Alien invasive vegetation:
 - *Cortaderia selloana*
 - *Salix babylonica*

Figure 14: A. Litter dumping (26° 2' 19.18"S 28° 13' 13.16"E); B. Storm-water drainage from the houses (26° 2' 10.59"S 28° 13' 8.73"E); C. Storm-water drainage from the road (26° 2' 5.73"S 28° 13' 6.34"E); D. Erosion gully (26° 2' 14.47"S 28° 13' 13.05"E); E. Cultivation for subsistence farming (26° 2' 11.75"S 28° 13' 12.10"E); F. Cultivation for subsistence farming (26° 2' 11.75"S 28° 13' 12.10"E). . G. Area used as a landfill (26° 2' 14.38"S 28° 13' 9.78"E); H. Congestion of informal human settlements (squatter camps) (26° 2' 13.33"S 28° 13' 7.64"E); I. Concrete building within the wetland (26° 2' 15.51"S 28° 13' 12.50"E).

- Remove litter and rubble within and around the pan basin;
- Make plans to designate alternative dumping sites outside the wetland (e.g. recycling zone for litter such as plastics);
- Channel cleaning;
- Ploughing areas around the pan basin and leave them for natural vegetation to re-establish
- Practice regular mowing before weeds start flowering to allow natural grass species to come in
- Revegetate areas around the pan basin that remain eroded after ploughing if natural vegetation does not re-establish
- Typical Species:
 - *Imperata cylindrical*
 - *Eragrostis plana*
 - *Eragrostis gummiflua*
 - *Eragrostis curvula*
 - *Agrostis lachnantha*
 - *Paspalum distichum*
 - *Juncus effusus*
- Later species to plant once the grasses have established to attract local avifauna species:
 - *Kniphofia caulescens*
 - *Crinum bulbispermum*

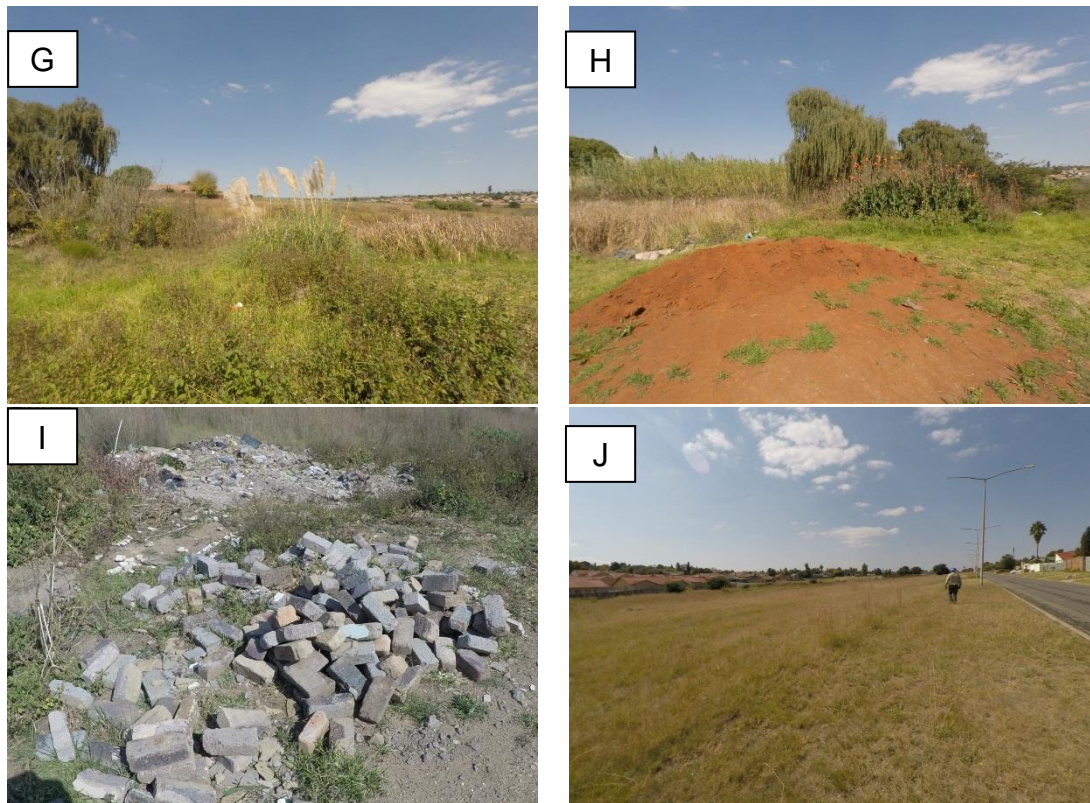
- Dumping of building rubble and litter;
- Sewage discharge into channel;
- Tracks and paths;
- Damaged fencing and damaged storm-water drain; and
- Alien invasive vegetation:
 - *Solanum delagoense*
 - *Bidens pilosa*
 - *Arundo donax*
 - *Morus alba*
 - *Salix babylonica*
 - *Cortaderia selloana*

Figure 16: Damaged fencing (26°2'18.15"S; 28°13'18.54"E); B. damaged storm-water drain (26°2'17.24"S; 28°13'20.12"E); C. Dumping of rubble and alien invasive vegetation (26°2'20.00"S; 28°13'30.14"E); D. Dumping of rubble (26°2'29.20"S; 28°14'17.79"E); E. Dumping of litter (26°2'17.48"S; 28°13'18.89"E); F. Dumping of rubble and litter (26°2'17.15"S; 28°13'19.66"E). G. Presence of alien invasive vegetation (26°2'17.25"S; 28°13'20.90"E); H. Dumping of sand and alien invasive vegetation (26°2'17.37"S; 28°13'22.84"E); I. Dumping of rubble (26°2'19.61"S; 28°13'29.39"E); J. Open area surrounding channel and possible recreational space for community (26°2'22.99"S; 28°13'46.21"E).

- Replace damaged fencing and fix damaged storm-water drain;
- Removal of rubble and litter around the channel and in the open surrounding area and supply an alternative official dumping site;
- Upgrade sewerage infrastructure to limit sewerage discharge into the streams;
- Revegetate the channel using indigenous flora:
- Typical Species:
 - *Typha capensis*
 - *Juncus effuses*
 - *Kyllinga erecta*
 - *Schoenoplectus decipiens*
- Revegetate the open area using indigenous flora:
- Typical Species:
 - *Erythrina lysistemon trees*
 - *Celtis Africana trees*
 - *Melinis repens*
 - *Eragrostis racemosa*
- Create designated paths in the open surrounding area and bridges across the channel; and
- Create a recreational area for the community in the open surrounding area by providing benches, park facilities and planting trees to provide shade.

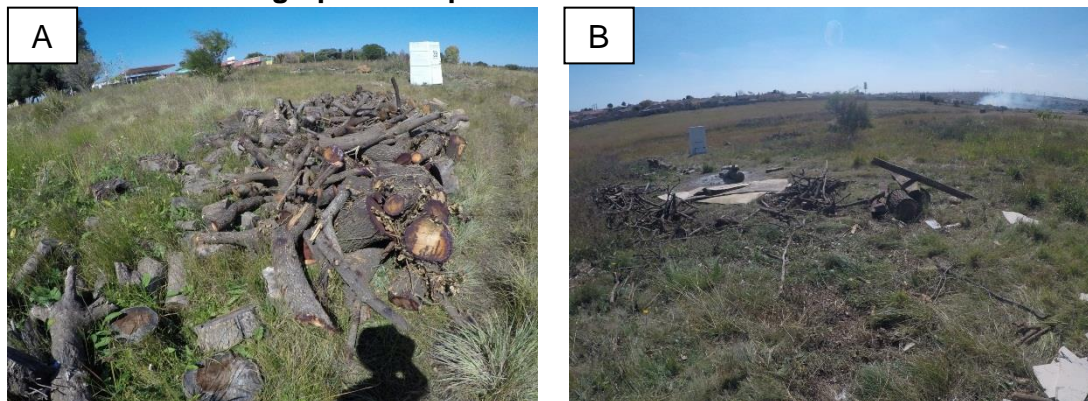
Figure 17: A. Dumping of plant material (26°2'40.26"S; 28°13'3.18"E); B. Dumping of rubble and litter (26°2'41.41"S; 28°13'3.47"E).

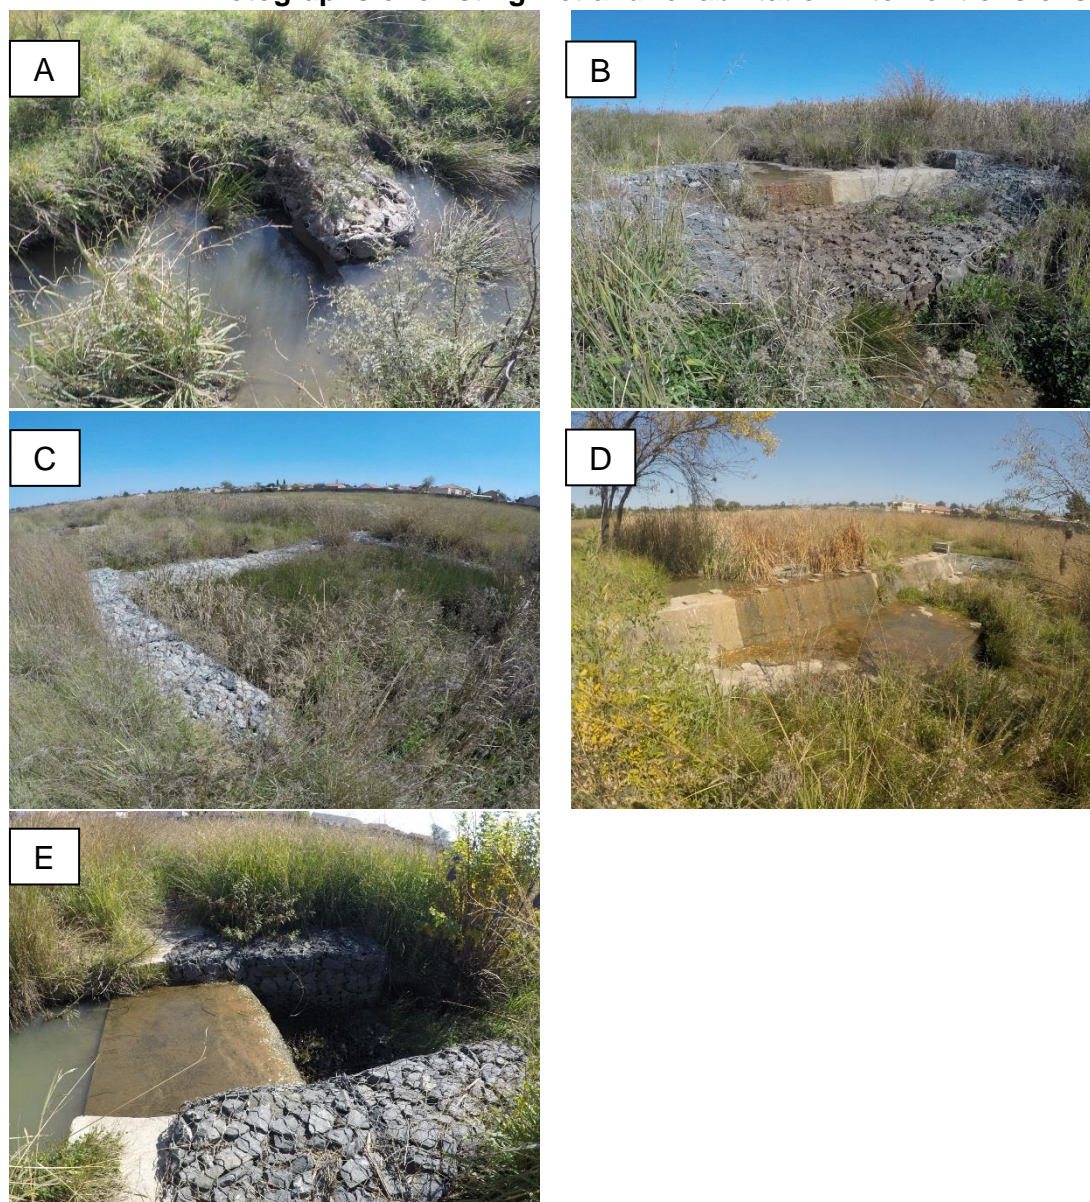
Figure 18: A. Gabion (26°2'40.72"S; 28°13'1.38"E); B. Buttress gabion weir (26°2'36.43"S; 28°13'4.67"E); C. Gabion (26°2'35.77"S; 28°13'5.11"E); D. Concrete weir (26°2'45.54"S; 28°12'58.03"E); E. Buttress gabion weir (26°2'43.68"S; 28°12'59.07"E).

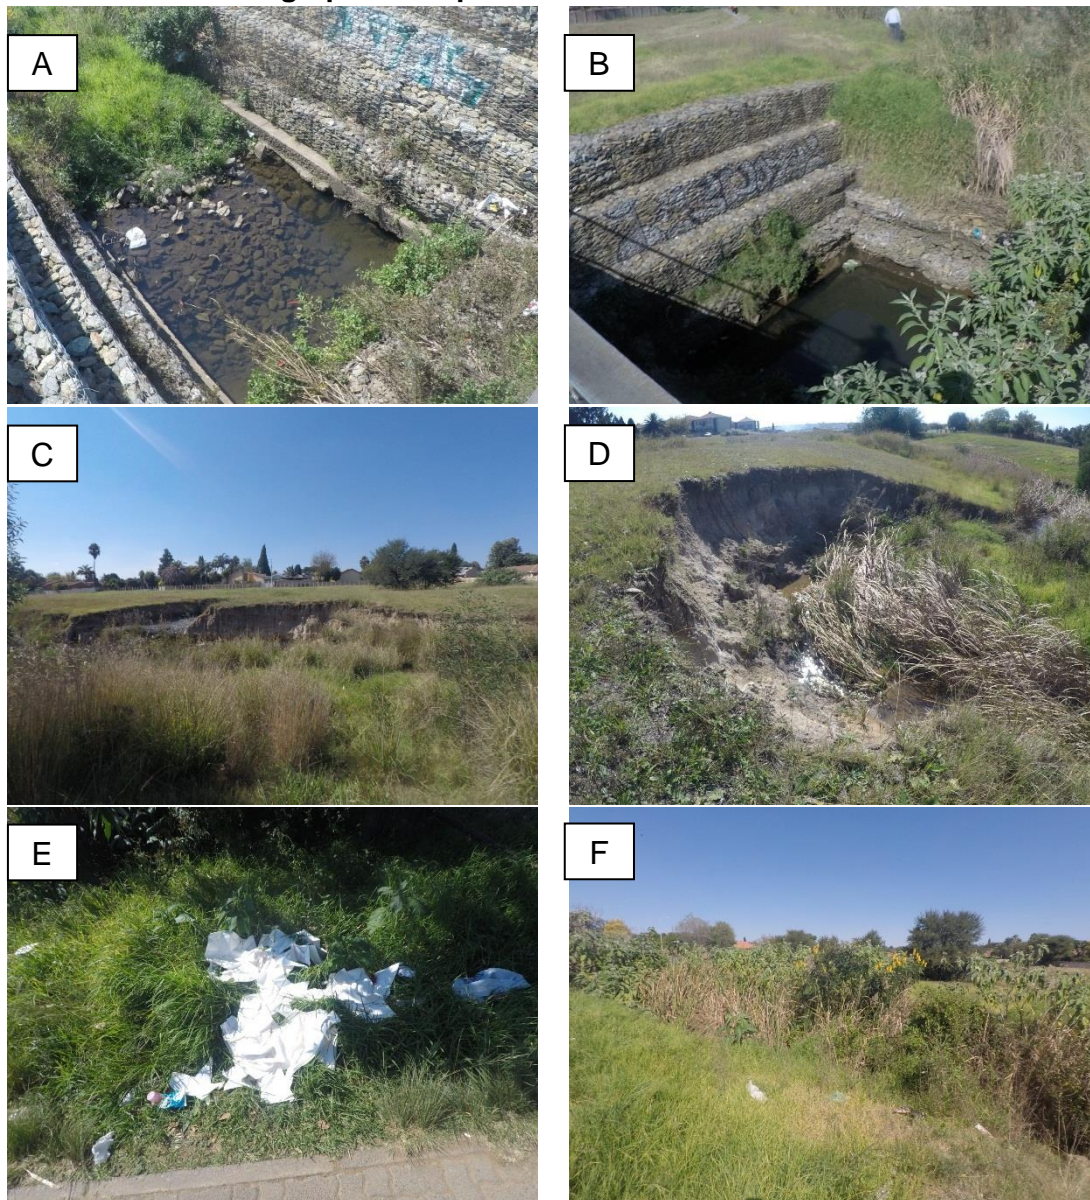
- Large active erosion in channel;
- Erosion beneath and damage of gabion intervention;
- Litter and pollutants in water; and
- Alien invasive vegetation:
 - *Arundo donax*
 - *Cortaderia selloana*
 - *Solanum mauritianum*

Figure 19: A. Erosion beneath gabion weir (26°2'59.46"S; 28°13'17.55"E); B. Alien invasive vegetation growing on structure (26°2'59.46"S; 28°13'17.55"E); C. Large active erosion of channel (26°2'56.19"S; 28°13'17.25"E); D. Large active erosion of channel (26°2'49.31"S; 28°13'16.32"E); E. Litter (26°3'1.29"S; 28°13'19.75"E); F. Alien invasive vegetation (26°3'1.12"S; 28°13'19.43"E).

- Removal of litter and supply garbage bins within park and paths;
- Replace or restore damaged gabion structure; and
- Fence off structural intervention and channel from children's park to improve safety.

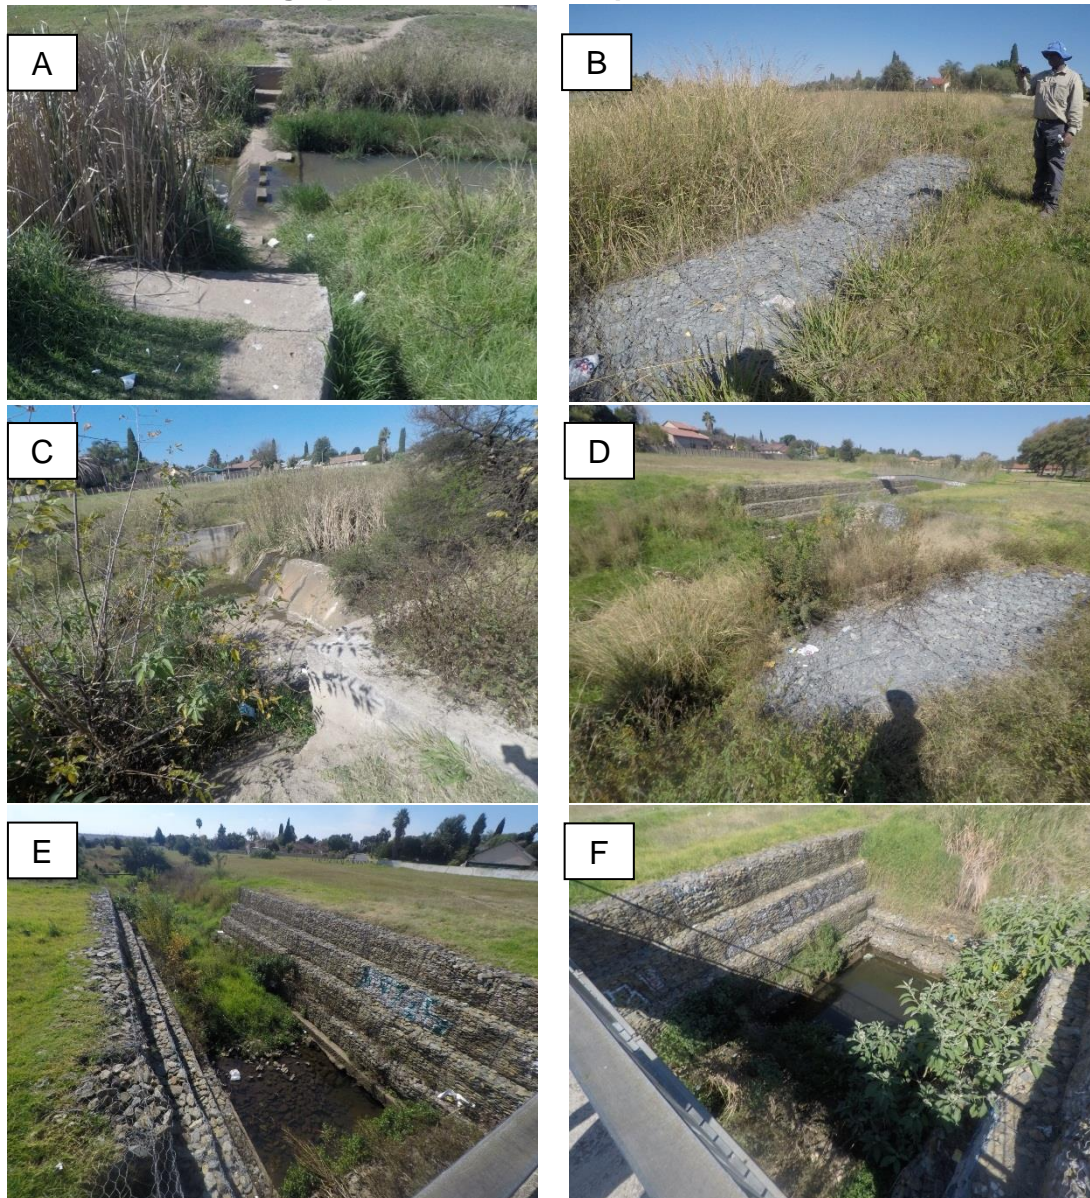
Figure 20: A. Concrete buttress weir (26°2'47.61"S; 28°13'16.44"E); B. Gabion mattress (26°2'48.04"S; 28°13'16.36"E); C. Concrete buttress weir (26°2'54.47"S; 28°13'17.03"E); D. Gabion mattress (26°2'58.56"S; 28°13'17.33"E); E. Gabion weir (26°2'59.46"S; 28°13'17.55"E); F. Gabion weir (26°2'59.46"S; 28°13'17.55"E).

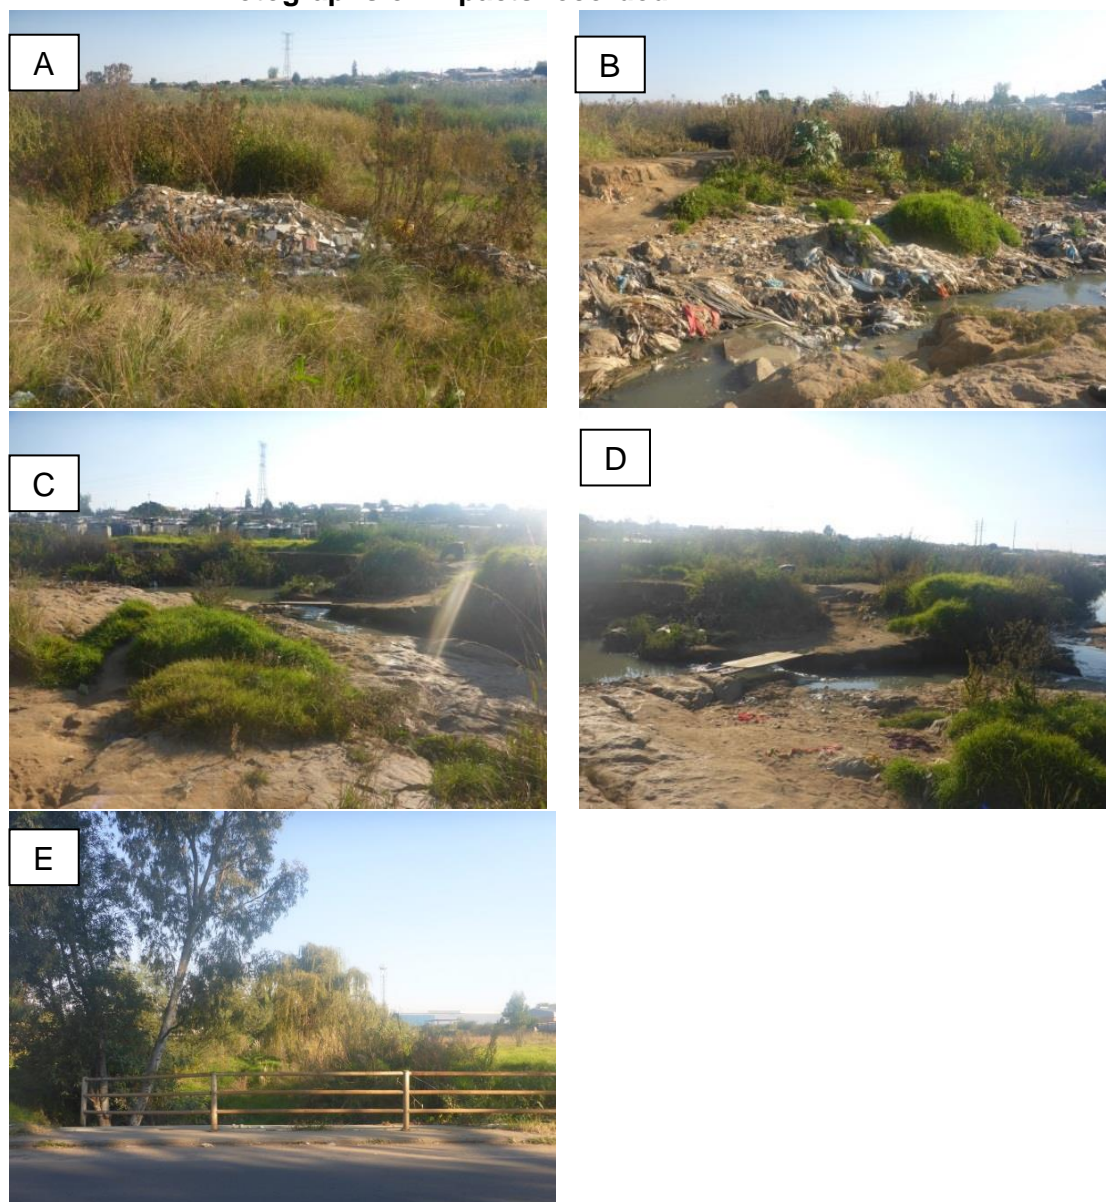
Figure 22: Photographs indicating some of the impacts observed.

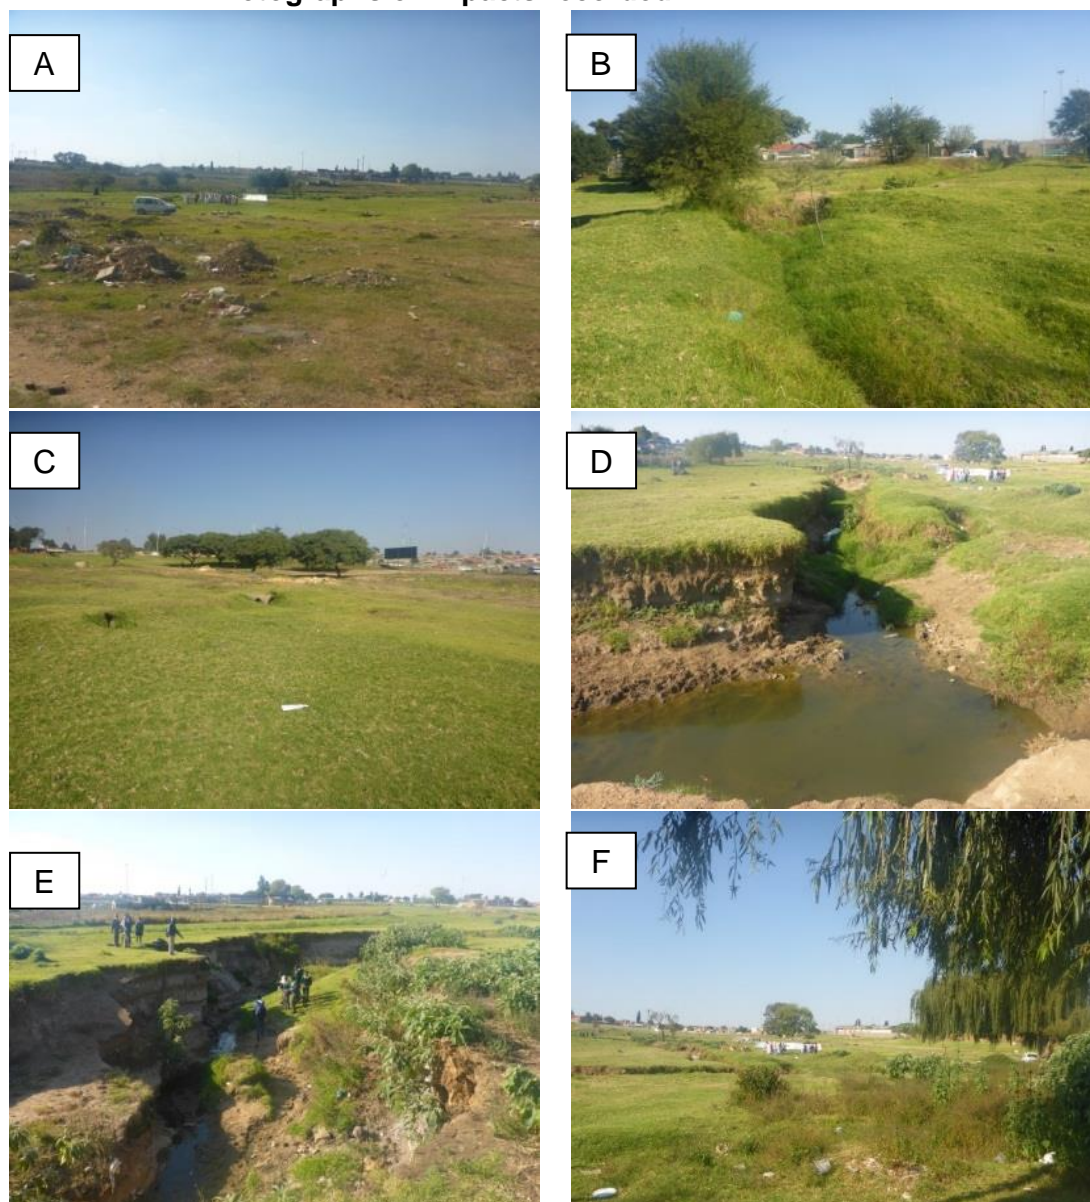
Figure 25: Photographs indicating some of the impacts observed.

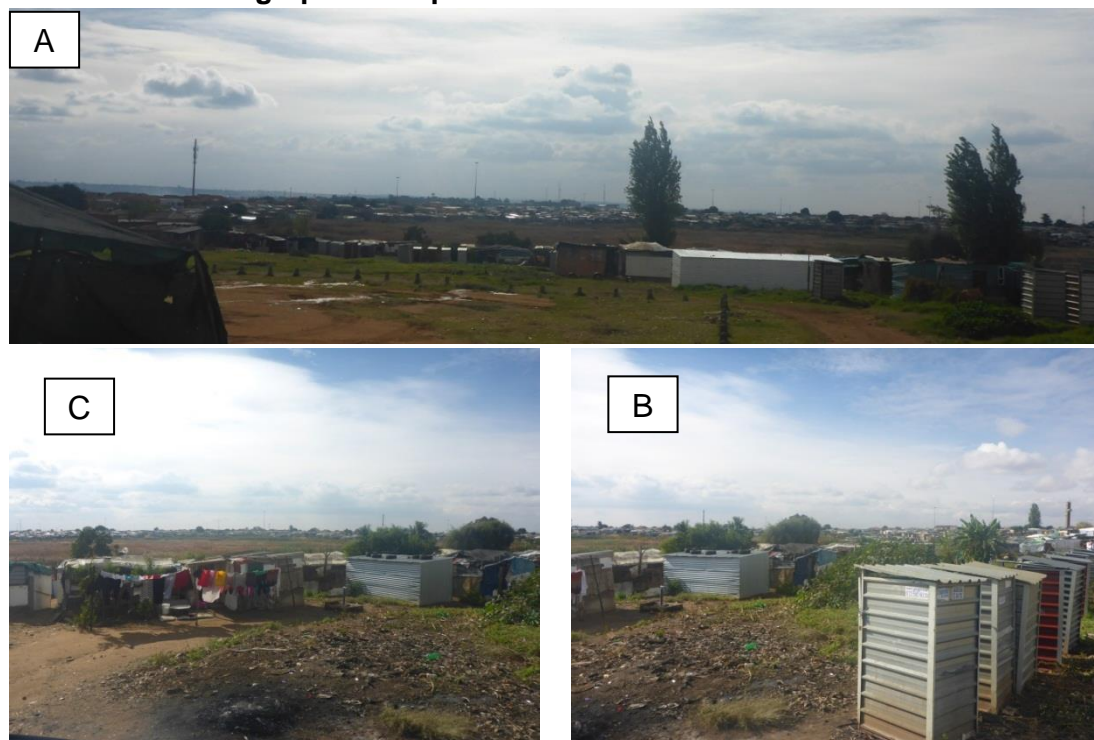
Figure 27: Photographs indicating some of the existing wetland impacts onsite.

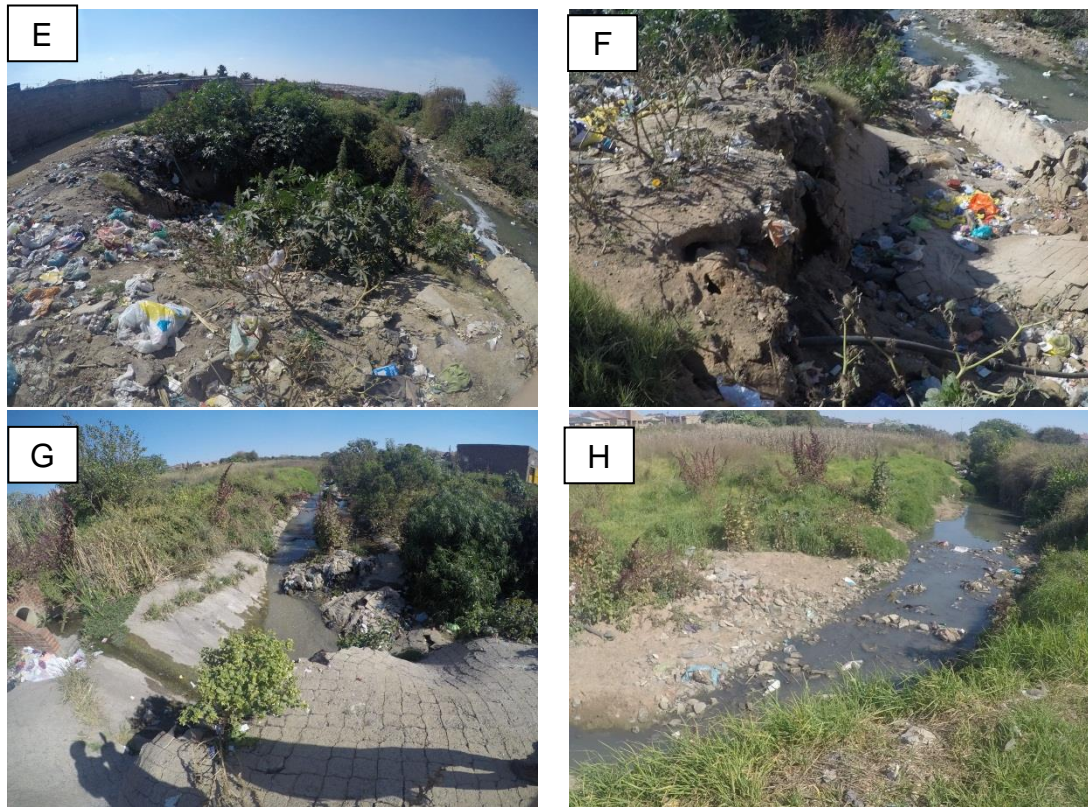
Figure 28: A. Litter (26°0'49.58"S; 28°11'27.15"E); B. Alien invasive vegetation (26°0'48.92"S; 28°11'28.72"E) C. Large active erosion beneath bridge (26°0'48.94"S; 28°11'28.77"E); D. Large active erosion and litter beneath bridge and gabion weir (26°0'48.94"S; 28°11'28.77"E); E. Large active erosion and litter (26°0'48.94"S; 28°11'28.77"E); F. Large active erosion and litter (26°0'48.94"S; 28°11'28.77"E); G. Alien invasive vegetation and polluted water (26°0'49.56"S; 28°11'28.48"E); H. Sedimentation and polluted water (26°0'50.15"S; 28°11'26.91"E).

- Formalize the water channel;
- Restore or replace bridge and crossing for cars and pedestrians to improve safety for community;
- Stabilisation of erosion by construction erosion control structures
- Removal of alien invasive vegetation and water pollutants; and
- Removal of rubble and litter around the channel and in the open surrounding area and supply an alternative official dumping site.

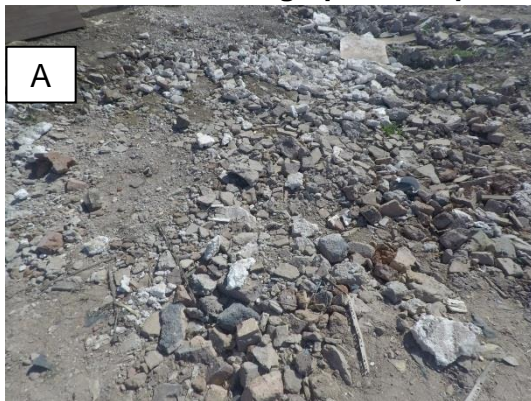
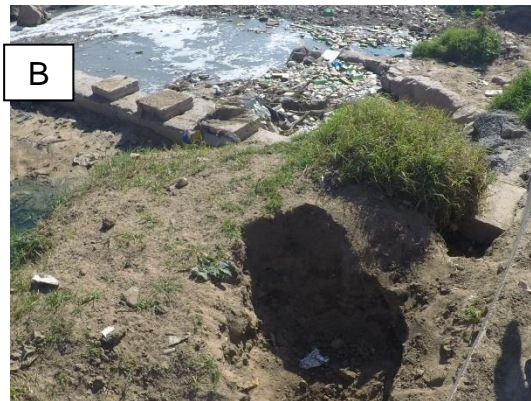
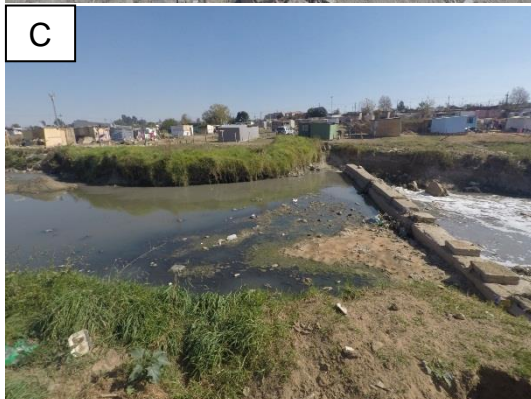
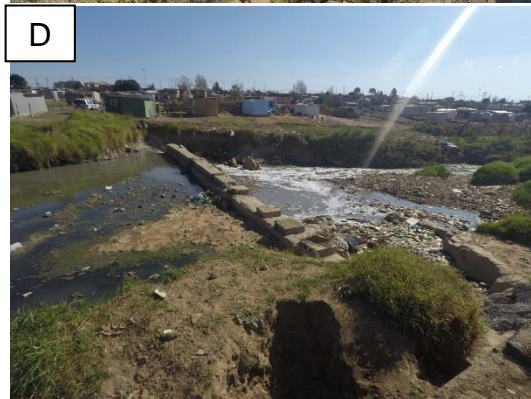
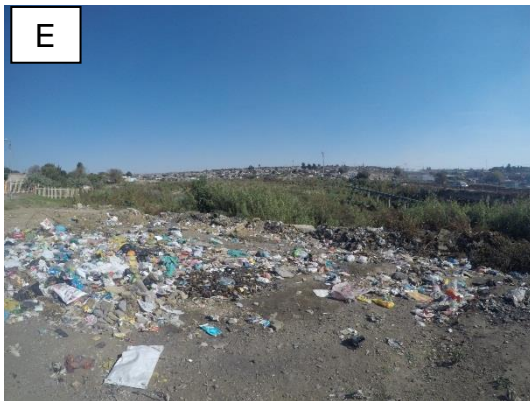
Figure 30: A. Dumping of building rubble (25°59'57.25"S; 28°11'40.76"E); B. Erosion of channel bank (25°59'57.11"S; 28°11'39.84"E) C. Erosion at far-side of intervention and polluted water (25°59'57.11"S; 28°11'39.84"E); D. Erosion and polluted water (25°59'57.11"S; 28°11'39.84"E); E. Dumping of rubble and litter (25°59'59.88"S; 28°11'43.99"E).

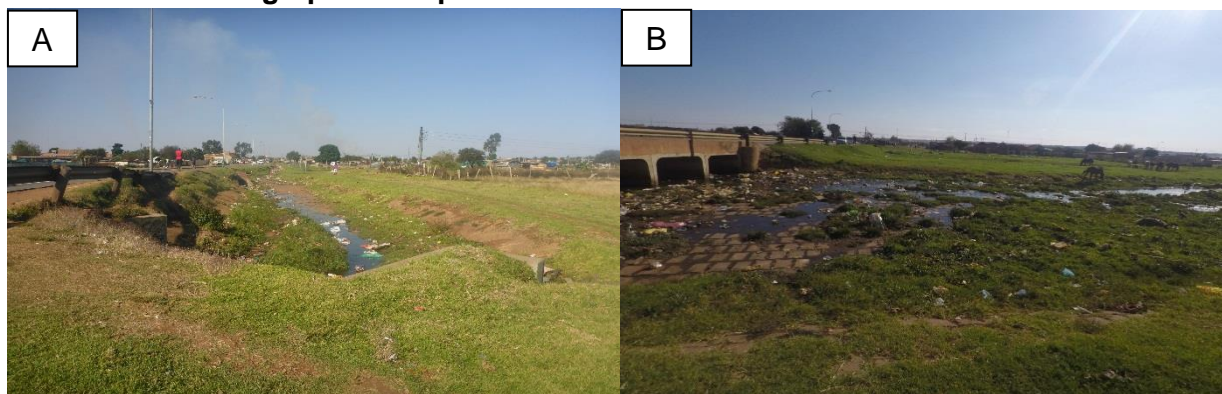
- Litter; and
- Water quality deterioration – surcharging manhole and sewerage discharge into watercourses.

Figure 31: A. Open surrounding area (25°58'52.27"S; 28°12'50.22"E); B. Litter (25°58'52.29"S; 28°12'50.46"E)

- Provide garbage bins for litter;
- Revegetate the channel using indigenous flora:
- Typical Species:
 - *Typha capensis*
 - *Juncus effuses*
 - *Kyllinga erecta*
 - *Schoenoplectus decipiens*
- Revegetate the open area using indigenous flora:
- Typical Species:
 - *Erythrina lysistemon* trees
 - *Celtis Africana* trees
 - *Melinis repens*
 - *Eragrostis racemose*
- Create designated paths in the open surrounding area and bridges across the channel; and
- Create a recreational area for the community in the open surrounding by providing benches, park facilities and planting trees to provide shade.

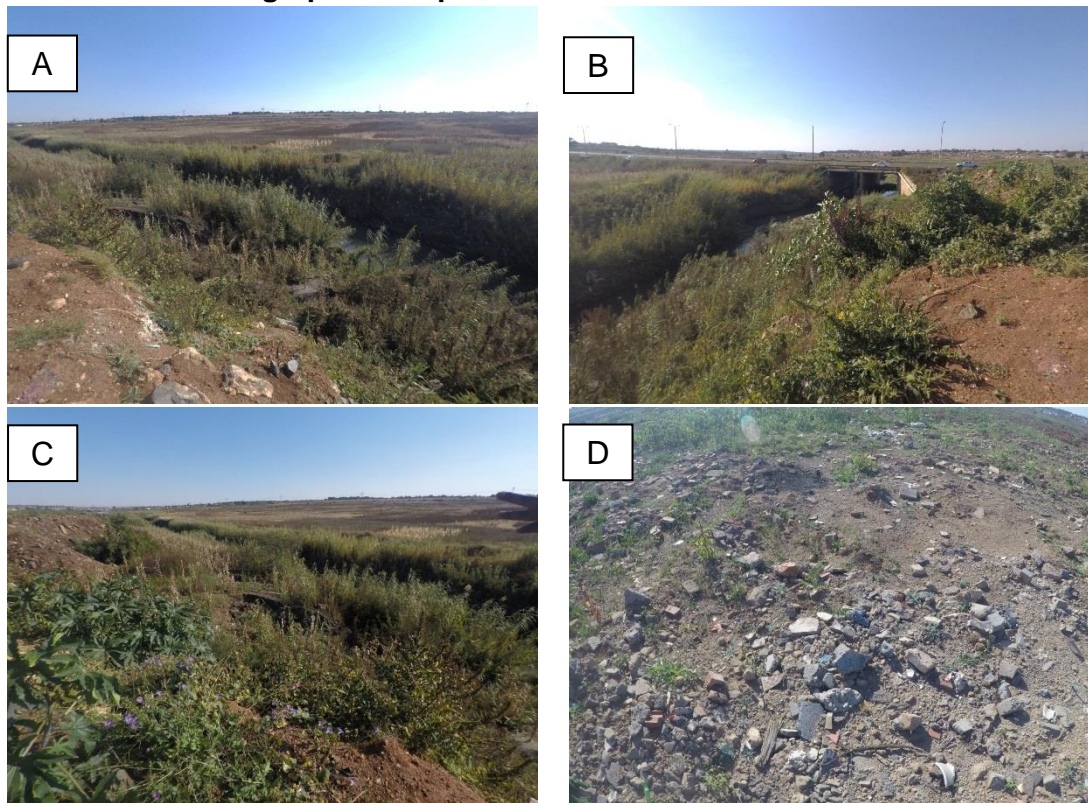
Figure 32: A. Alien invasive vegetation and erosion upstream (25°57'36.39"S; 28°12'22.56"E); B. Alien invasive vegetation and erosion downstream (25°57'36.39"S; 28°12'22.55"E); C. Alien invasive vegetation and erosion upstream (25°57'36.50"S; 28°12'22.55"E); D. Dumping of rubble (25°57'37.39"S; 28°12'23.92"E).

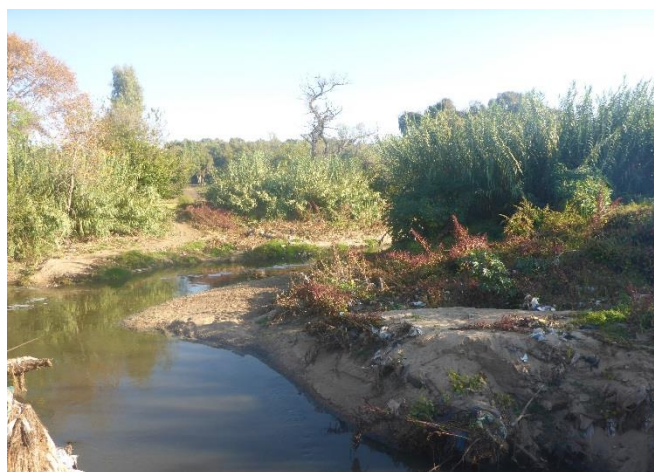
Figure 34: Alien invasive vegetation and sedimentation (25°55'20.10"S; 28°13'38.66"E).

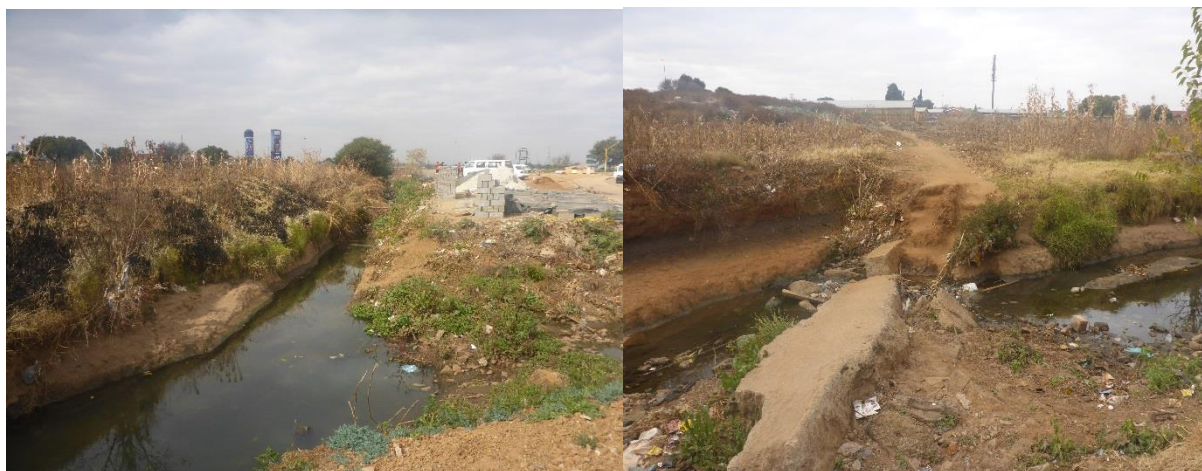
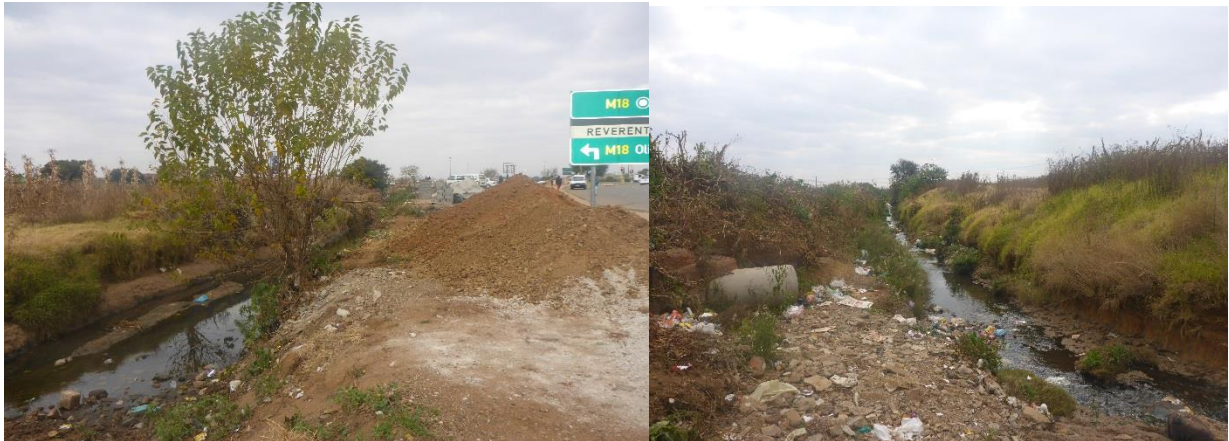
Figure 36: Photographs indicating some of the impacts observed within HGM 7.1
