City of Ekurhuleni Wetland and Watercourse Rehabilitation Planning within the Rietvlei Catchment

Situation Assessment Report

Wetland Consulting Services (Pty.) Ltd. in association with GreenGab Consulting (Pty) Ltd.

May 2018

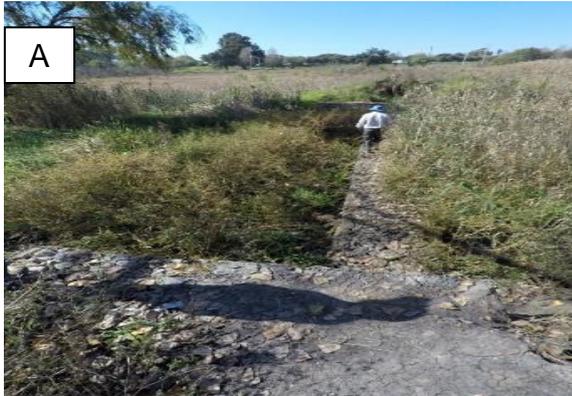
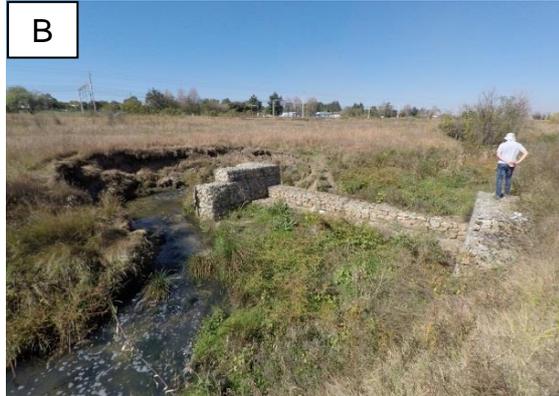
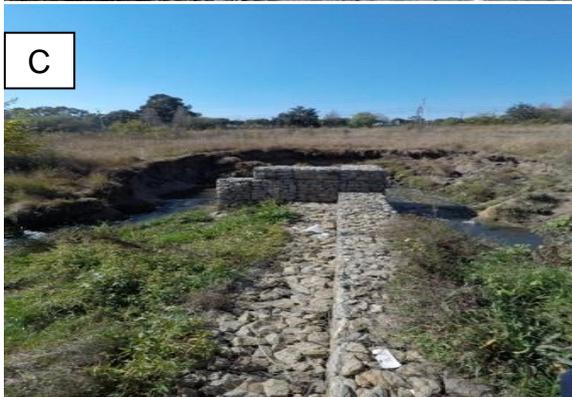
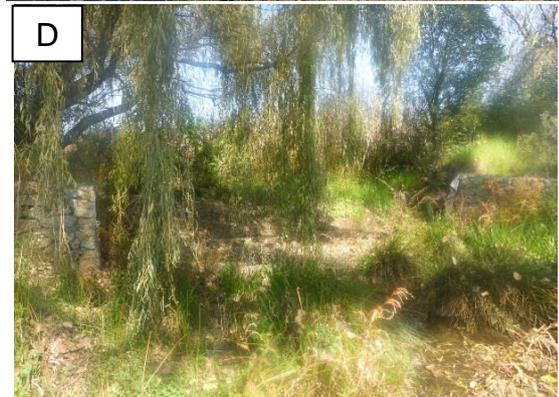
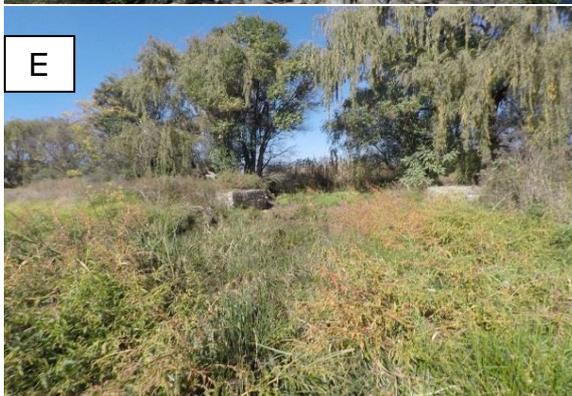
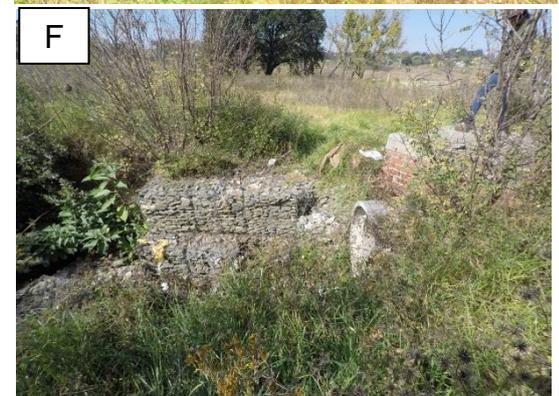
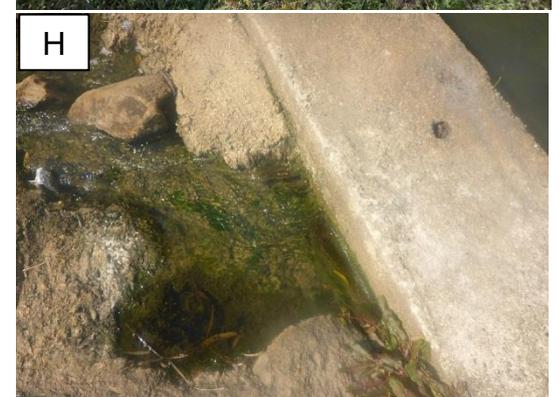
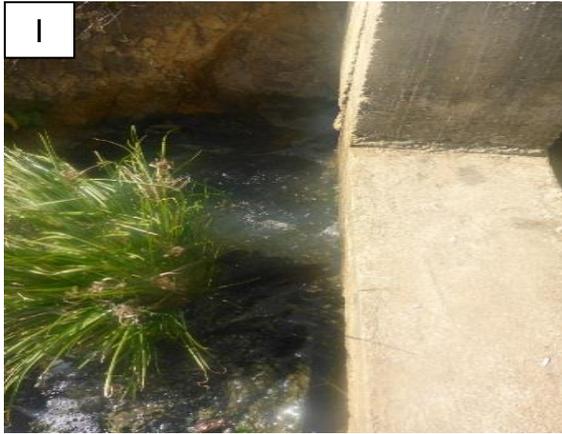
Figure 13: A. Gabion weir: A21A-03-003 (26°4'38.15"S; 28°13'32.30E); B. Headcut erosion at far side of gabion weir: A21A-03-004 (26°4'40.15"S; 28°13'33.46E); C. Headcut erosion at far side of gabion weir: A21A-03-004 (26°4'40.15"S; 28°13'33.46E); D. Gabion weir: A21A-03-006 (26°4'46.61"S; 28°13'25.64E); E. Gabion weir (26°4'46.98"S; 28°13'26.44E); F. Gabion weir with concrete pipe (26°4'28.84"S; 28°13'33.13E).

1. Rehabilitation Activities instream:
 - a. Repair of existing rehabilitation structural activities instream (gabion and concrete structures) in order to improve their performances;

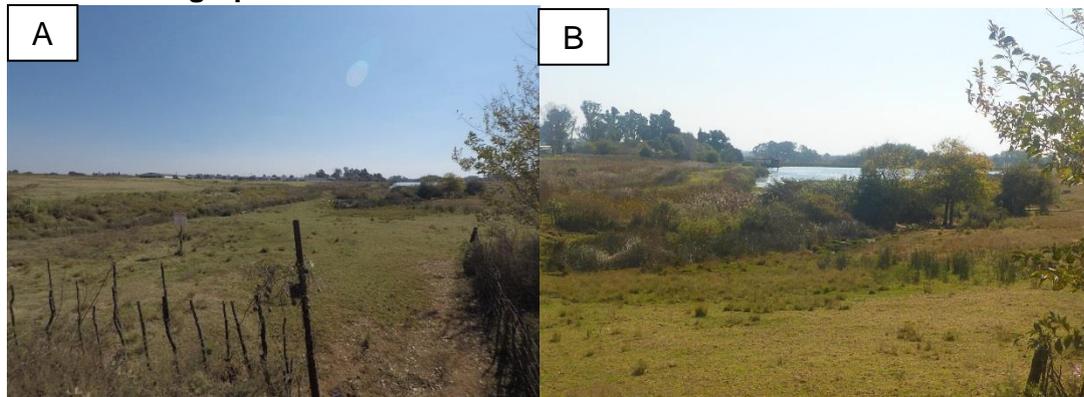
Figure 15: View of the trench and dam (25°59'9.15"S; 28°19'53.69E).

- Deactivate diversion channels, trenches and drains;
- Removal of alien vegetation invasive;
- Buffer agricultural activities away from the edge of the wetland; and
- Removal of redundant infrastructure and levelling of heap of soil within the wetland area.

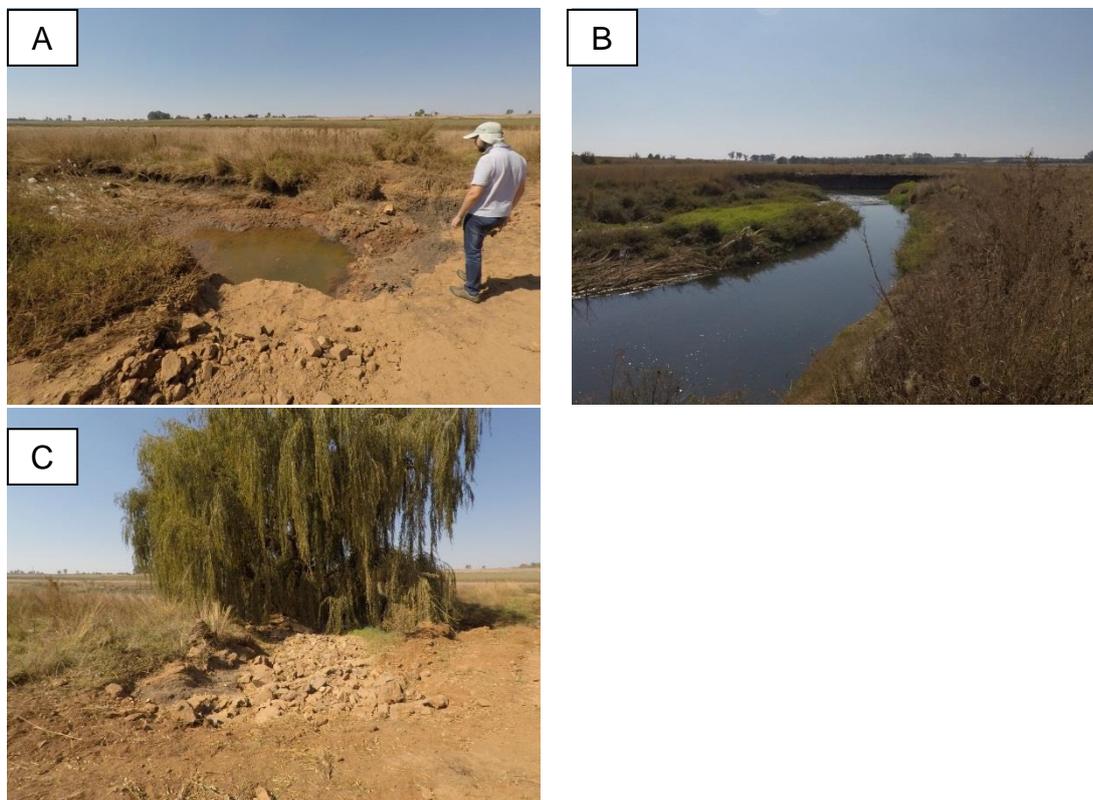
Figure 17: A. Headcut erosion of channel (25°58'8.97"S; 28°18'3.99E); B. Headcut erosion of channel (25°58'7.48"S; 28°18'5.36E); C. Alien invasive vegetation, namely *Salix babylonica* (25°58'7.67"S; 28°18'3.36E).

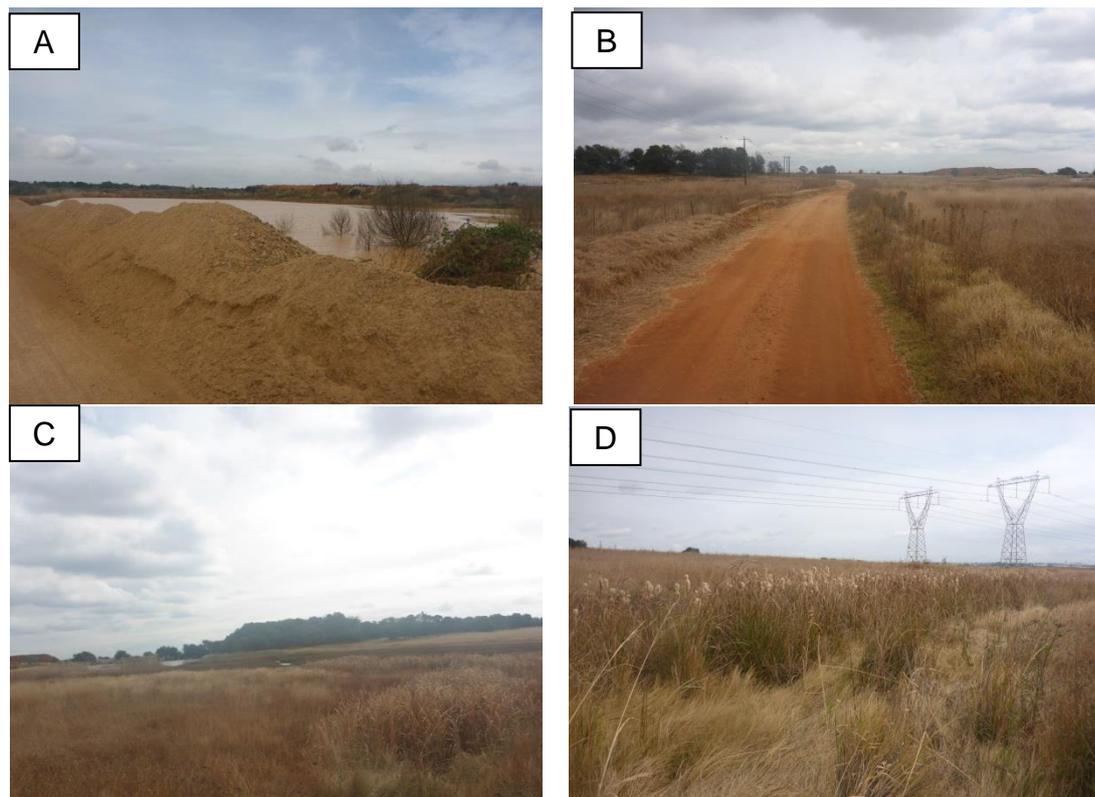
Figure 21: A. Excavation and sediment deposition from sand mining activities (26°1'34.87"S; 28°20'1.04"E); B. One of the informal roads within the valley bottom (26°1'41.74"S; 28°20'53.44"E); C. Alien invasive vegetation adjacent to a dam (26°1'35.09"S; 28°20'38.7"E); D. Power lines (26°1'34.88"S; 28°19'7.59"E).

- Remove alien invasive vegetation.

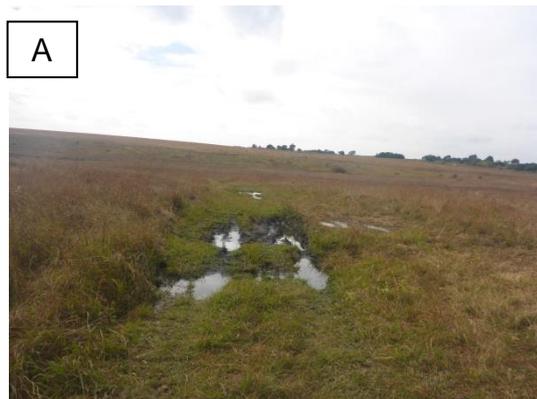
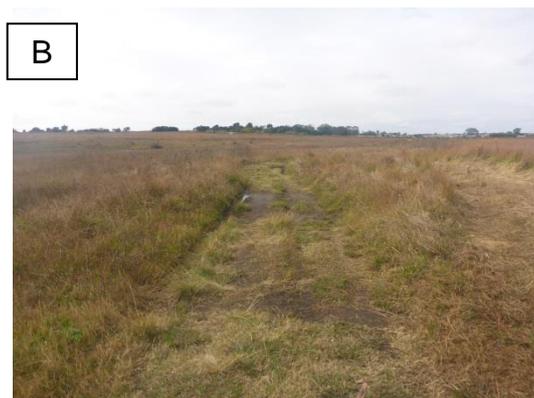
- Weakly channelled valley bottom wetland, i.e. channel is not continuous;
- Informal roads damaged from driving forming ruts and creating preferential flow paths;
- Presence of a water pipeline;
- Landscape in between secure estate (on opposite side of a formal road that cuts through the valley bottom wetland);
- Deeply incised channel;
- Dumping of litter; and
- Alien invasive vegetation
 - *Populus alba*
 - *Acacia mearnsii*
 - *Bidens Formosa*

Figure 23: A. Damaged informal roads from driving forming ruts and creating preferential flow paths (26°3'19.20"S; 28°18'49.84"E); B. Damaged informal roads from driving forming ruts and creating preferential flow paths (26°3'19.20"S; 28°18'49.84"E). C. Presence of a water pipeline (26°3'37.01"S; 28°19'4.66"E); D. Private estates across the road but within the valley bottom wetland (26°3'38.65"S; 28°19'10.27"E), E. Litter dumping in and outside the channel (26°1'23.73"S; 28°18'12.06"E), F. Alien invasive vegetation (26°1'24.67"S; 28°18'12.73"E), G. Upstream of incised channel (26°1'27.73S; 28°18'0.01"E); H. Downstream of incised channel (26°1'27.73S; 28°18'0.01"E).

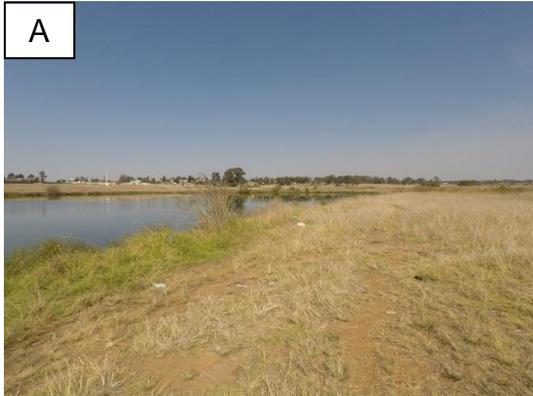
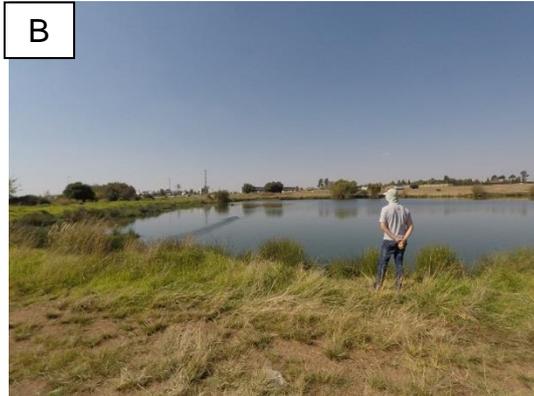
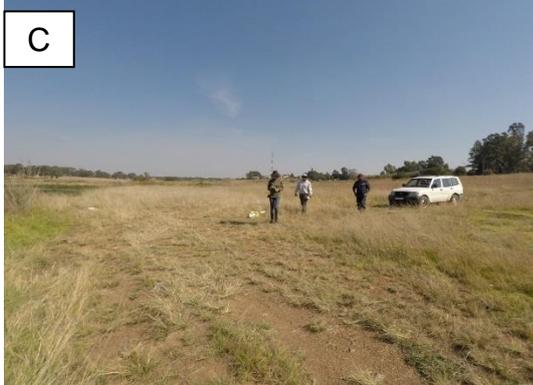
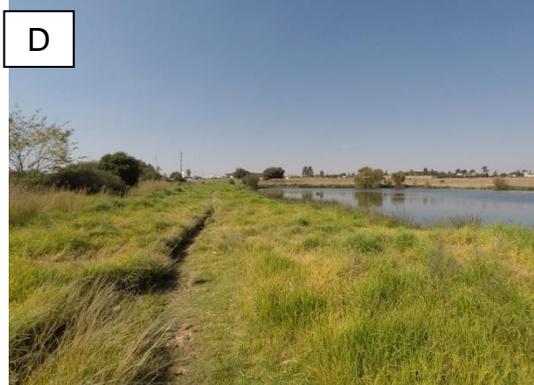
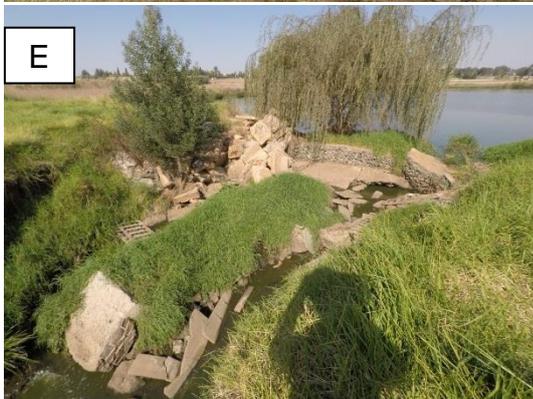
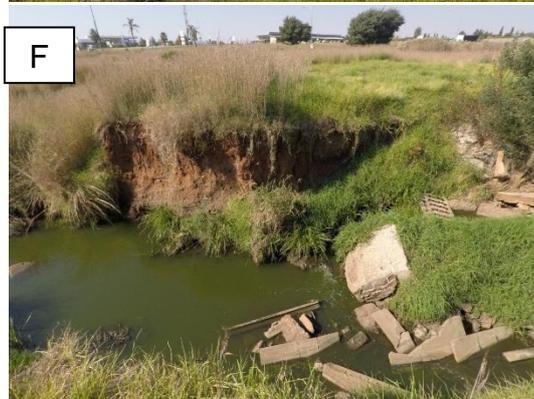
Figure 24: A. Open space suitable for recreational area (26°4'52.56"S; 28°17'3.61E); B. Open space suitable for recreational area (26°4'52.56"S; 28°17'3.61E); C. Open space suitable for recreational area (26°4'52.56"S; 28°17'3.61E); D. Path (26°4'51.46"S; 28°17'4.09E); E. Collapsed dam wall and bridge (26°4'50.54"S; 28°17'7.34E); F. Headcut erosion of channel (26°4'50.54"S; 28°17'7.34E). G. Damaged dock (26°4'53.70"S; 28°17'3.62E); H. Alien invasive vegetation (26°5'38.91"S; 28°16'41.15E); I. Alien invasive vegetation, namely *Arunda donax* (26°5'39.38"S; 28°16'41.28E); J. Collapsed bridge wall and alien vegetation, namely *Cortaderia selloana* (26°6'16.92"S; 28°16'1.67E); K. Alien invasive vegetation, namely *Eucalyptus grandis* (26°6'16.97"S; 28°16'1.43E); L. Erosion of road where a channel cuts through and alien vegetation (26°3'43.68"S; 28°17'58.97"E).

- Replace collapsed dam wall and bridge;
- Removal of water pollutants;
- Improve road by installing a low-lying gabion crossing that is cemented on top to allow diffuse flow;
- Removal of alien invasive vegetation;
- Revegetate the open area using indigenous flora:
- Typical Species:
 - *Erythrina lysistemon trees*
 - *Celtis Africana trees*
 - *Melinis repens*
 - *Eragrostis racemosa*
- Create designated paths in the open surrounding area and bridges at the dam wall; and
- Create a recreational area for the community in the open surrounding by providing benches, park facilities and planting trees to provide shade.

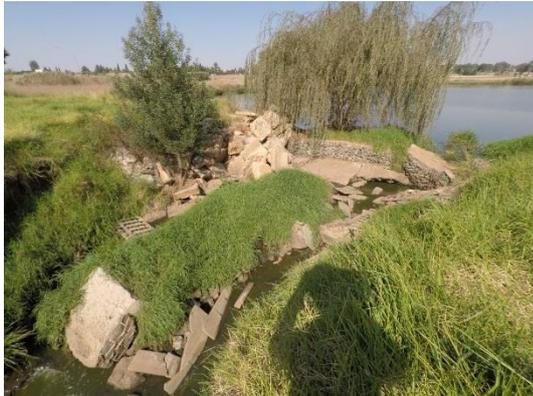
Figure 25: A. Collapsed dam wall and bridge (26°4'50.54"S; 28°17'7.34E).

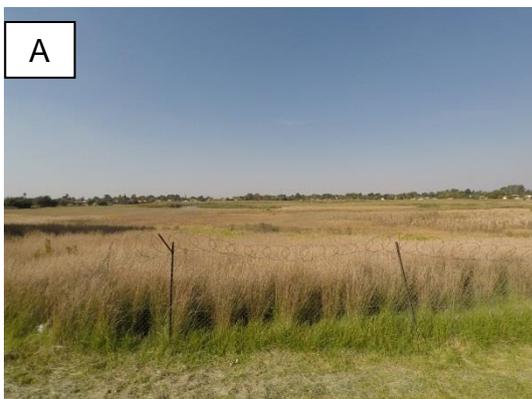
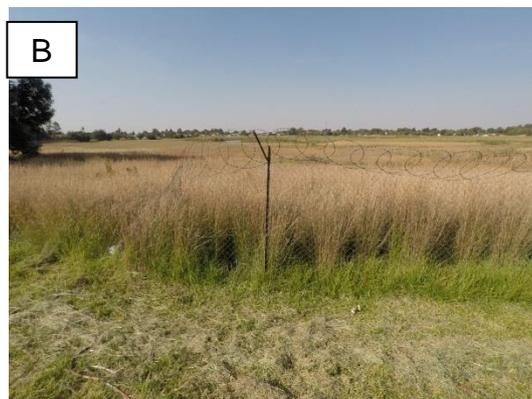
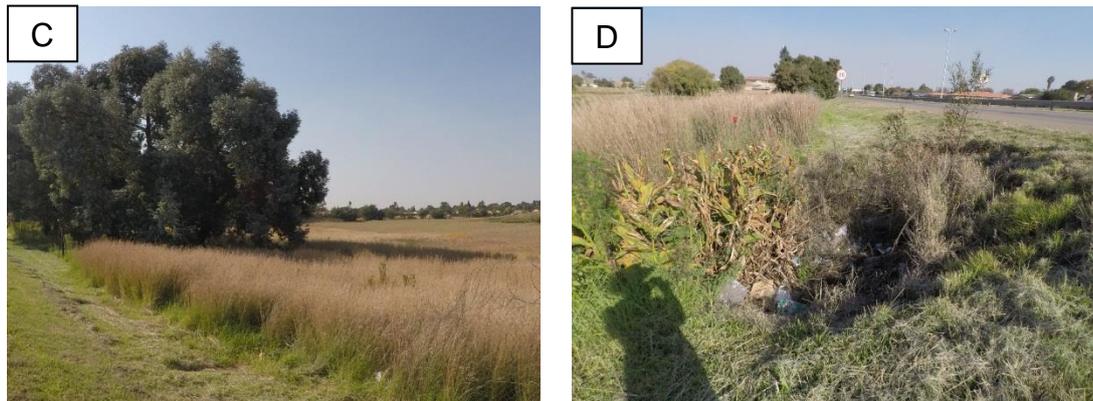
- Damaged fencing;
- Litter; and
- Alien invasive vegetation, namely *Eucalyptus grandis*.

Figure 26: A. Damaged fencing (26°6'57.31"S; 28°15'22.30E); B. Damaged fencing (26°6'57.31"S; 28°15'22.30E); C. Alien invasive vegetation, namely *Eucalyptus grandis* (26°6'57.31"S; 28°15'22.30E); D. Litter (26°6'57.31"S; 28°15'22.30E).

- Replace fencing;
- Remove litter; and
- Remove alien invasive vegetation.

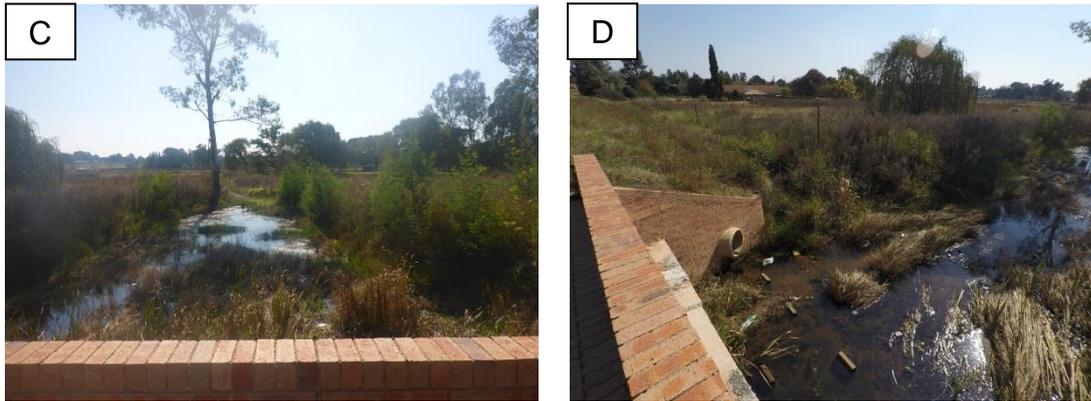
Figure 27: A. Alien invasive vegetation, namely *Populus alba* (26°6'3.53"S; 28°19'2.21E); B. Upstream of bridge and alien invasive vegetation, namely *Salix babylonica* (26°4'43.25"S; 28°19'20.30E); C. Downstream of bridge and alien invasive vegetation, namely *Eucalyptus grandis* (26°4'43.25"S; 28°19'20.30E); D. Litter (26°4'43.25"S; 28°19'20.30E).
