# REPORT

ENVIRONMENTAL IMPACT  
MANAGEMENT SERVICES

## MANUNGU COLLIERY SURFACE WATER SPECIALIST STUDY

**28 September 2018**

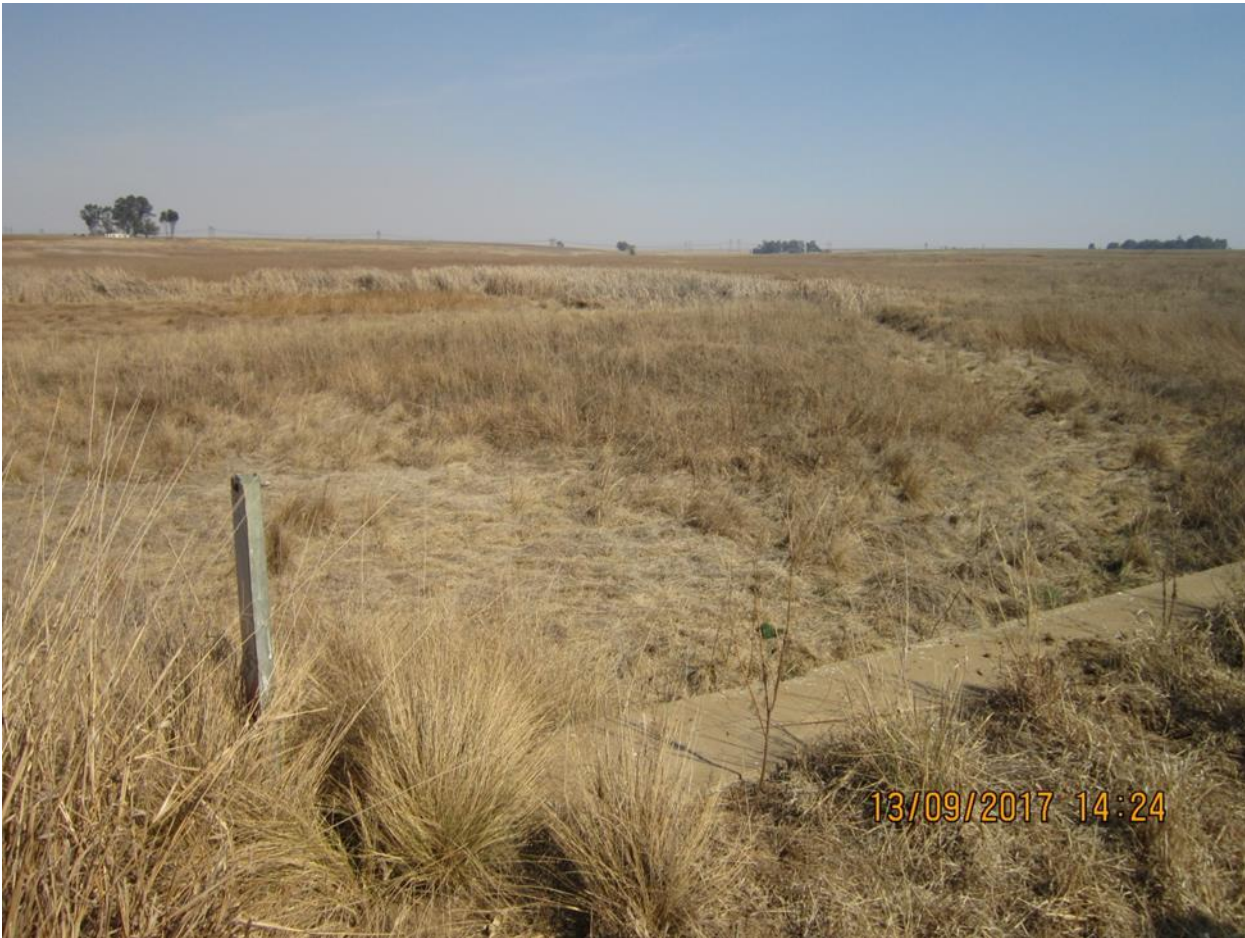
Figure 2: Western Stream

The topography is relatively flat. Localised areas have steeper slopes, particularly in the vicinity of the streams. The two streams are dammed with multiple farm dams on each stream. The water courses of the two streams in the mining rights area are reeded in places, but the water courses are generally poorly defined. The flood plains are not well developed.

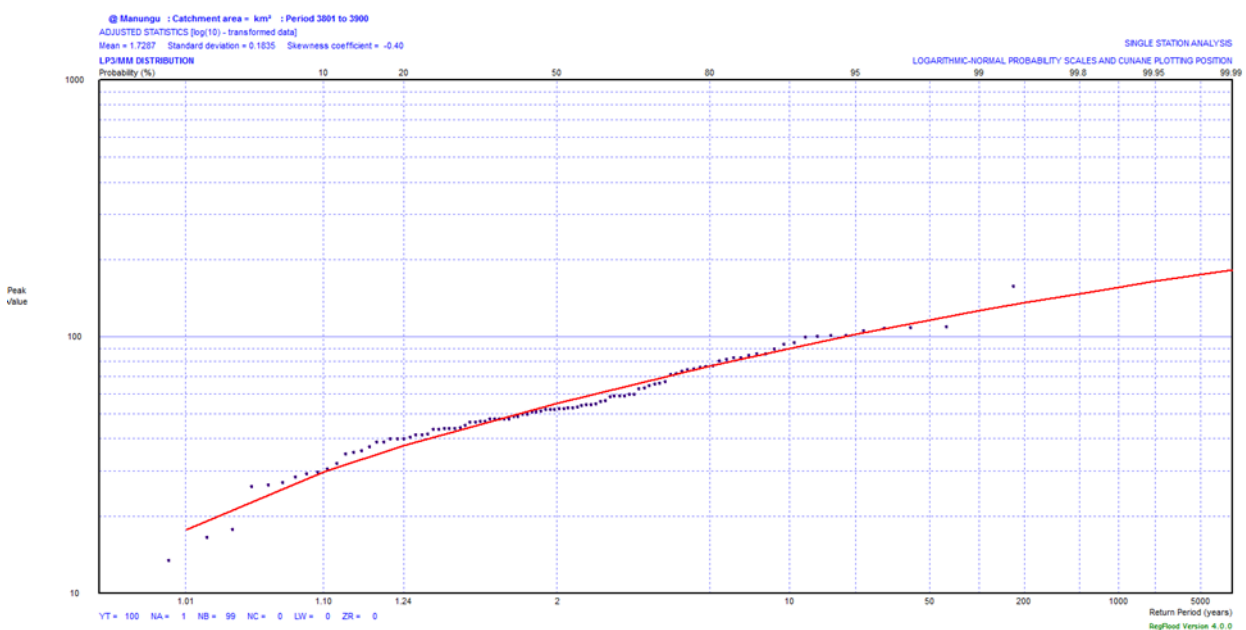
Figure 3: Log Pearson Type 3 statistical fit to the annual maximum series

The daily rainfall record, discussed in section 5.1.2, was analysed and the annual maximum series was extracted from the data. This annual maximum series was statistically analysed to determine various T-year recurrence interval 24-hour storm depths. A Log Pearson Type 3 fit was selected as the most appropriate statistical fit. This fit is shown in Figure 3. The rainfall record is long, consists of good data, is representative of the mining rights area, and is suitable to be used to calculate peak rainfall.

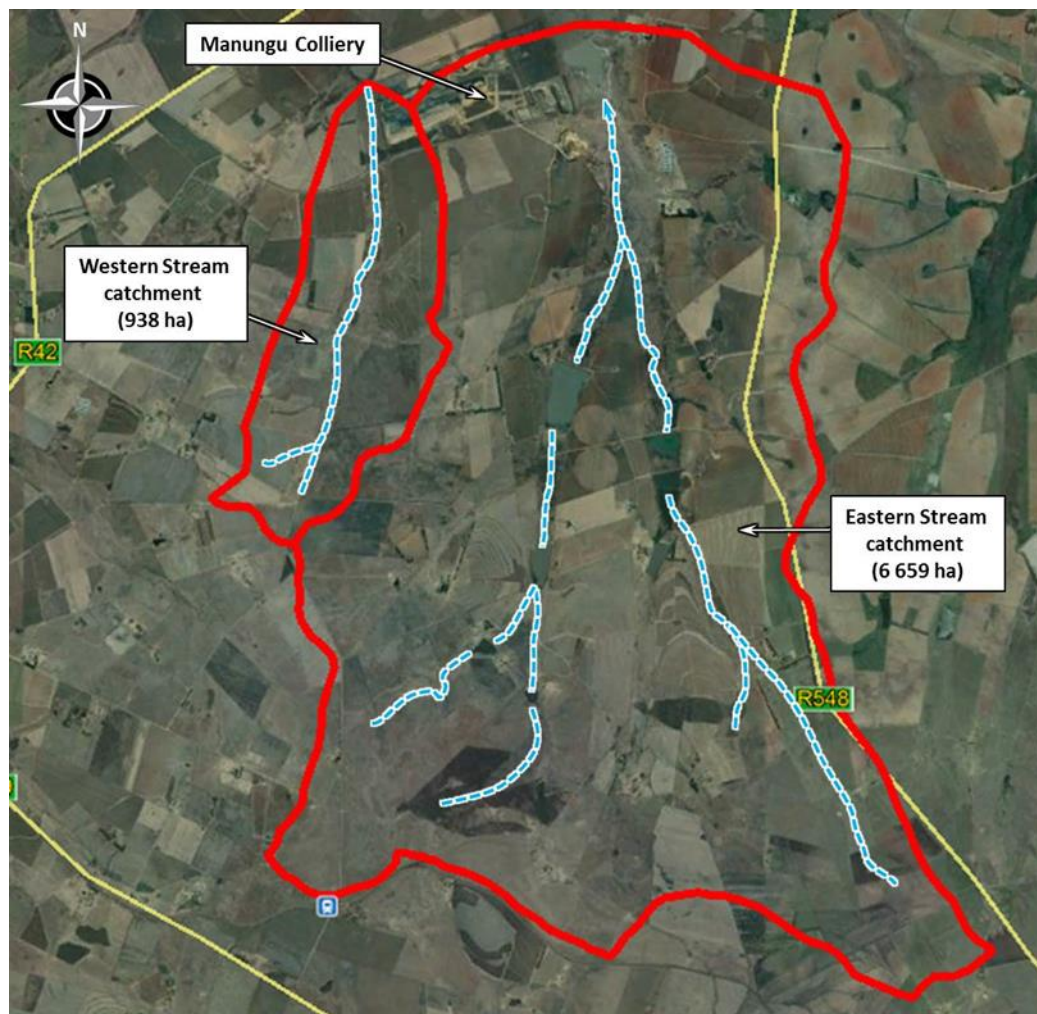
Figure 4: Catchment delineation

The mean annual runoff for the quaternary catchments B20A is 25.25 Mm<sup>3</sup> (Middleton and Bailey, 2009). The mean annual runoff values in Table 5 were scaled from the quaternary catchment runoff, based on relative catchment size.

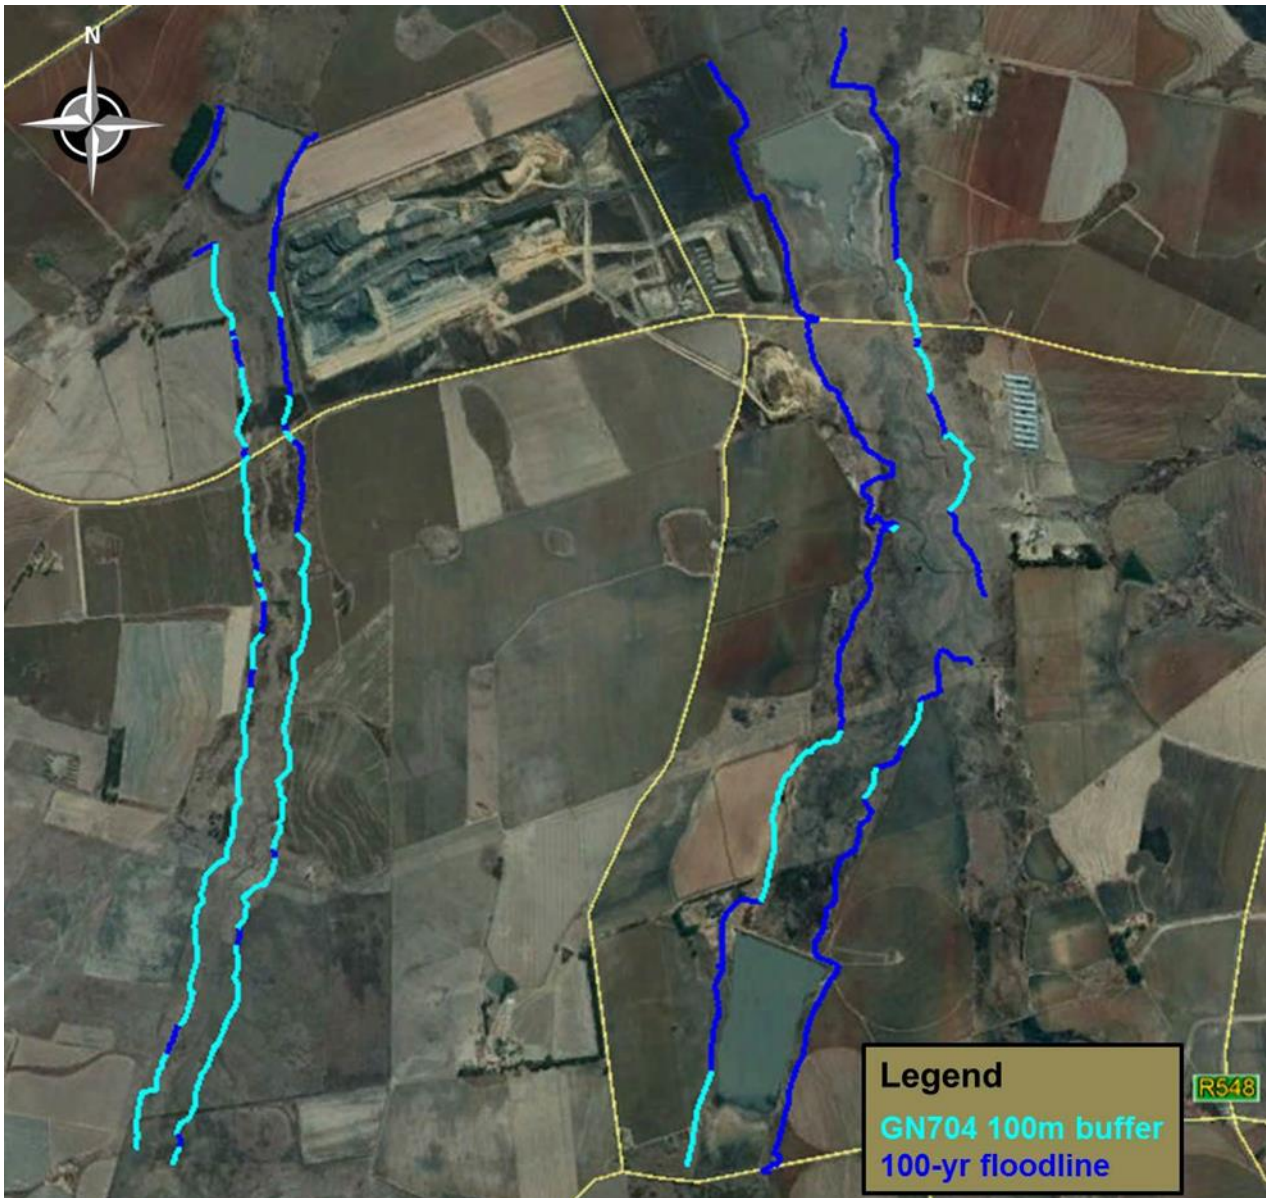
Figure 6: Surface water buffer zones

Pollution control dams are required as part of the project so Section 4a of GN 704 will apply to these. The surface water buffer zone therefore is the greater of the 100-year floodline or 100 m from the water course. The buffer zones for the Eastern and Western streams are shown in Figure 6.

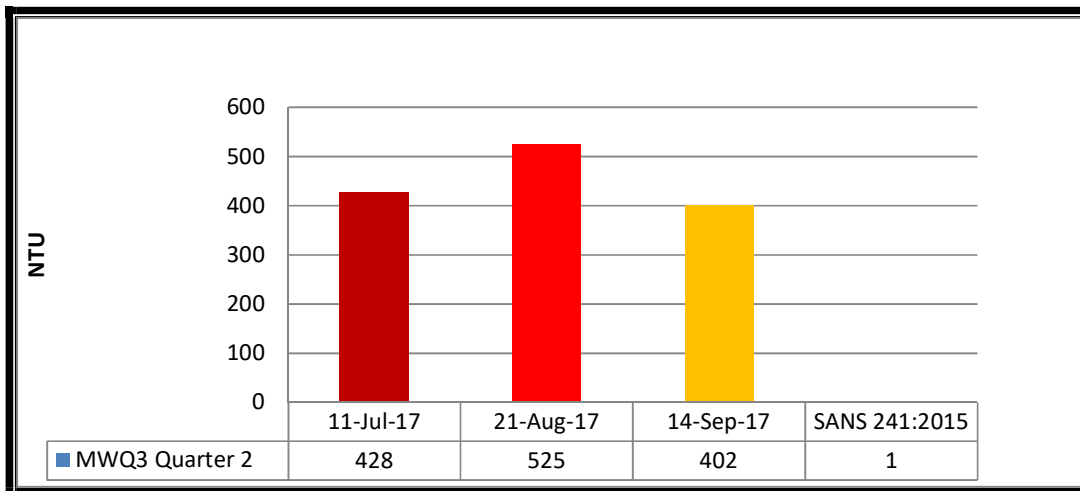
Figure 4—5: Turbidity Non-Compliant

- Most variables were within the expected SANS limits, except Turbidity which had an average of 372 NTU. However, when comparing current data to the baseline water quality, a slight deterioration is observed for some variables.
- Turbidity is the cloudiness or haziness of a fluid caused by large numbers of individual particles that are generally invisible to the naked eye, similar to smoke in air. The measurement of turbidity is a key test of water quality. Turbidity is common due to natural geology.
- See Table 4-2 below for all analyzed variables as compared to the baseline water quality results and SANS 241:2015 limits, also see Figure 4-5 for non-compliance with the SANS 241:2015 limits.

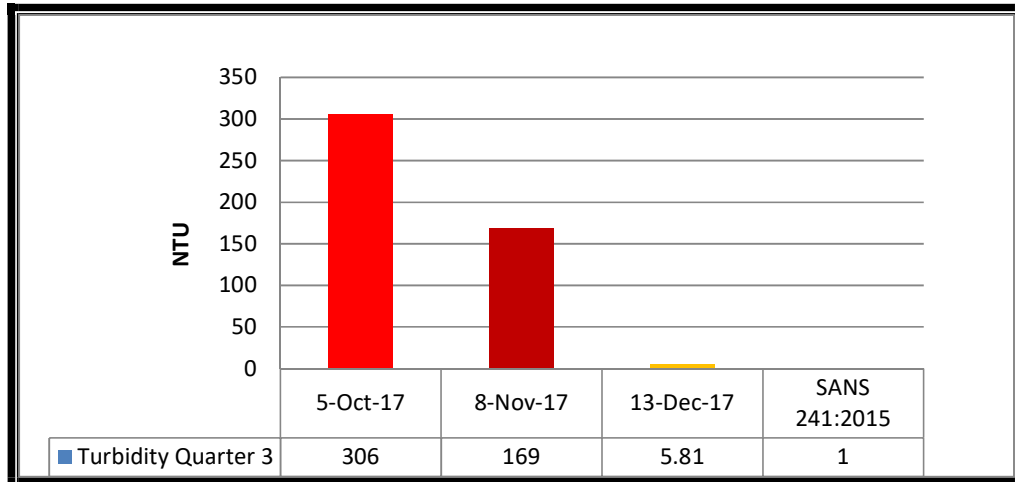
**Figure 4-4: Turbidity Non-Compliant**

- Most variables were within the expected SANS 241:2015 limits, except Turbidity which had an average of 160.27 NTU for the three months. However, when comparing current data to the baseline water quality, a slight deterioration is observed for some variables.
- Turbidity is the cloudiness or haziness of a fluid caused by large numbers of individual particles that are generally invisible to the naked eye, similar to smoke in the air. The measurement of turbidity is a key test of water quality. Turbidity is common due to natural geology.
- Refer to **Table 4-2** below for all analyzed variables as compared to the baseline water quality results and SANS 241:2015 limits, also see **Figure 4-4** for non-compliance with the SANS 241:2015 limits.

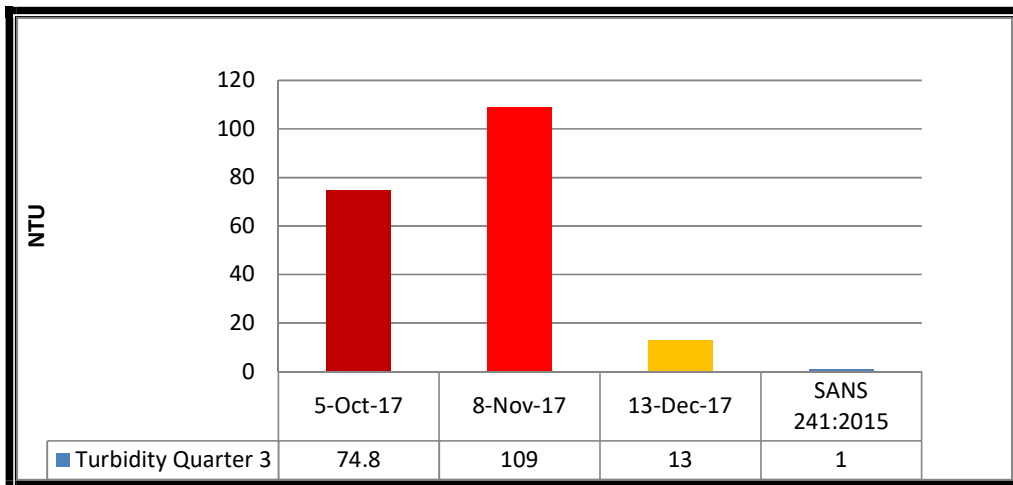
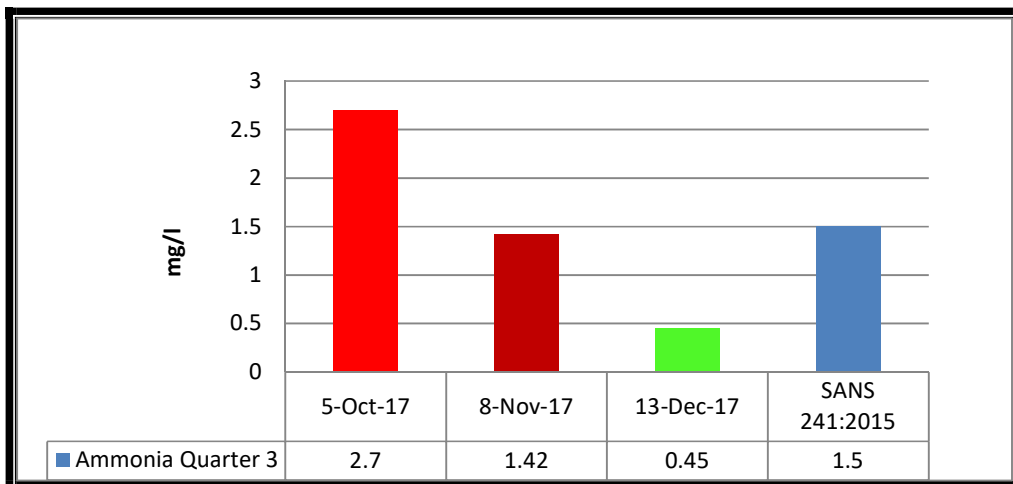
- According to the standards set by SANS 241-2015, some variables were found to have exceeded the limits, these variables include Turbidity and Ammonia.
- Turbidity had an average of 65.6 NTU for these 3 months and Ammonia exceeded the limit in November with a value of 2.7 mg/l.
- As indicated earlier in the report there are other mining activities in the vicinity of the mine not associated with Manungu Colliery. Some of the changes in the variables may not be impacts associated with the operation at Manungu Colliery.
- Some variables showed an increase when compared to the baseline water quality results.
- Refer to **Table 4-3** below for all analyzed variables as compared to the baseline water quality results and SANS 241:2015, also see **Figures 4-5 to 4-6** for non-compliance with SANS 241:2015.
