Water Resource Report for the proposed expansion of the Manungu Colliery

Mpumalanga, South Africa

January 2018

Manungu Colliery – Expansion

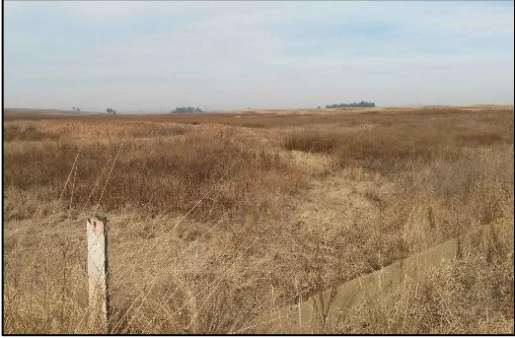
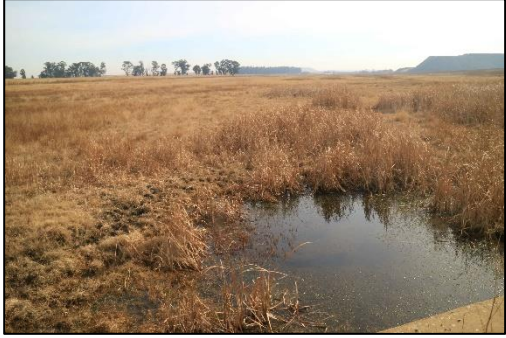
GPS	26°14'17.21"S, 28°40'36.90"E	
Site	MAN1 was located within a wetland upstream of Manungu Colliery and upstream of site MAN2. The site was characterized by a small pool below a culvert and surrounded by farmland. <i>In situ</i> water quality was conducted here. The South African Scoring System: Version 5 (SASS5) was not recommended for this site.	
	Upstream	Downstream

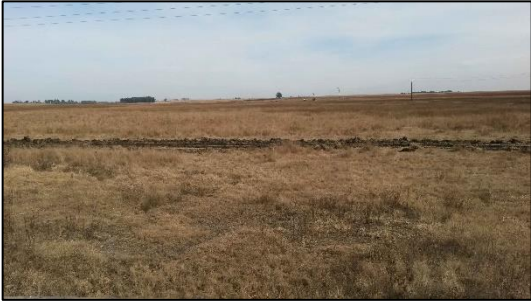
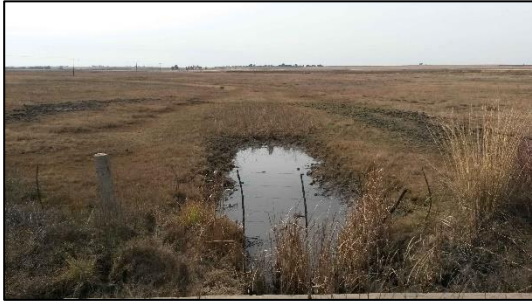
<p>MAN2</p>

<p>GPS</p>	<p>26°12'31.06"S, 28°41'13.41"E</p>	
<p>Site</p>	<p>MAN2 was characterised by a small pool below a culvert and surrounded by farmland. The site constitutes a wetland system and was situated downstream of Manungu Colliery. <i>In situ</i> water quality was conducted here. SASS5 was not recommended for this site.</p>	
	<p style="text-align: center;">Upstream</p>	<p style="text-align: center;">Downstream</p>
<p>MAN3</p>

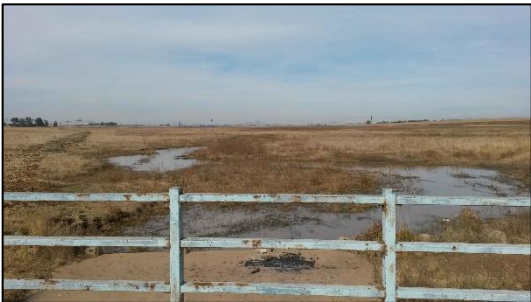
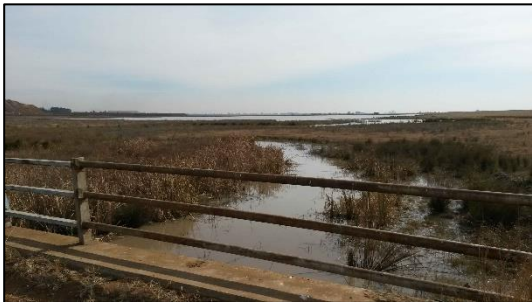
<p>GPS</p>	<p>26°13'58.12"S, 28°42'28.21"E</p>	
<p>Site</p>	<p>MAN3 was located upstream of Manungu Colliery on the Bronkhorstspruit at the inlet to a dam. The site was situated adjacent to chicken farms and agricultural lands. The site was characterized by slow flowing waters over mud substrate with abundant marginal vegetation. Isolated areas of stones were present which included concrete bedrock. <i>In situ</i> water quality and SASS5 was conducted here.</p>

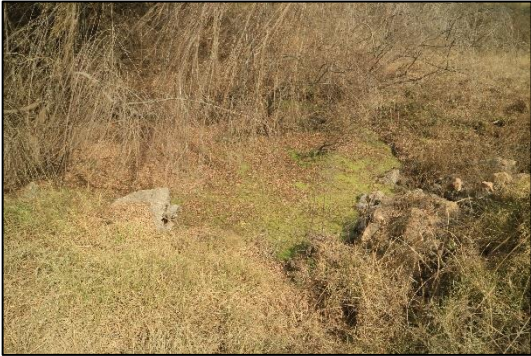
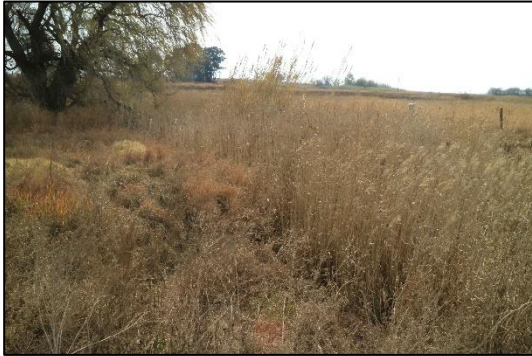
<p style="text-align: center;">Upstream</p>	<p style="text-align: center;">Downstream</p>
<p>MAN4</p>

<p>GPS</p>	<p>26°11'42.78"S, 28°41'52.81"E</p>

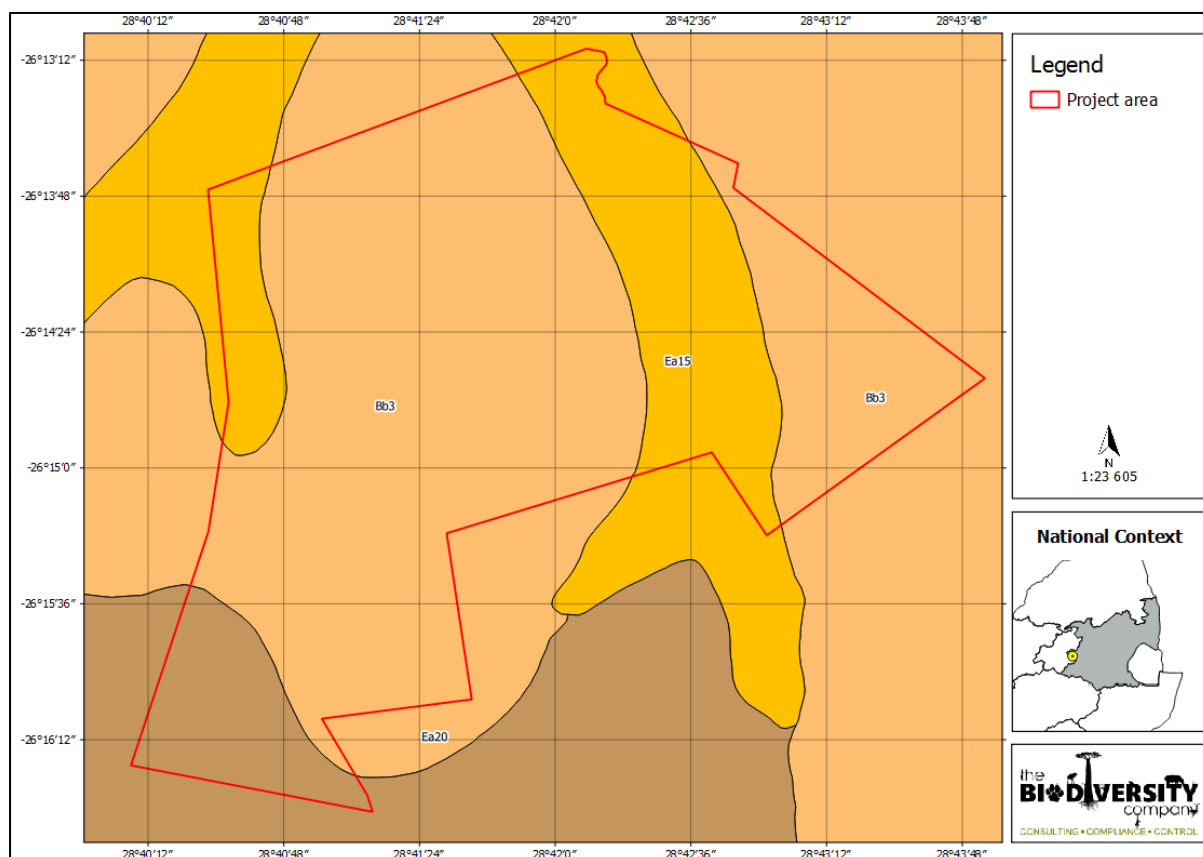
Figure 5: The land types in the project assessment area (MRA)

Land Type	Expected Soil Features
Bb3	PLINTHIC CATENA: UPLAND DUPLEX AND MARGALITIC SOILS RARE; Dystrophic and/or mesotrophic; red soils not widespread
Ea15	ONE OR MORE OF: VERTIC, MELANIC, RED STRUCTURED DIAGNOSTIC HORIZONS; Undifferentiated
Ea20	ONE OR MORE OF: VERTIC, MELANIC, RED STRUCTURED DIAGNOSTIC HORIZONS; Undifferentiated

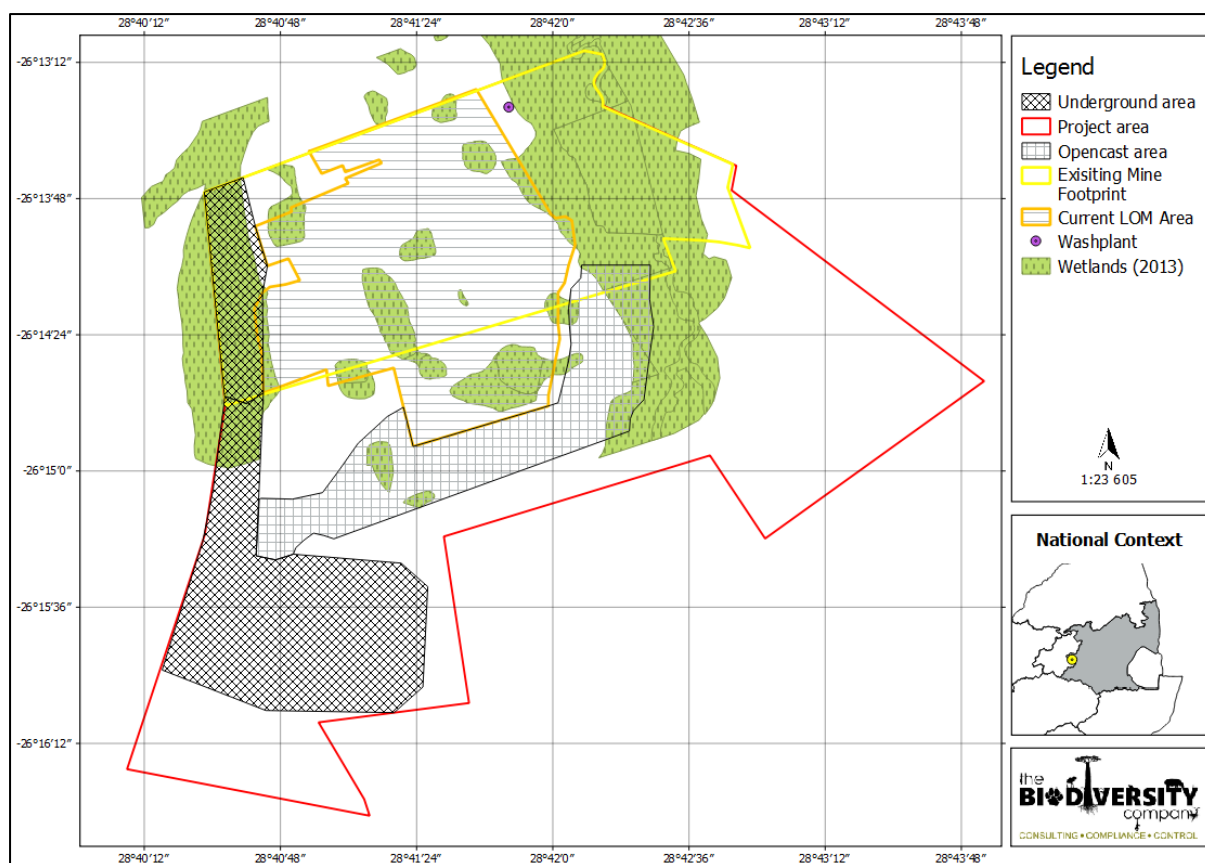
Figure 9: The wetland areas delineated by EFC for the assessment area (2013)

Ecotone Freshwater Consultants CC (EFC) conducted a specialist wetland assessment for a portion of the project area in 2013. Information collated and generated for the study has been considered to supplement this updated wetland assessment. The extent of wetland areas identified and delineated in 2013 is presented in Figure 9.

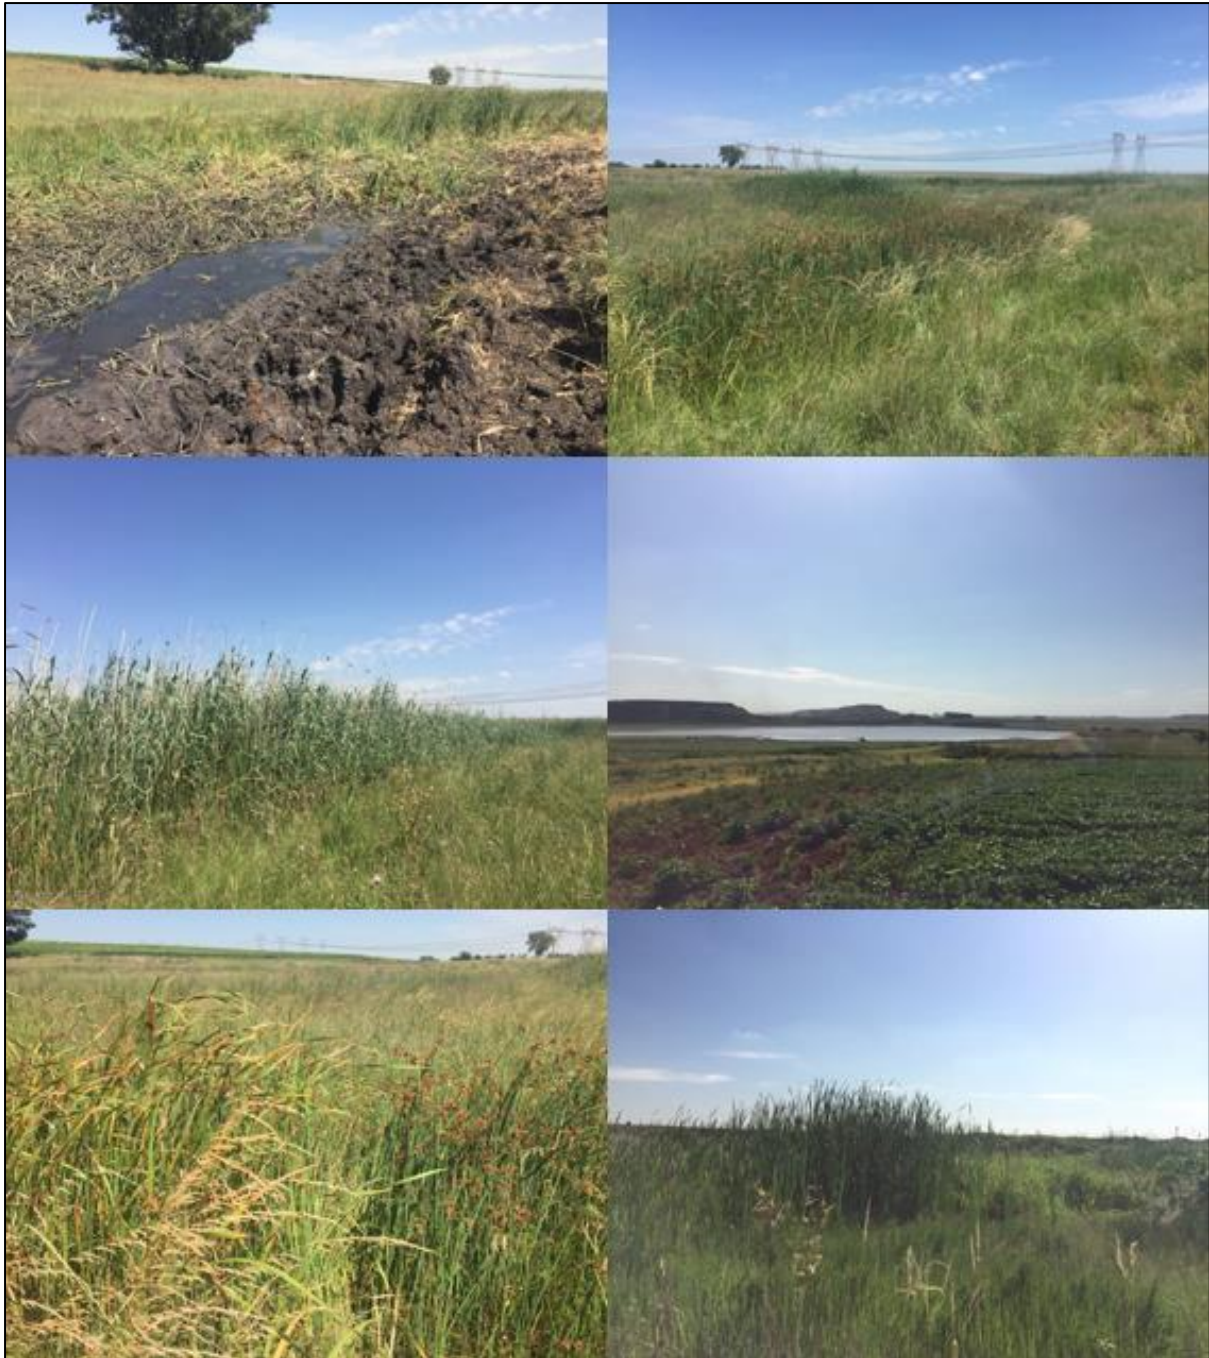
Figure 13: A photo collage of some wetland systems identified for the project (January 2018)

The wetland areas had the greatest species composition in comparison to all the different areas. Patches of *Imperata cylindrica*, *Agrostis lachnantha var. lachnantha* as well as *Typha capensis* occurred throughout the wetland. *Crinum bulbispermum*, *Eucomis autumnalis* as well as *Nerine angustifolia* are flora species associated with marshy or moist areas which occurred throughout the wetland area.

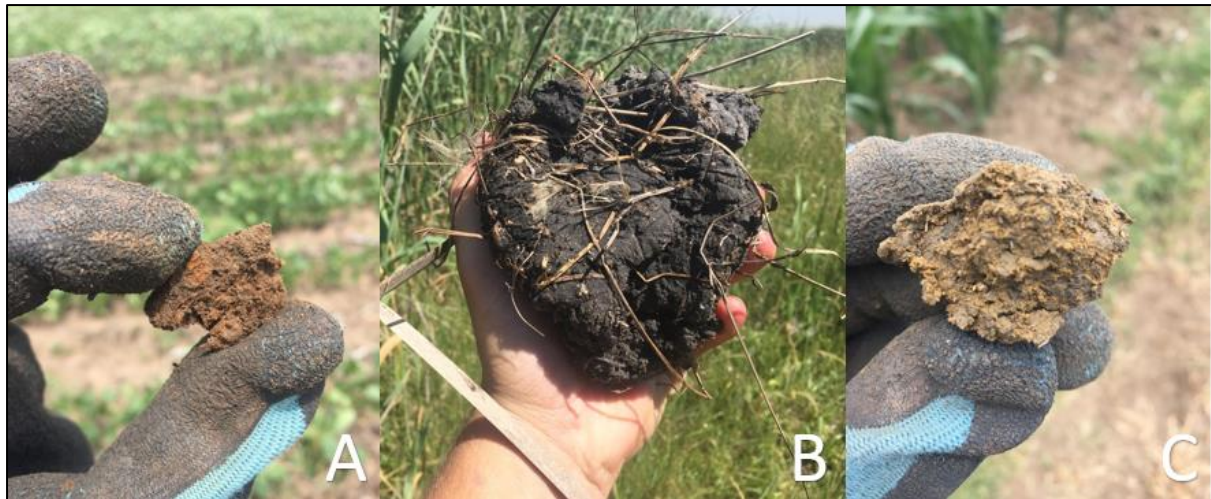
Figure 15: Photographs of Soil Wetness and Soil Forms considered for the study. A: Mottling, B: Melanic topsoil, C: G horizon

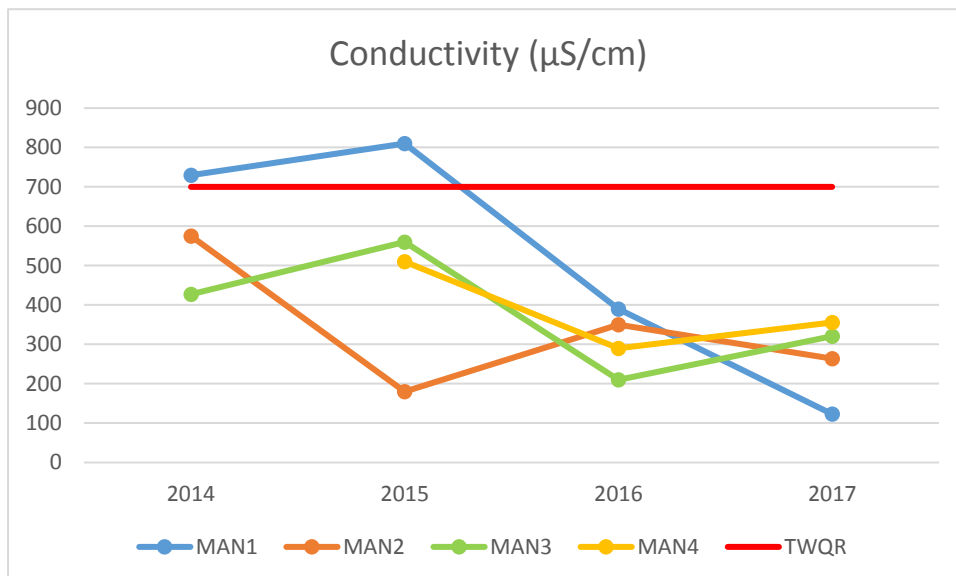
Figure 21: Spatial and Temporal trends for Conductivity levels

Conductivity levels within the systems were elevated during the low flow survey in comparison to the high flow survey (Table 20 and Table 21). This is attributed to the concentration of dissolved solids during the dry season. Elevated conductivity levels were observed at site MAN4 during the low flow survey. All sites fell within TWQR limits during the high flow survey. Trends indicate overall decreased dissolved solid concentration levels from the 2014 to 2017 surveys, indicating improved water quality conditions. Increases in conductivity levels were observed between MAN1, MAN2 and MAN4, however, connectivity of the system was unlikely during the survey and flow was absent from all three sites. Increases in dissolved solids was observed between sites MAN2 and MAN4, and MAN3 and MAN4, indicating an influx of dissolved solids within the downstream reaches (Figure 21).

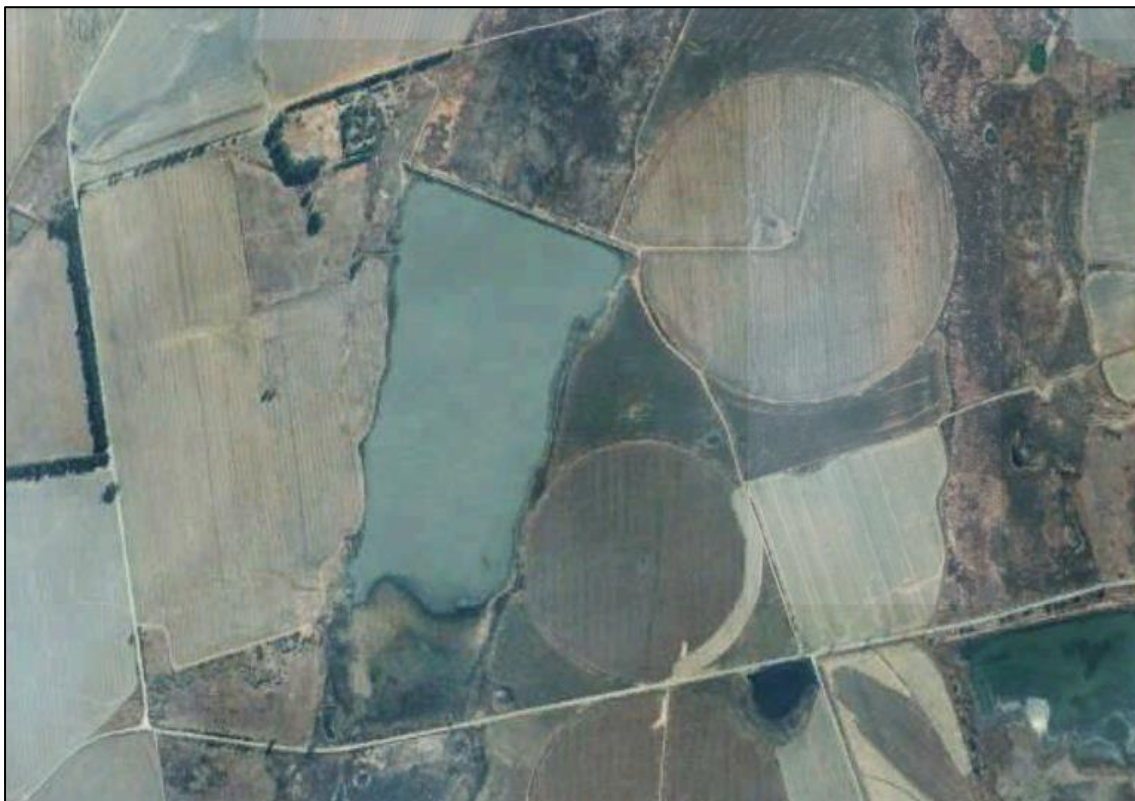
Figure 22: Impoundments and agriculture located on the Bronkhorstspruit system (Google Earth Imagery, 2017)

Impacts to the bed, channel and flow modification in the catchment are moderate to large due to the presence of dams and several river crossings which have altered the natural flows, while transforming the channel characteristics due to the absence of natural flows. The number of farm dams in the project area has collected and retained water in the catchment area, reducing the natural base flows within the project area rivers, resulting in no flow between the Manungu Colliery biomonitoring sites. The catchment activities in the assessed reaches have resulted in large amounts of abstraction from the aquatic systems as well as impacts to water quality (Figure 22). Livestock have impacted some sites within the project area through vegetation trampling which has result in erosion and sedimentation of instream aquatic areas (Figure 23).

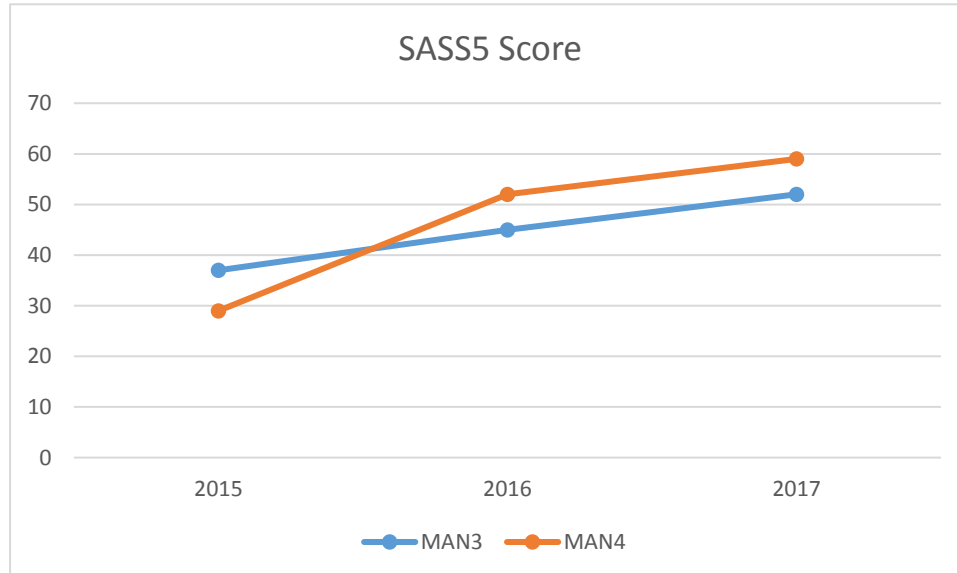
Figure 26: Spatial and temporal trends for the SASS5 scores during high flow periods in the Bronkhorstspruit associated with Manungu Colliery (2017 period)

A gradual increase in total sensitivity scores was observed at sites MAN3 and MAN4 from the 2015 to 2017 surveys (Figure 26). The increase in total scores can be attributed to increased flows within the systems due to increased rainfall volumes. Furthermore, the stabilisation of water quality within the systems contributes to an increase in biotic integrity. However, a decrease in ASPT scores was observed during the 2017 survey from that of the 2016 survey (Figure 27). The decrease can be attributed to a combination of water quality (Table 20 and Table 21) and habitat modification (Table 25). Site MAN4 is presented as it is the most downstream site and should present the cumulative impacts in the Bronkhorstspruit associated with Manungu Colliery. Based on these trends a dry spell was present during the 2015 monitoring period. Following the dry spell, a fluctuation in SASS5 scores was noted, with scores showing a steady increase since the 2016 high flow survey. The ASPT scores were seen to reflect higher scores during the consecutive low flow assessments compared to the respective high flow assessments. The higher scores may be attributed to variances in habitat availability due to water volumes at the time of each survey.
