ENVIRONMENTAL IMPACT MANAGEMENT SERVICES

UPDATE OF MANUNGU CLOSURE COSTING AS PER DMR GUIDELINE- SEPTEMBER 2018

E018_ClosureCostingReport_001

Manungu Closure Cost Comparison 2018- 2019

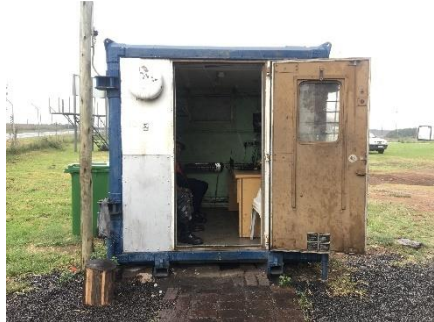
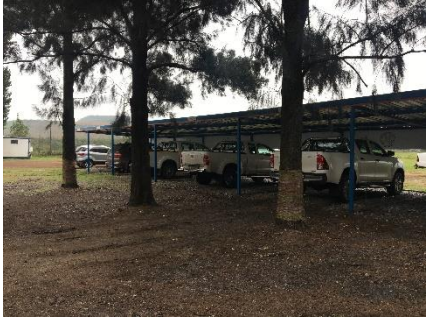
| Area | Description |
|---|---|
| | <div style="display: flex; justify-content: space-around;"> <div style="text-align: center;"> <p>Guard house (Ref no 11 on drawing E018-000-002)</p> </div> <div style="text-align: center;"> <p>Carports (Ref no 9&10 on drawing E018-000-002)</p> </div> </div> |

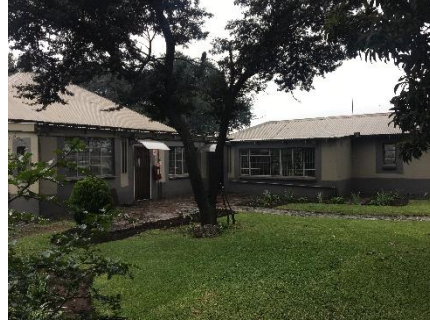
| Area | Description | |
|---|--|---|
| | <p>Boardroom (Ref no 14 on drawing E018-000-002)</p> | <p>Main office building (Ref no 18 on drawing E018-000-002)</p> |

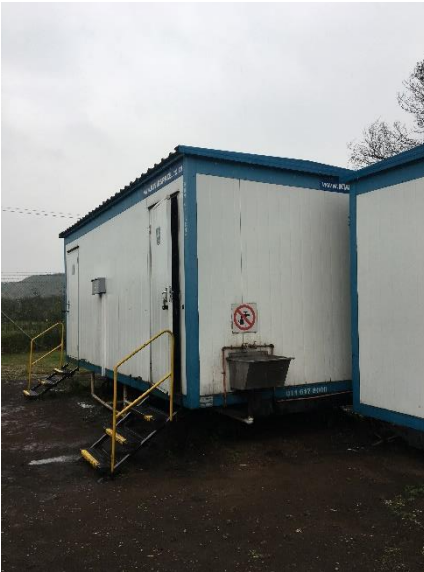
| Area | Description | |
|---|--|---|
| | <p>Offices (Ref no 16 on drawing E018-000-002)</p> | <p>Dog houses (Ref no 17 on drawing E018-000-002)</p> |

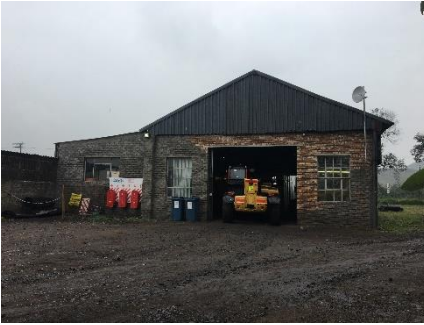
| Area | Description | |
|---|--|---|
| | <p>Abandoned buildings and JoJo water tank slab (Ref no 14 & 15 on drawing E018-000-002)</p> | <p>Lapa and storage area (Ref no 8 on drawing E018-000-002)</p> |

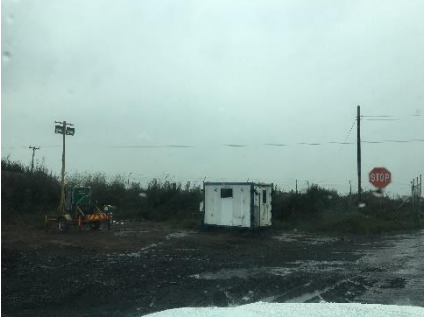
| Area | Description | |
|---|---|---|
| | <p>Offices (Ref no 2,3,4,5 on drawing E018-000-002)</p> | <p>Septic tank (Ref no 26 on drawing E018-000-002)</p> |

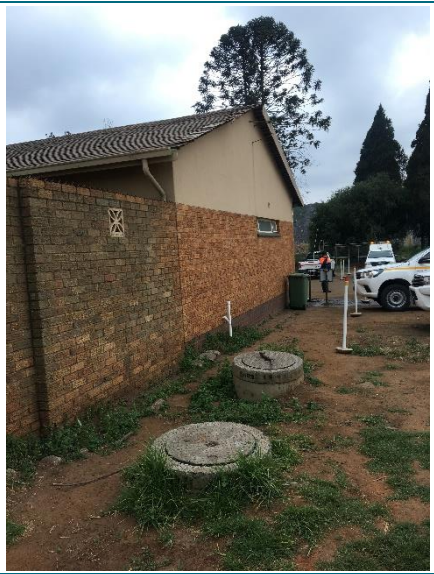
| Area | Description | |
|---|---|--|
| | <p>Braai area (Ref no 25 on drawing E018-000-003)</p> | <p>Offices (Ref no 22,23 & 24 on drawing E018-000-003)</p> |

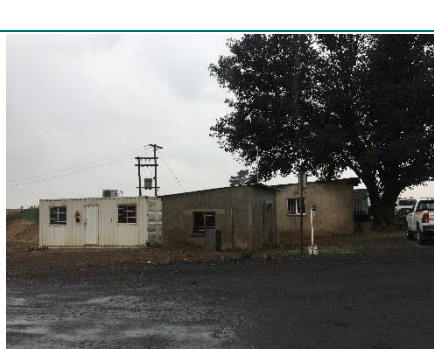
| Area | Description | |
|---|---|--|
| | <p>Offices (Ref no 21 on drawing E018-000-003)</p> | <p>Brick building and container (Ref no 18 & 20 on drawing E018-000-003)</p> |

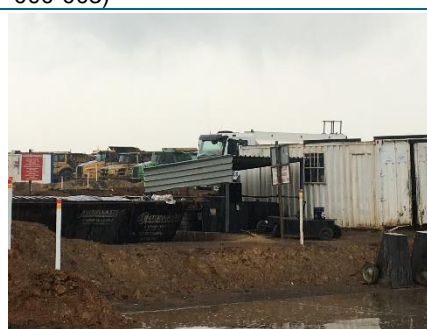
| Area | Description | |
|---|---|--|
| | <p>Septic tank (Ref no 19 on drawing E018-000-003)</p> | <p>Abandoned buildings and JoJo tanks slabs (Ref no 16 & 17 on drawing E018-000-003)</p> |

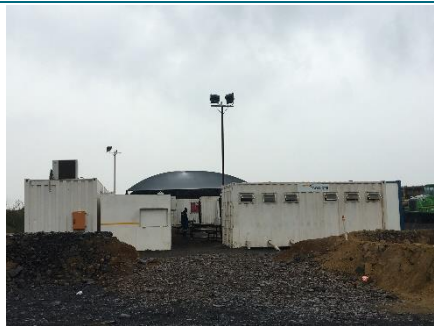
| Area | Description | |
|---|---|---|
| | Wash bay (Ref no 1 on drawing E018-000-003) | Containers (Ref no 11 on drawing E018-000-003) |

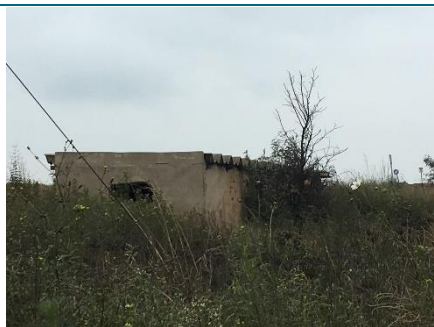
| Area | Description | |
|---|---|---|
| | Hard park (Ref no 27, 28 & 29 on drawing E018-000-003) | Chicken run concrete bases (Ref no 6 on drawing E018-000-001) |

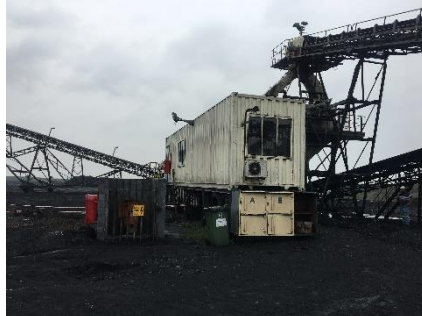
| Area | Description | |
|---|---|---|
| | Conveyors (Ref no 6 & 14 on drawing E018-000-004) | Reclaimed feeder (Ref no 2 on drawing E018-000-004) |

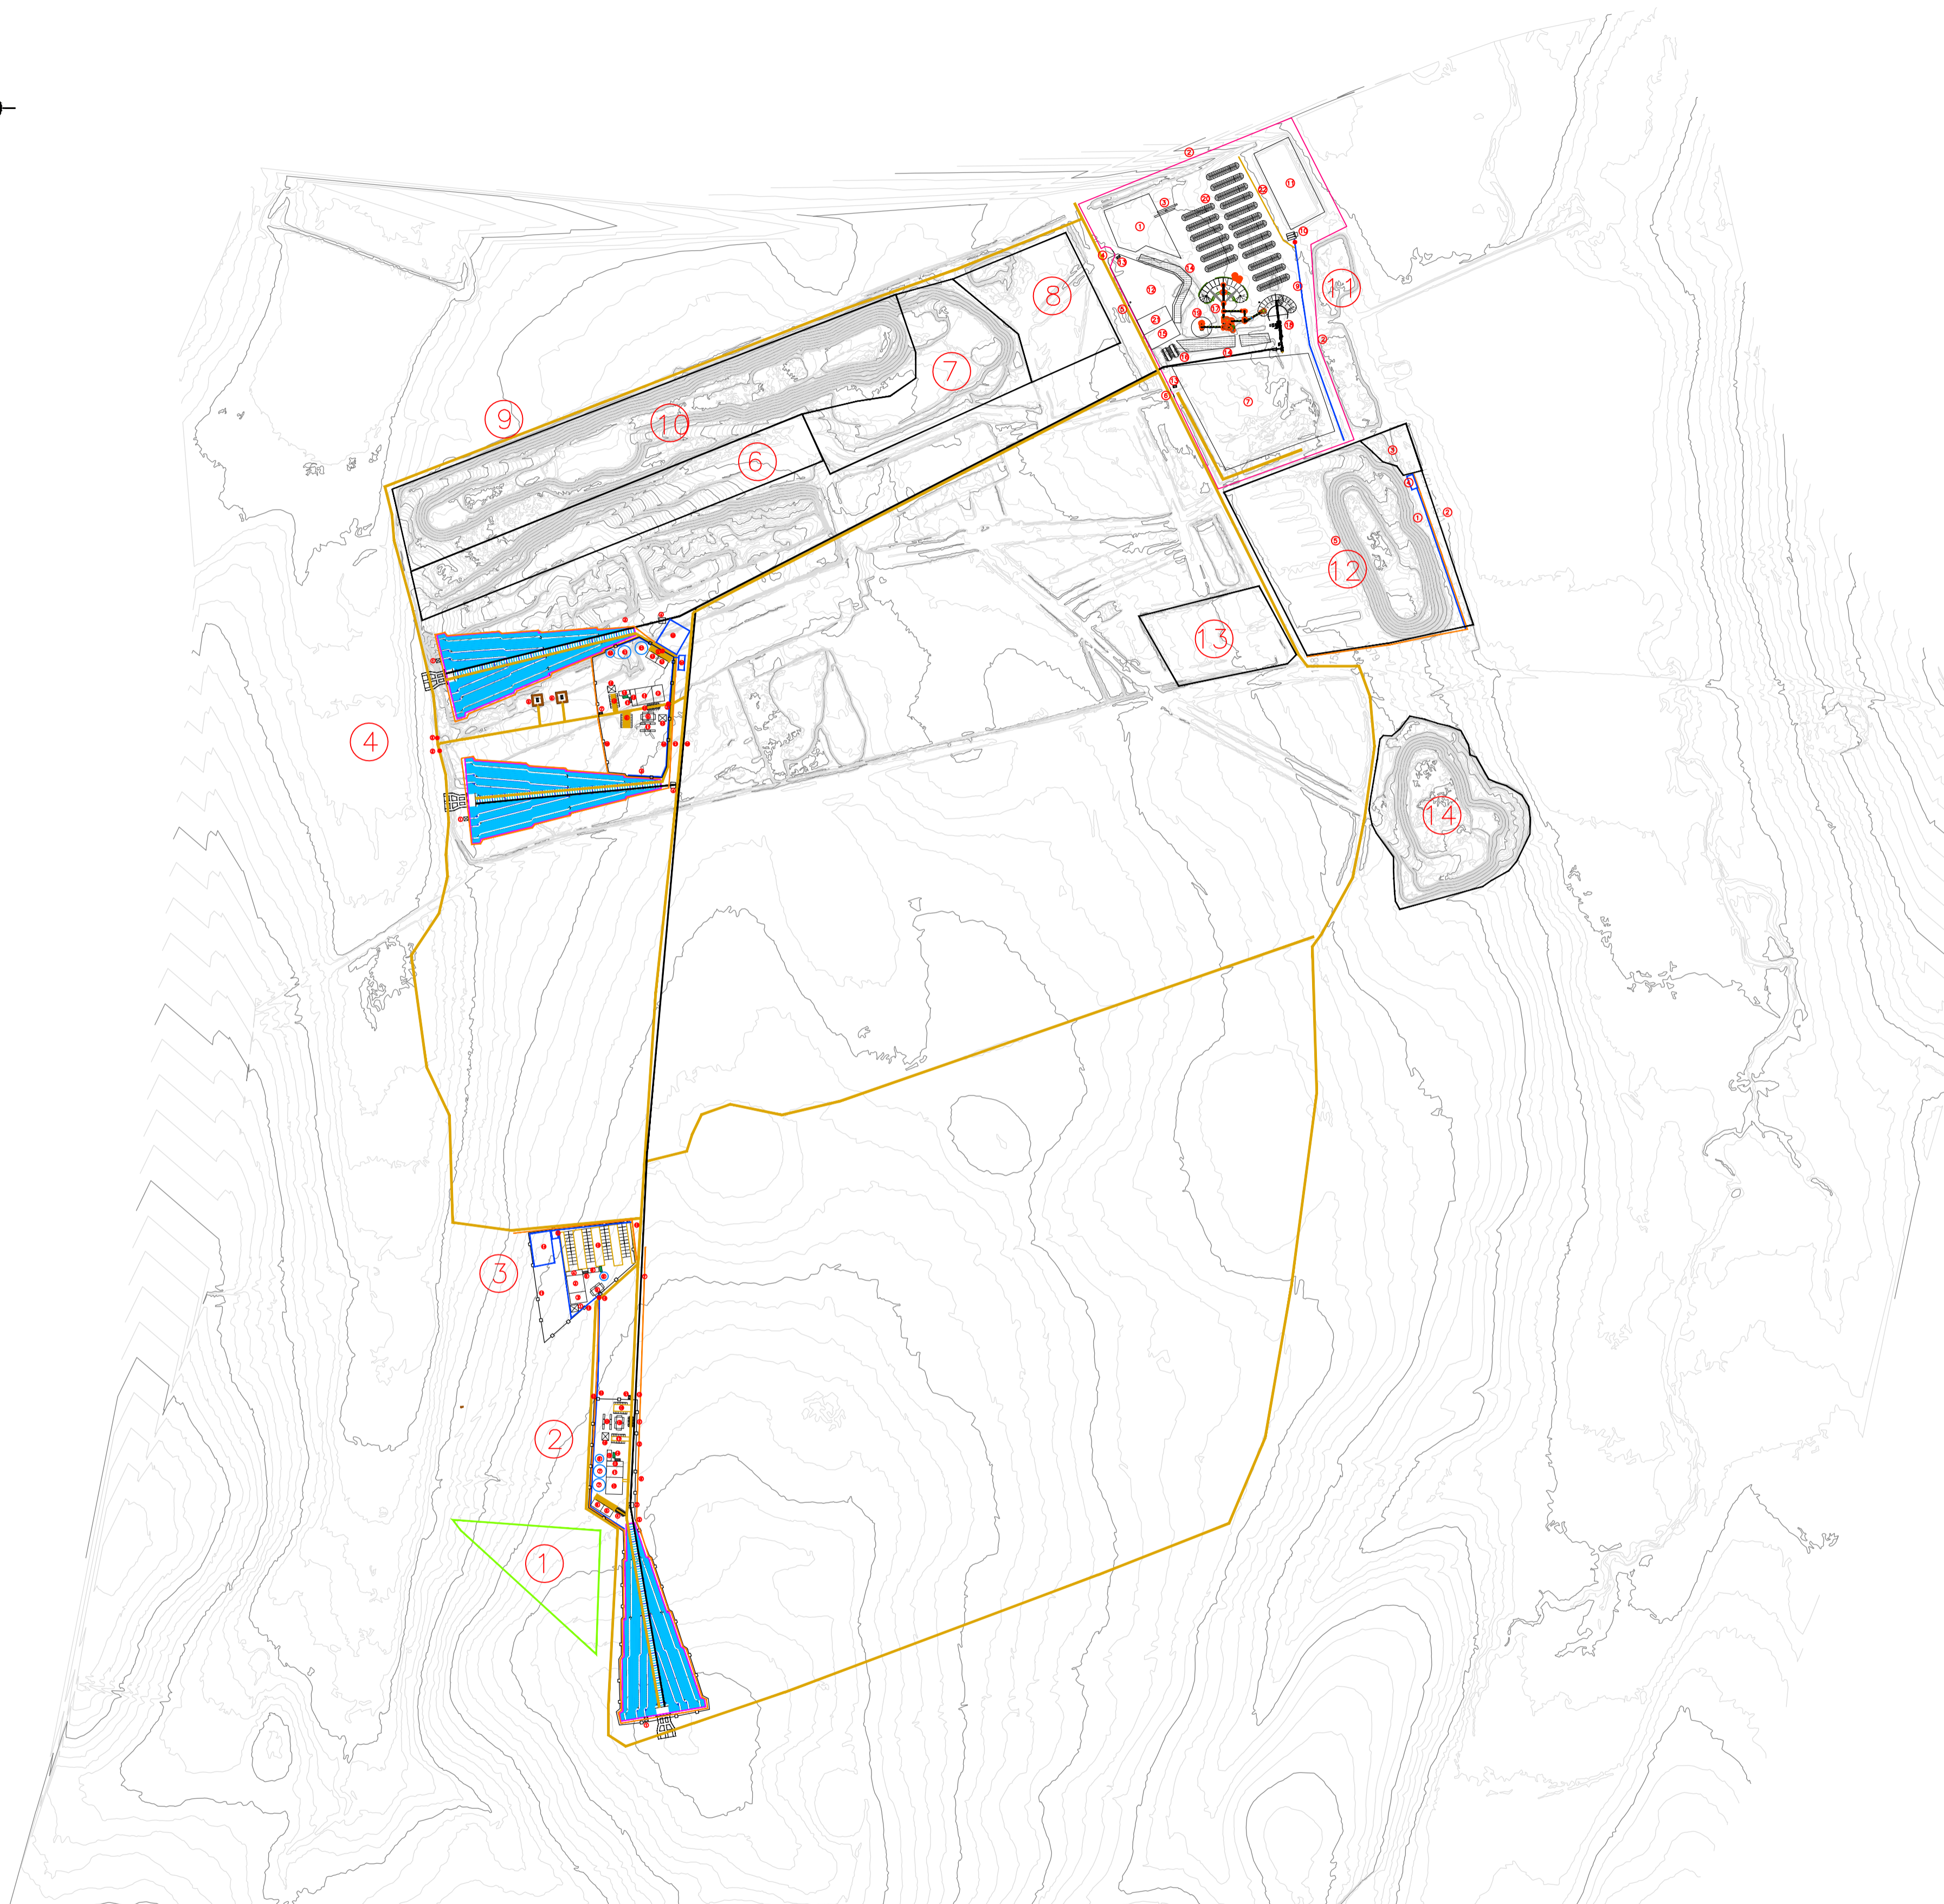
| DRAWING TITLE | SCHEDULED CLOSURE SITE WIDE LAYOUT PLAN | | | |

| ITEM | DESCRIPTION |
|---|---|
| ① | Proposed Shaft Boxcut Spoils |

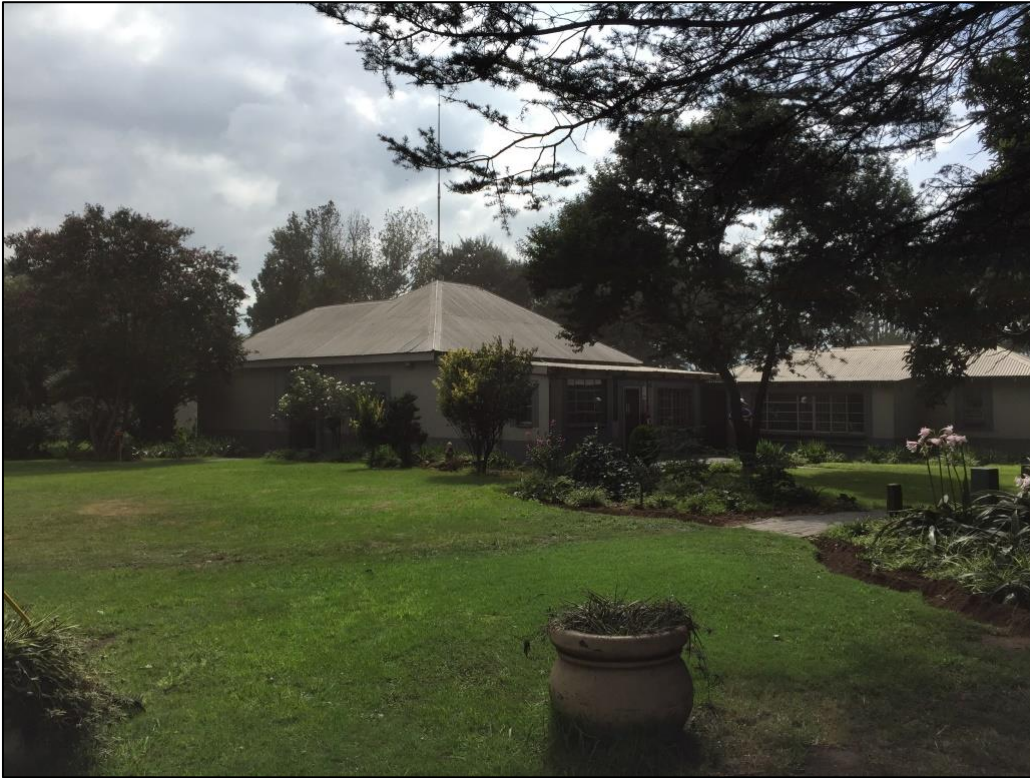
Figure 6-1: Main Office Building

All brick, steel and concrete structures (Figure 6-1 and Figure 6-2) need to be demolished to 1 m below ground level. The remaining rubble may be buried adjacent to the building sites or used as backfill material in the pit. Once the area is demolished the area needs to be covered with 150 mm (except at the Stockpile Area, replaced to 300 mm) of topsoil and vegetated.

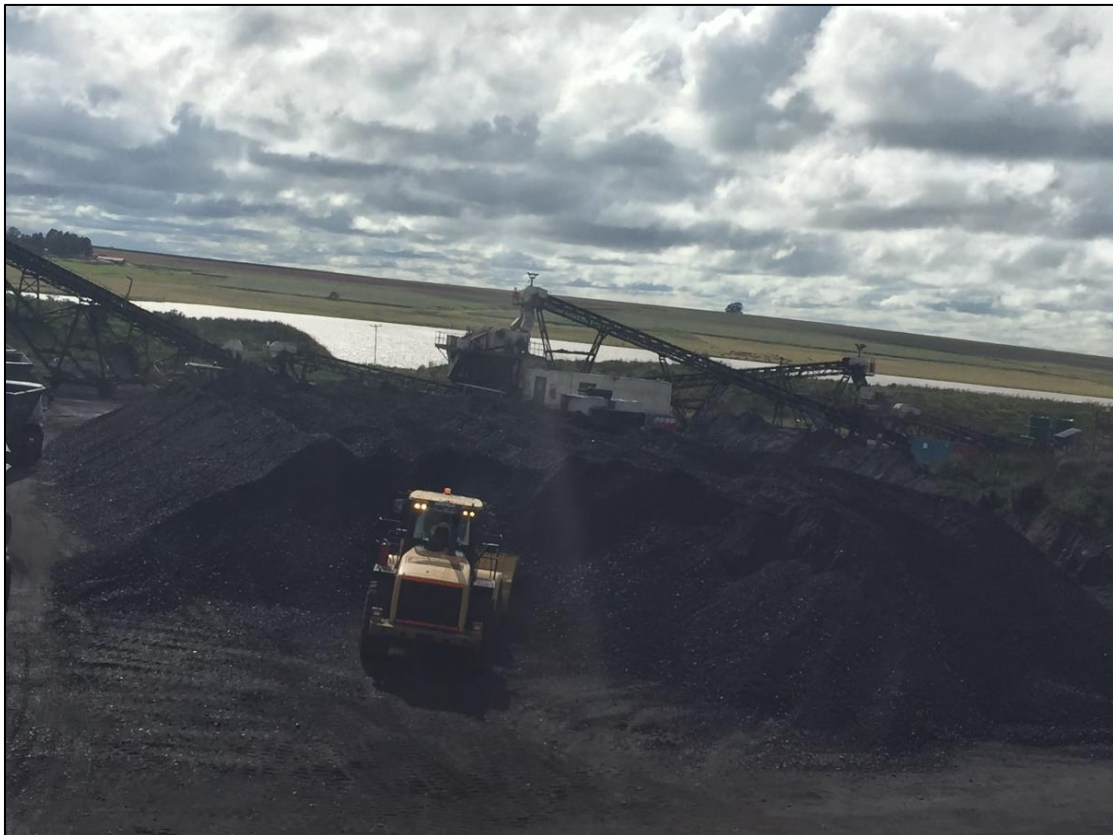
Figure 6-3: Manungu Crushing and Screening Plant

All fixed infrastructure associated with the plant (refer to Figure 6-3 below) needs to be stripped and broken down. Concrete needs to be removed to 1 m below ground level and soil replaced to 300 mm. This includes any conveyors, foundations and any concrete between buildings. All recoverable scrap steel can be sold and recycled. The calculations do not account for any value recovered from the sale of plant, steel or other material. A potential saving is however possible at the end of life of mine.

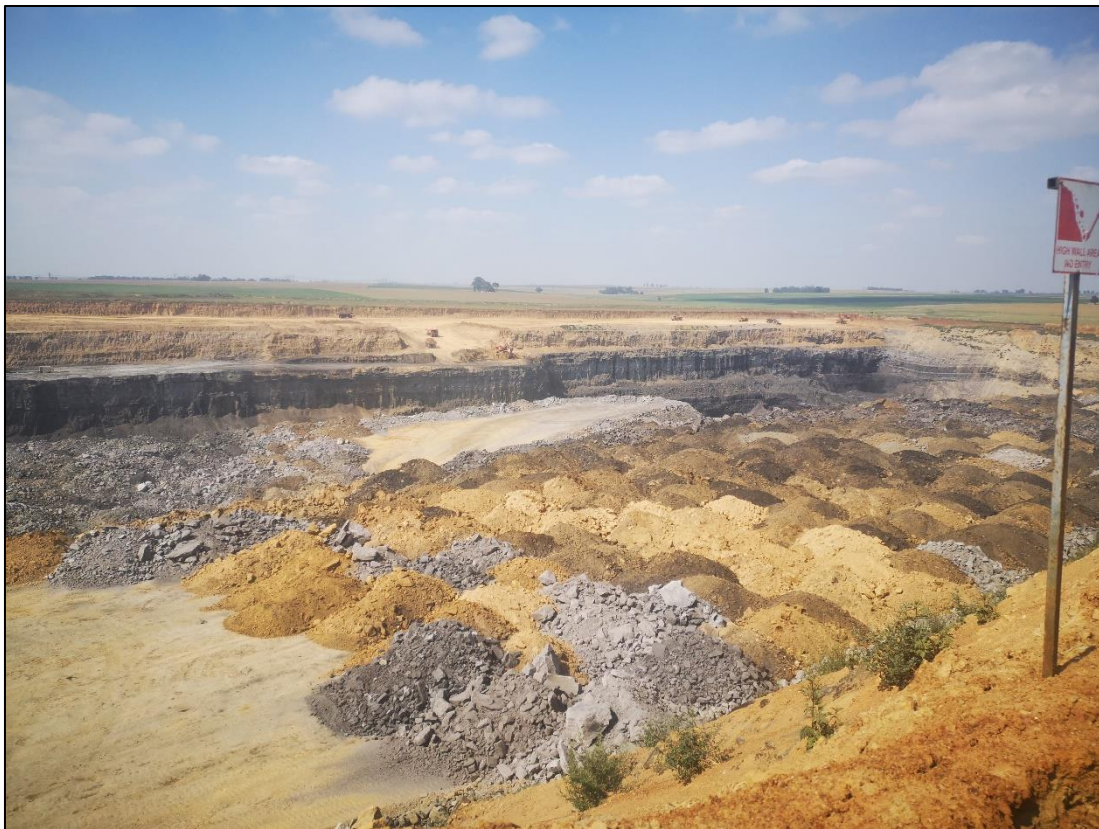
Figure 6-4: Manungu Open Pit and Partial Backfilled Area

Once mining of the open pit has been completed, the open pit will be filled with overburden, levelled and topsoil replaced. The areas that have been infilled will be shaped to reduce the likelihood of ponding occurring on surface and to blend in with the surrounding topography.

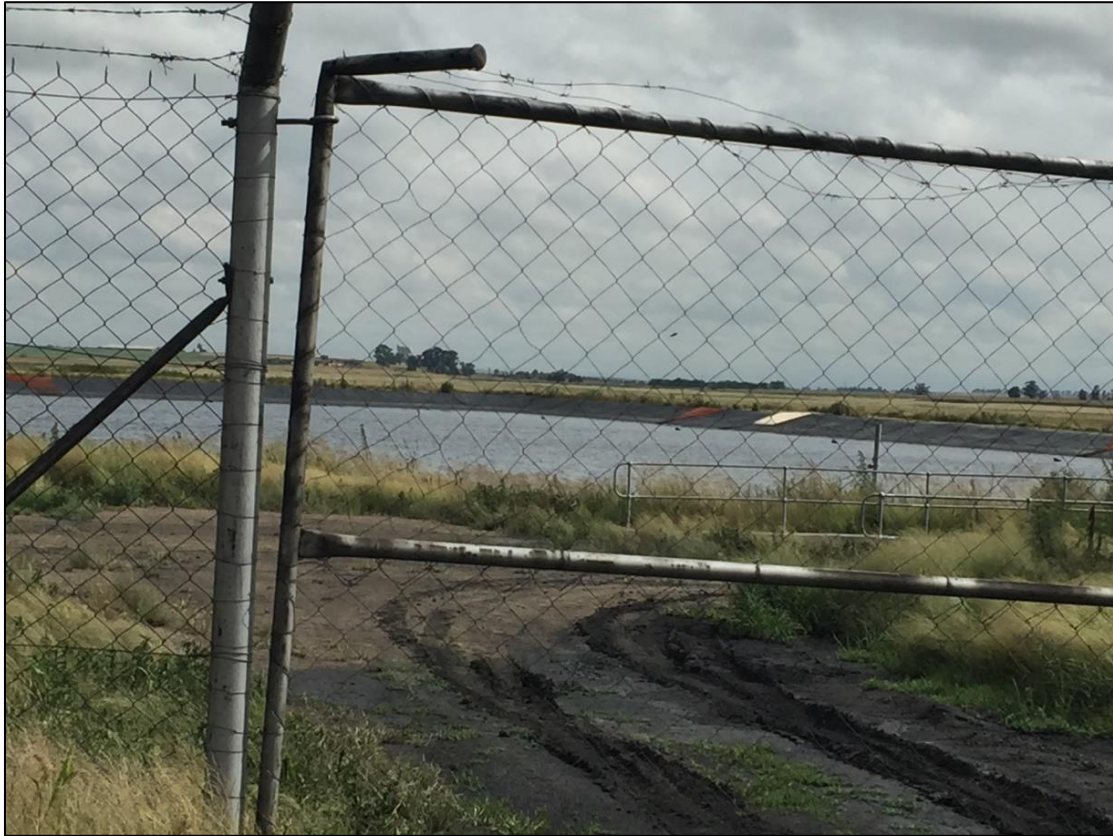
Figure 6-5: Manungu Pollution Control Dam

The PCDs will be removed at closure. The plastic lining must be removed and, unless recycled, disposed of in the designated waste site. The earth walls will be flattened and the area profiled. The pumps and pipes associated with the dam must be removed and if possible sold.

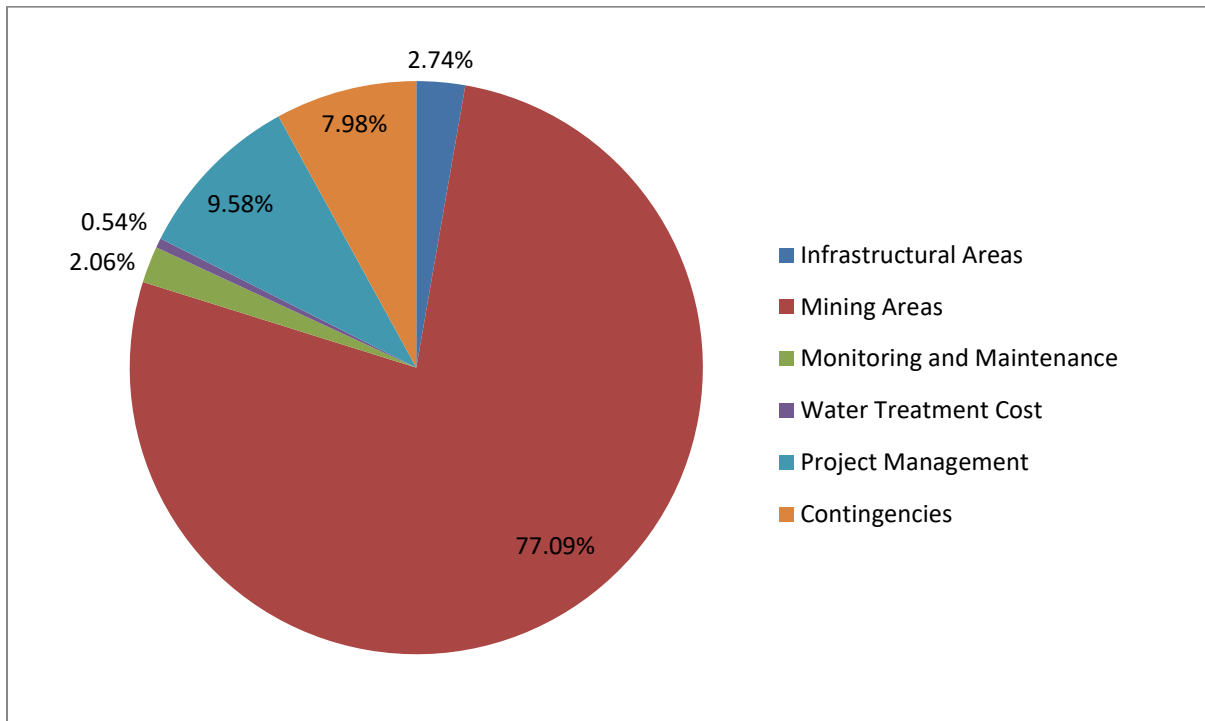
Figure 8-1: 2019 Cost Distribution for Manungu

Figure 8-1 further indicates the cost distribution between different components that make up the closure cost for Manungu. As can be expected the costs associated with the rehabilitation of mining areas is the largest contributor to the overall cost (77.09%). It should be noted that the backfilling of the pits and revegetation of the pit and dump footprints constitute to most of the Mining Area cost.
