# SOIL ASSESSMENT FOR THE CLOSURE OF THE ST HELENA SHAFT, HARMONY

## FREE STATE, SOUTH-AFRICA

June 2018

Report Name	Soil assessment for the closure of the St Helena Shaft, Harmony	
Submitted to	EIMS	
Survey/Report	Ivan Baker

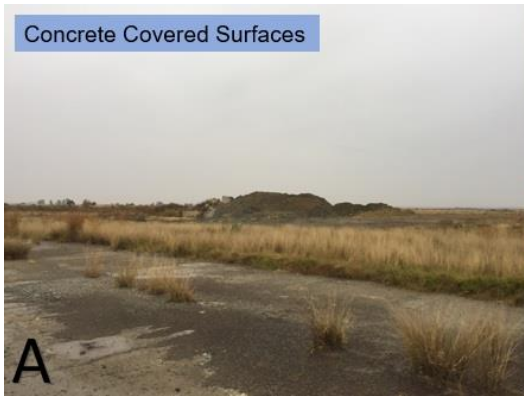
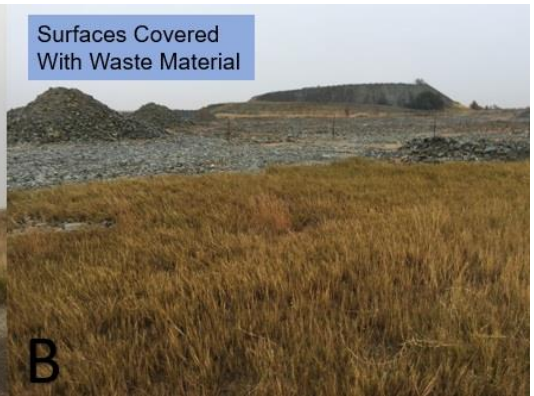
Man-made soil deposit	
Description	The Witbank soil form consist of an Orthic A-horizon on top of a soil layer formed by human deposits which include sport fields, landfill areas, mined or rehabilitated areas, etc.	
Site photos (see Figure 8 for locations)	<div><div><p>Concrete Covered Surfaces</p>

<p>A</p></div><div><p>Surfaces Covered With Waste Material</p>

<p>B</p></div></div>

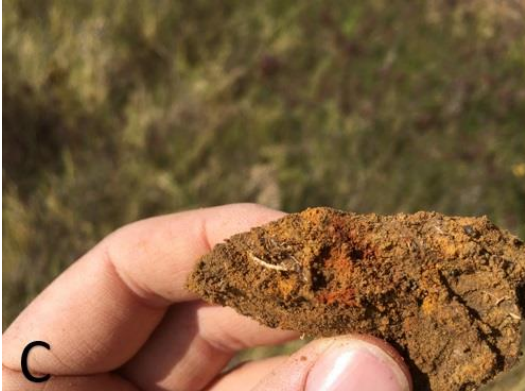
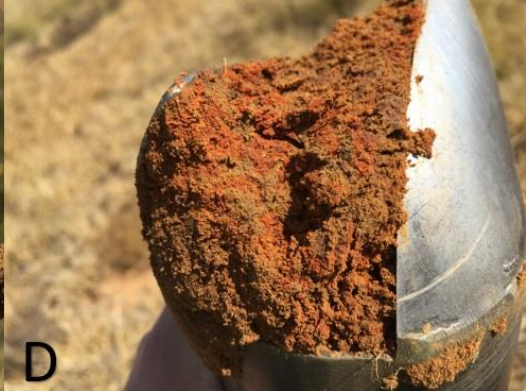
Yellow-Brown Apedal B-horizon	
	Soft Plinthic B-horizon	
Description	The Avalon soil form consists of an Orthic A-horizon, on top of a Yellow-Brown Apedal B-horizon, which on turn is on top of a Soft Plinthite B-horizon.	
Site photos	<div><div>

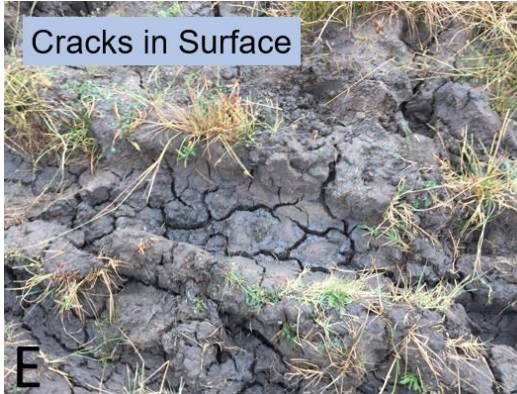
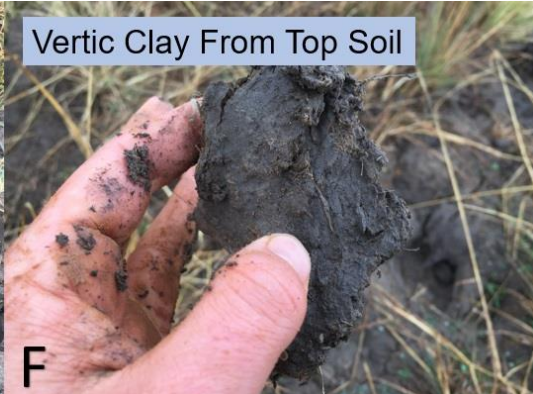
Unspecified material	
Description	The Arcadia soil form consists of a Vertic A-horizon on top of an unspecified material. A typical feature of Vertic top soils are cracks in the surface after dry periods.	
Site photos (see Figure 8 for locations)	<div><div>

<p>Cracks in Surface</p><p>E</p></div><div>

<p>Vertic Clay From Top Soil</p><p>F</p></div></div>

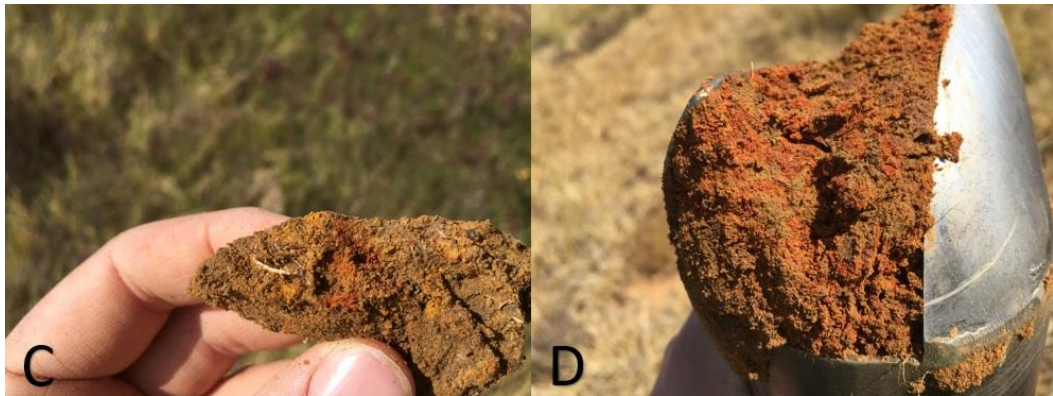
Soft Plinthic B-horizon	
Description	The Westleigh soil form consists of an Orthic A-horizon on top of a Soft Plinthic B-horizon.	
Site photos (see Figure 8 for locations)

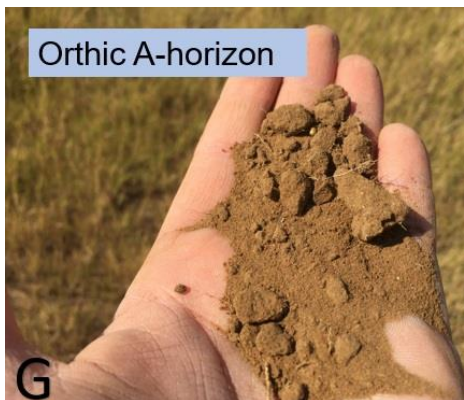
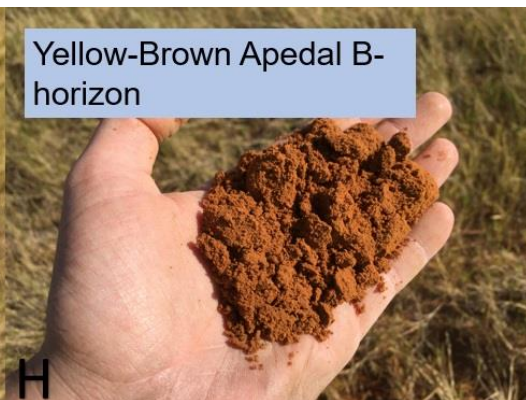
Yellow-Brown Apedal B-horizon	
Description	The Clovelly soil form consists of an Orthic A-horizon on top of a Yellow-Brown Apedal B-horizon.	
Site photos (see Figure 8 for locations)	<div><div>

<p>Orthic A-horizon</p><p>G</p></div><div>

<p>Yellow-Brown Apedal B-horizon</p><p>H</p></div></div>

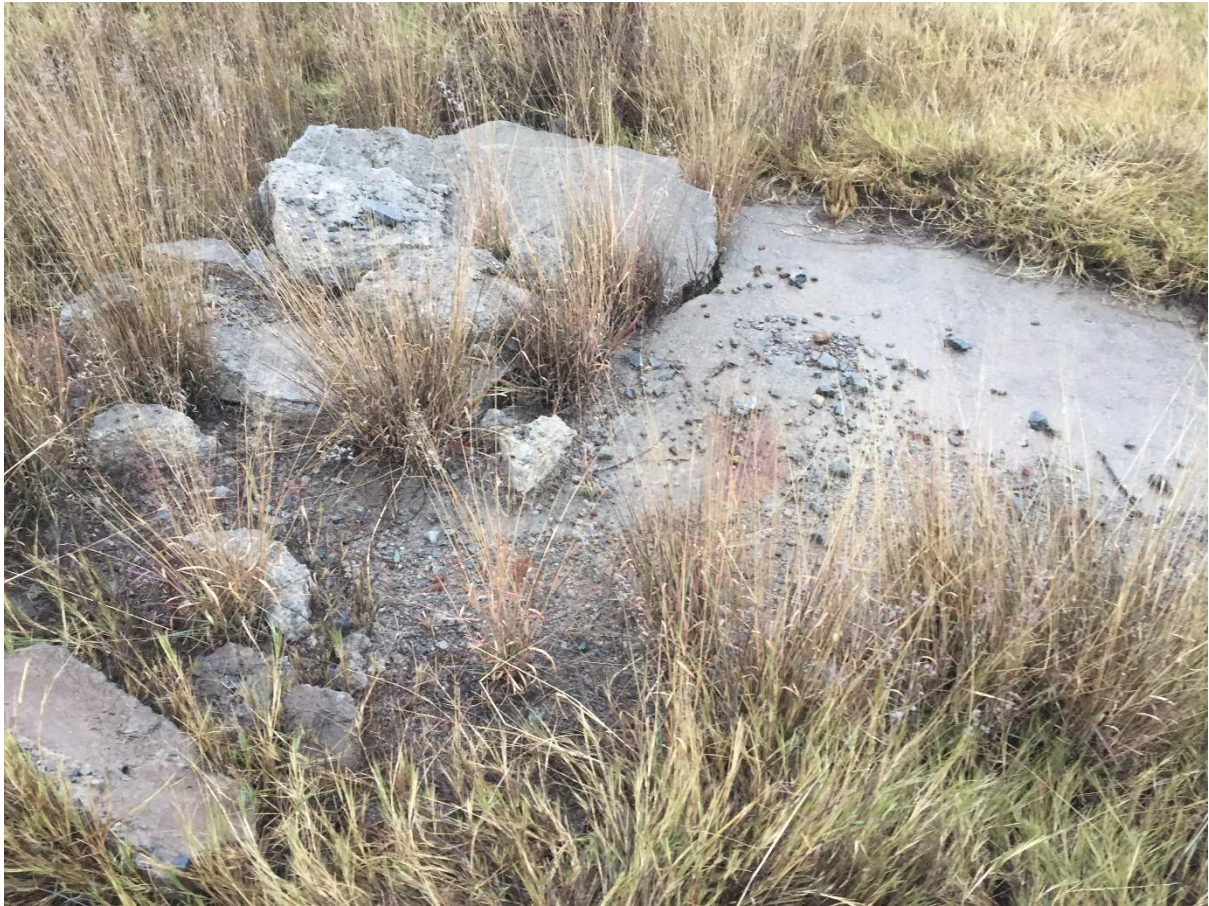
*Figure 21: Building material*

- All rubble and building material must be removed from site, see Figure 21;
- Any potential hazardous material within the waste rock should be assessed by a specialist to ensure that suitable recommendations are made for the safe removal thereof, this include waste material (Figure 22);

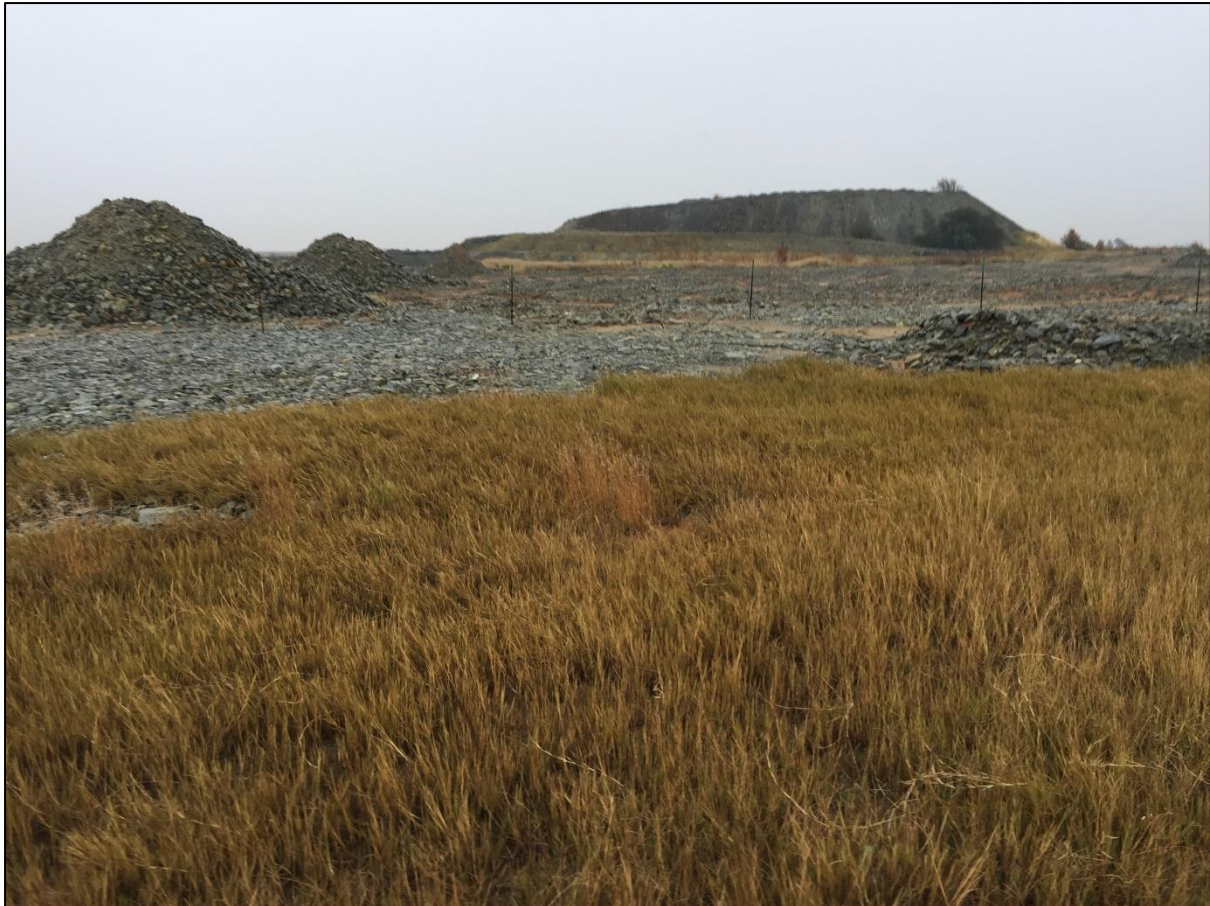
*Figure 22: Waste material covering the mining area*
