CLOSURE PLAN

HARMONY GOLD MINING COMPANY LIMITED: ST HELENA 10 SHAFT
FS30/5/1/2/2/86MR

EIMS REFERENCE: 1234
DOCUMENT TITLE: ST HELENA SHAFT 10 (FS30/5/1/2/2/86MR) CLOSURE PLAN

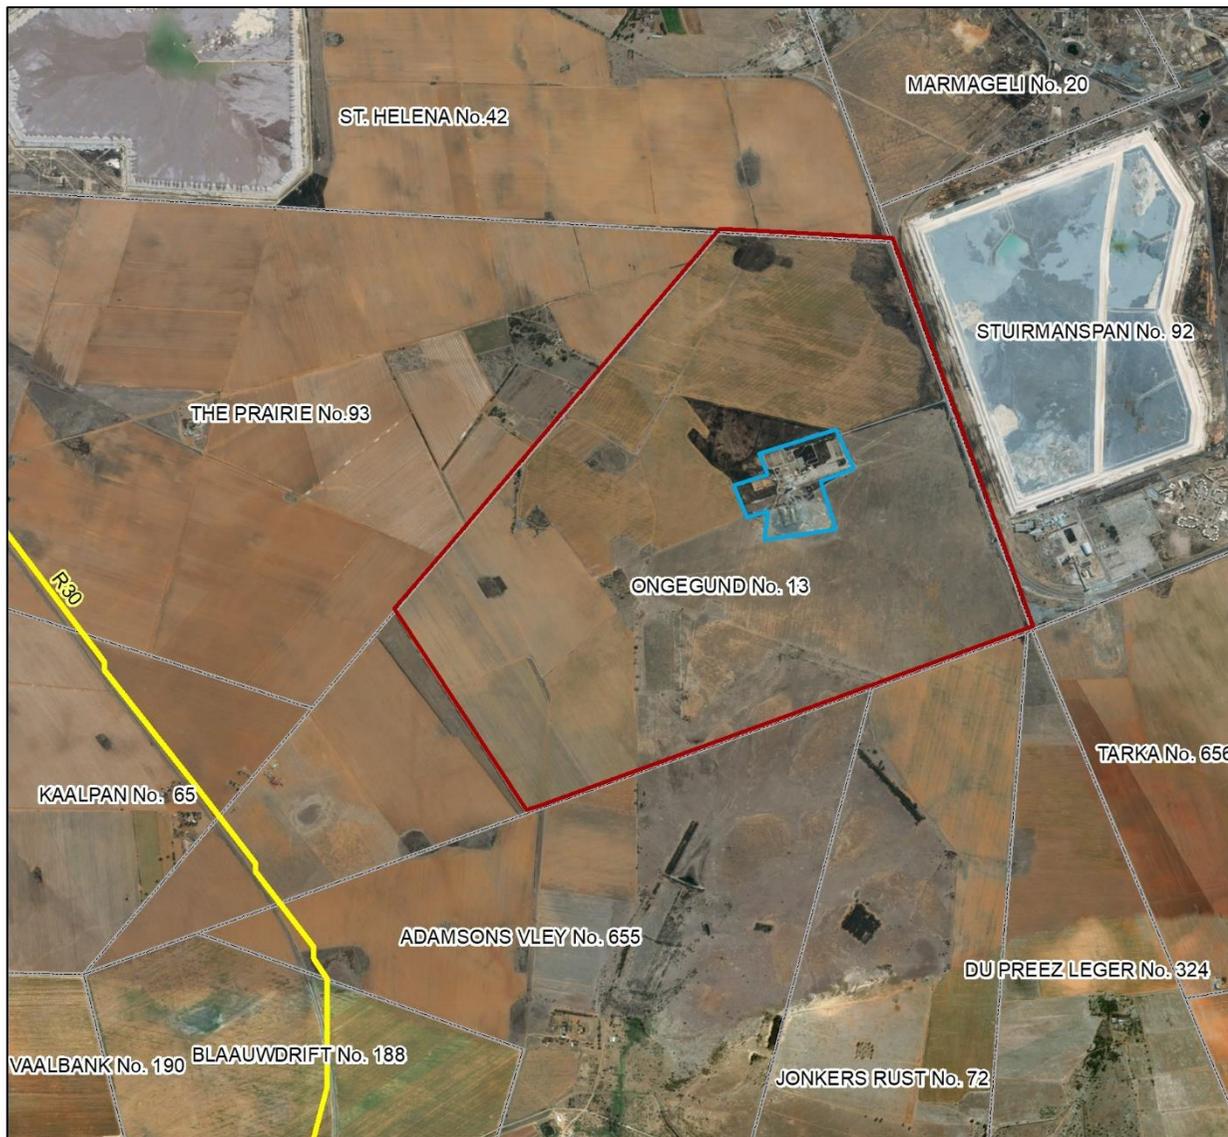
Figure 1: Locality Map showing the greater project area.

The St Helena shaft project area is located in the magisterial district of Matjhabeng within the Lejweleputswa District Council, Free State. Figure 1 provides a locality map of the greater project area, with a photograph of the site area (the area of works) provided in Figure 2. The project area is approximately 10km south of Welkom and is surrounded by wetland, grazing, agricultural crops, and industrial as well as commercial land use areas. A Tailings Storage Facility (TSF) is located directly to the east of the site. The St Helena 10 shaft was not formally operational and no old bearing material was mined from it.

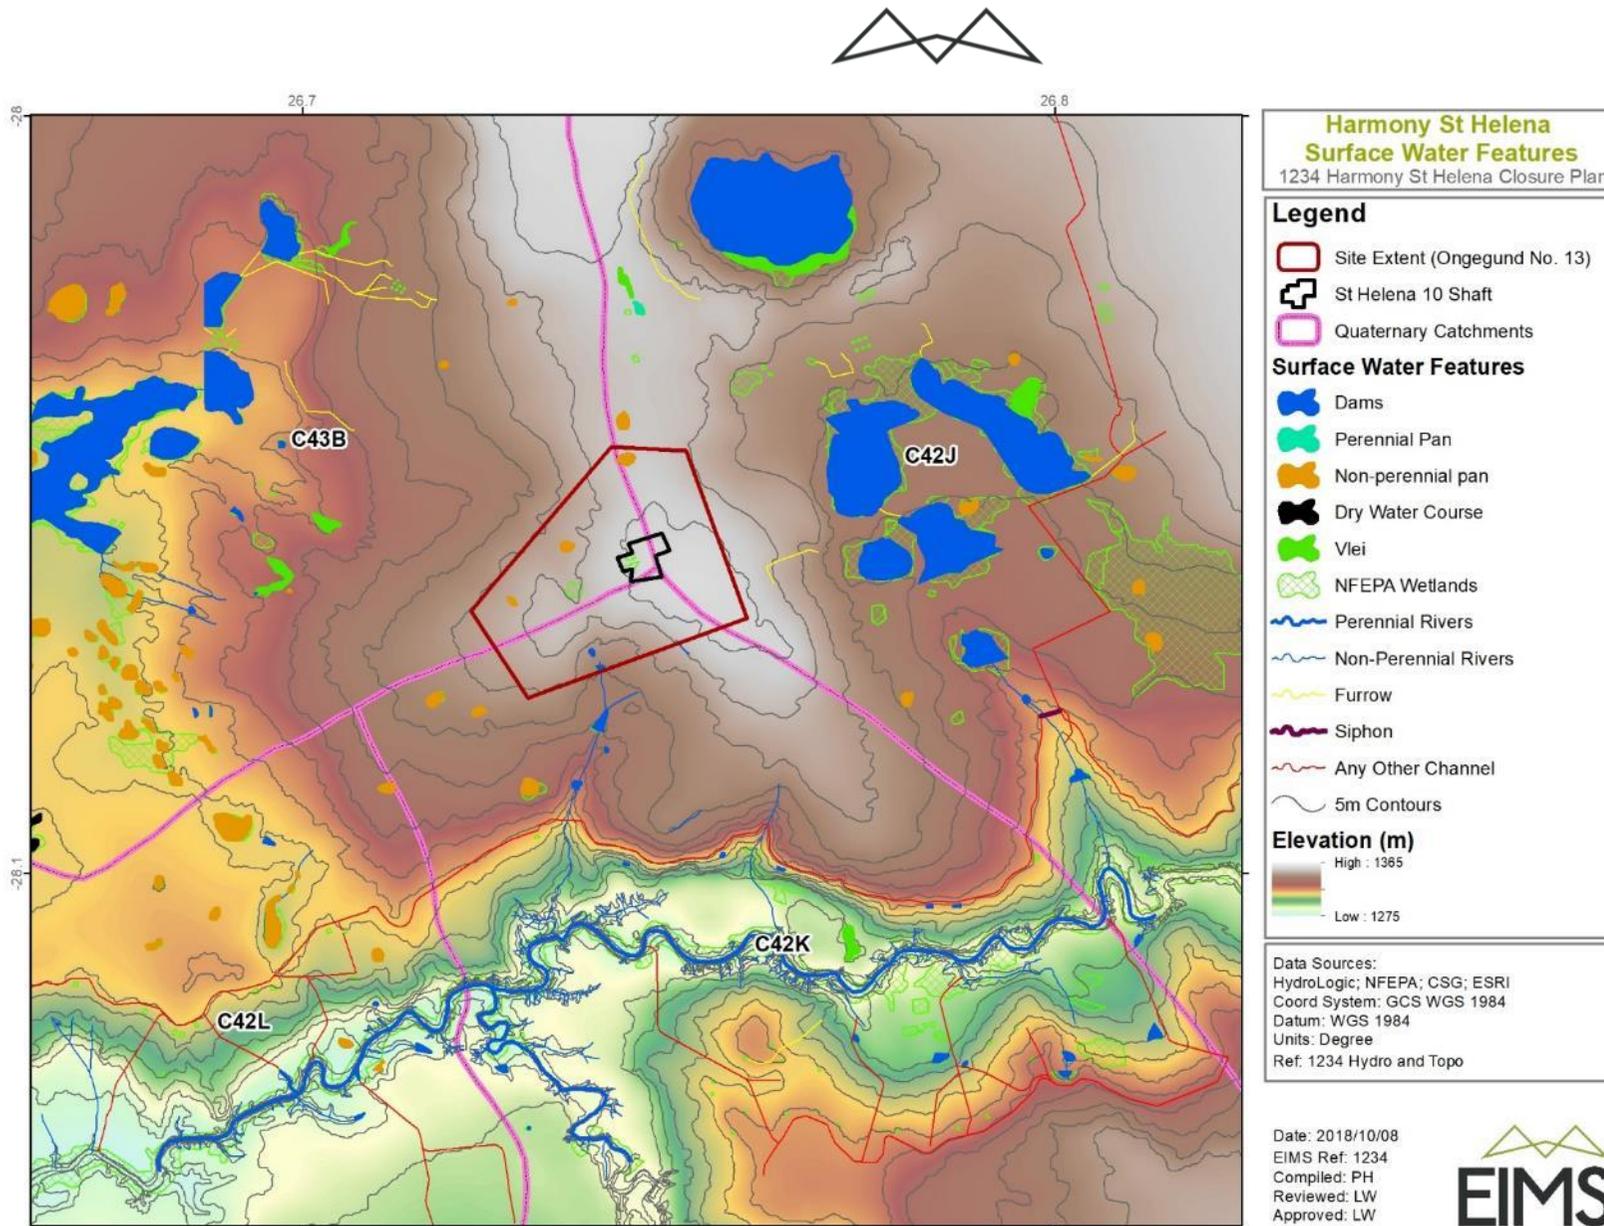
Figure 3: Hydrology and topography of region.

Figure 3 illustrates the topographical and hydrological setting of the site as identified by the surface water specialist. The site is positioned on the watershed of three quaternary catchments: C42J, C42K and C43B. An analysis of site topography undertaken in Section 4 as part of the storm water management plan, reveals that the site drains to quaternary C24K (based upon SRTM30 data used). This variation from the quaternary catchment's watersheds dataset is expected since the quaternary catchments for South Africa were derived using a low level of accuracy.

The primary river in the region around the site is the Sand River. A non-perennial river has its headwaters to the south of the site. This non-perennial river captures runoff from the site (which reaches it) and conveys it to the Sand River. A few small farm dams are located on this non-perennial river as indicated by the 1:50,000 topographical map data, with two of these farm dams located within the wider boundary of the site. Non-perennial pans are also located within the wider boundary of the site. During the site visit, both the non-perennial pans and two farm dams were found to be empty.

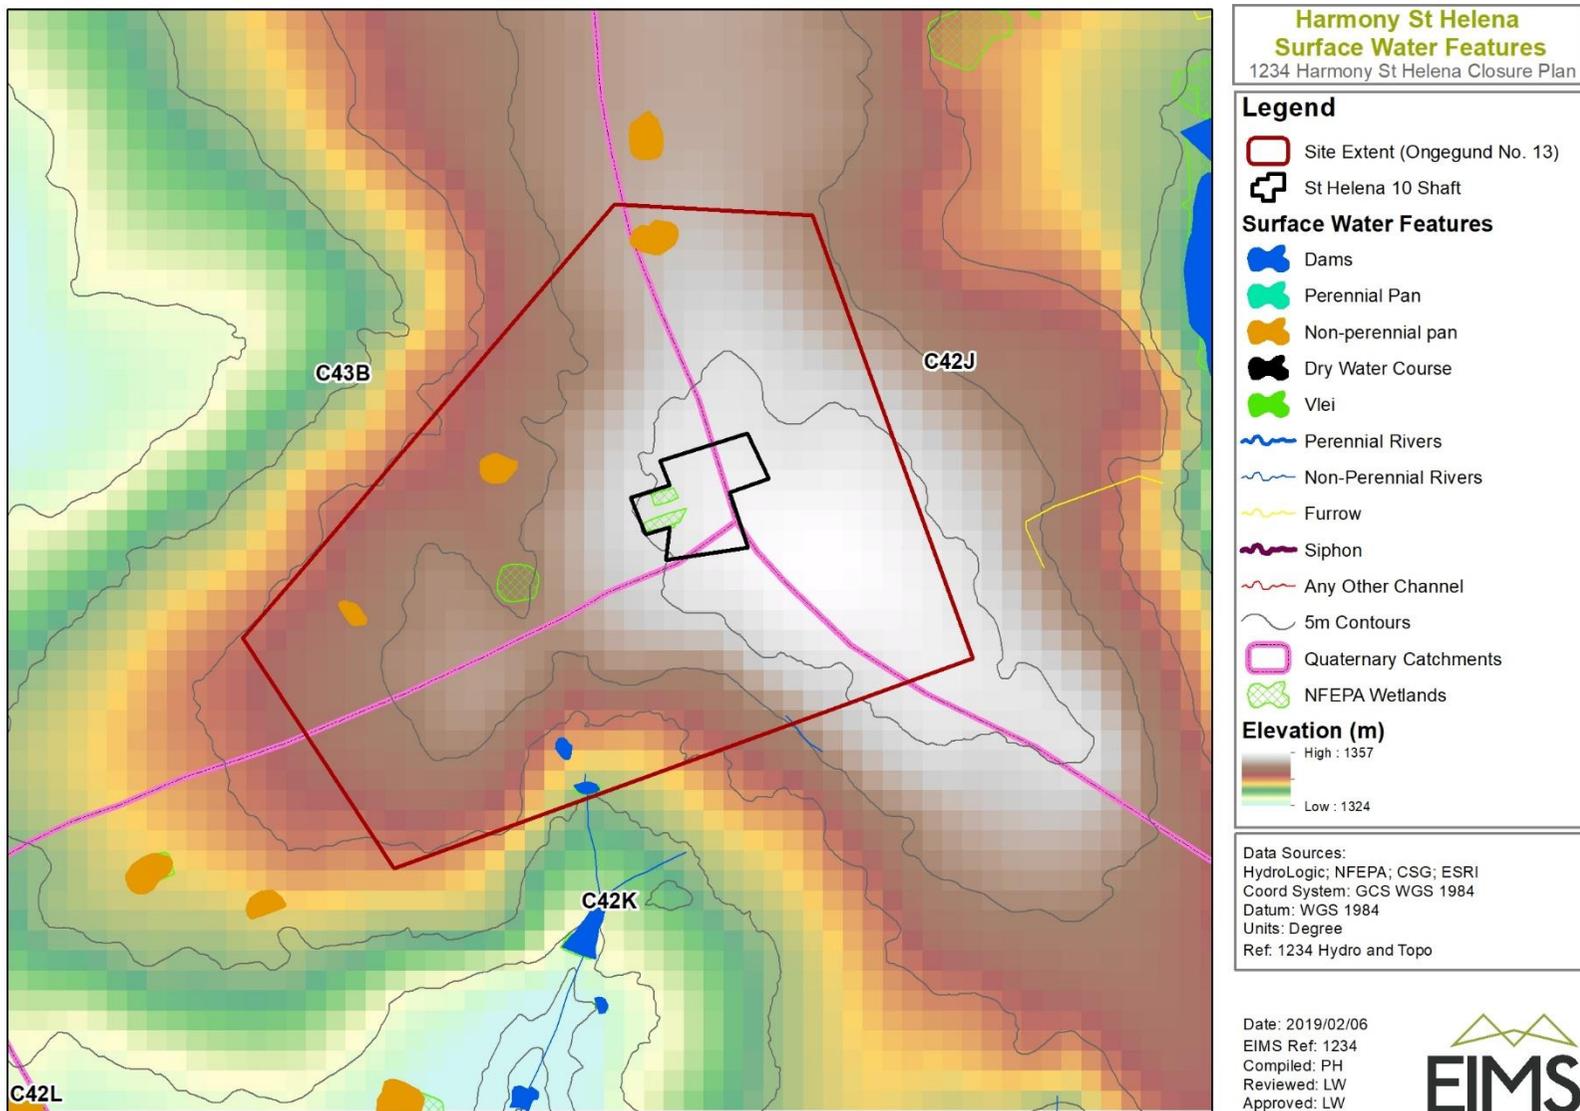
Figure 4: Hydrology and topography of site

When considering the site (i.e. the area of works) two open reservoirs are noted according to the 1:50,000 topographical map data. The rehabilitation of the site has, however, removed the northern open reservoir and only the southern open reservoir remains as a self-managed system. The location of this reservoir is indicated in the surface water assessment. The National Freshwater Ecosystems Priority Areas (NFEPA, 2011) dataset for South Africa indicates that a wetland is located to the west of the site, outside of the mining right area.

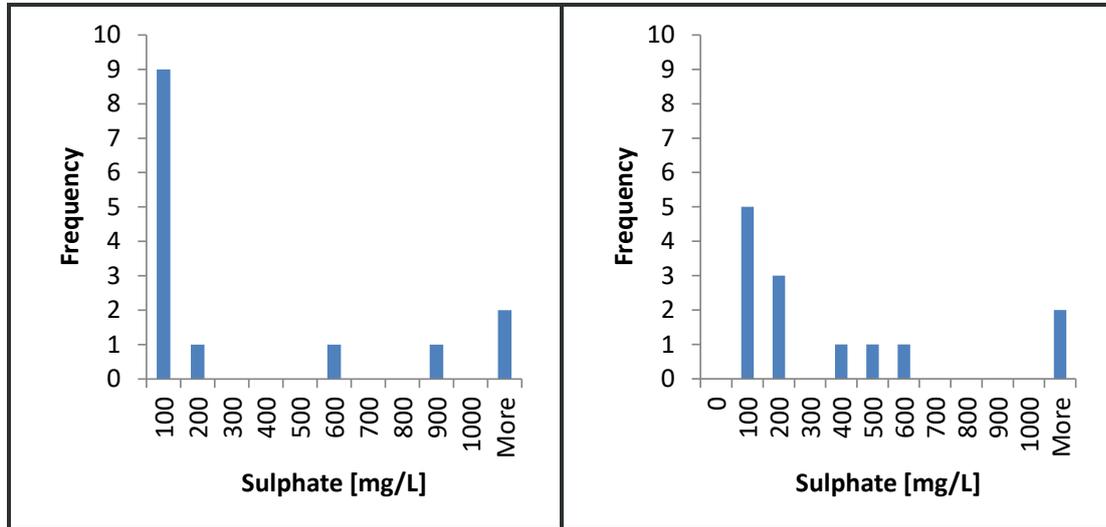
Harmony has run a groundwater quality monitoring programme in the Welkom area for many years. Limited water quality data (pH, Cl, and SO₄) is available for five boreholes to the north of the 10 Shaft assessment area and six borehole to the west of the assessment area (Figure 6). There is some variance in the data. However, pH is generally between 7 and 8, while sulphate is generally less than 200 mg/L (Figure 5). There appear to be no trends in the Cl data.

Figure 5: Histograms of SO₄ (sulphate) concentrations in Harmony monitoring boreholes west of (left) and north of (right) the 10 Shaft assessment area.

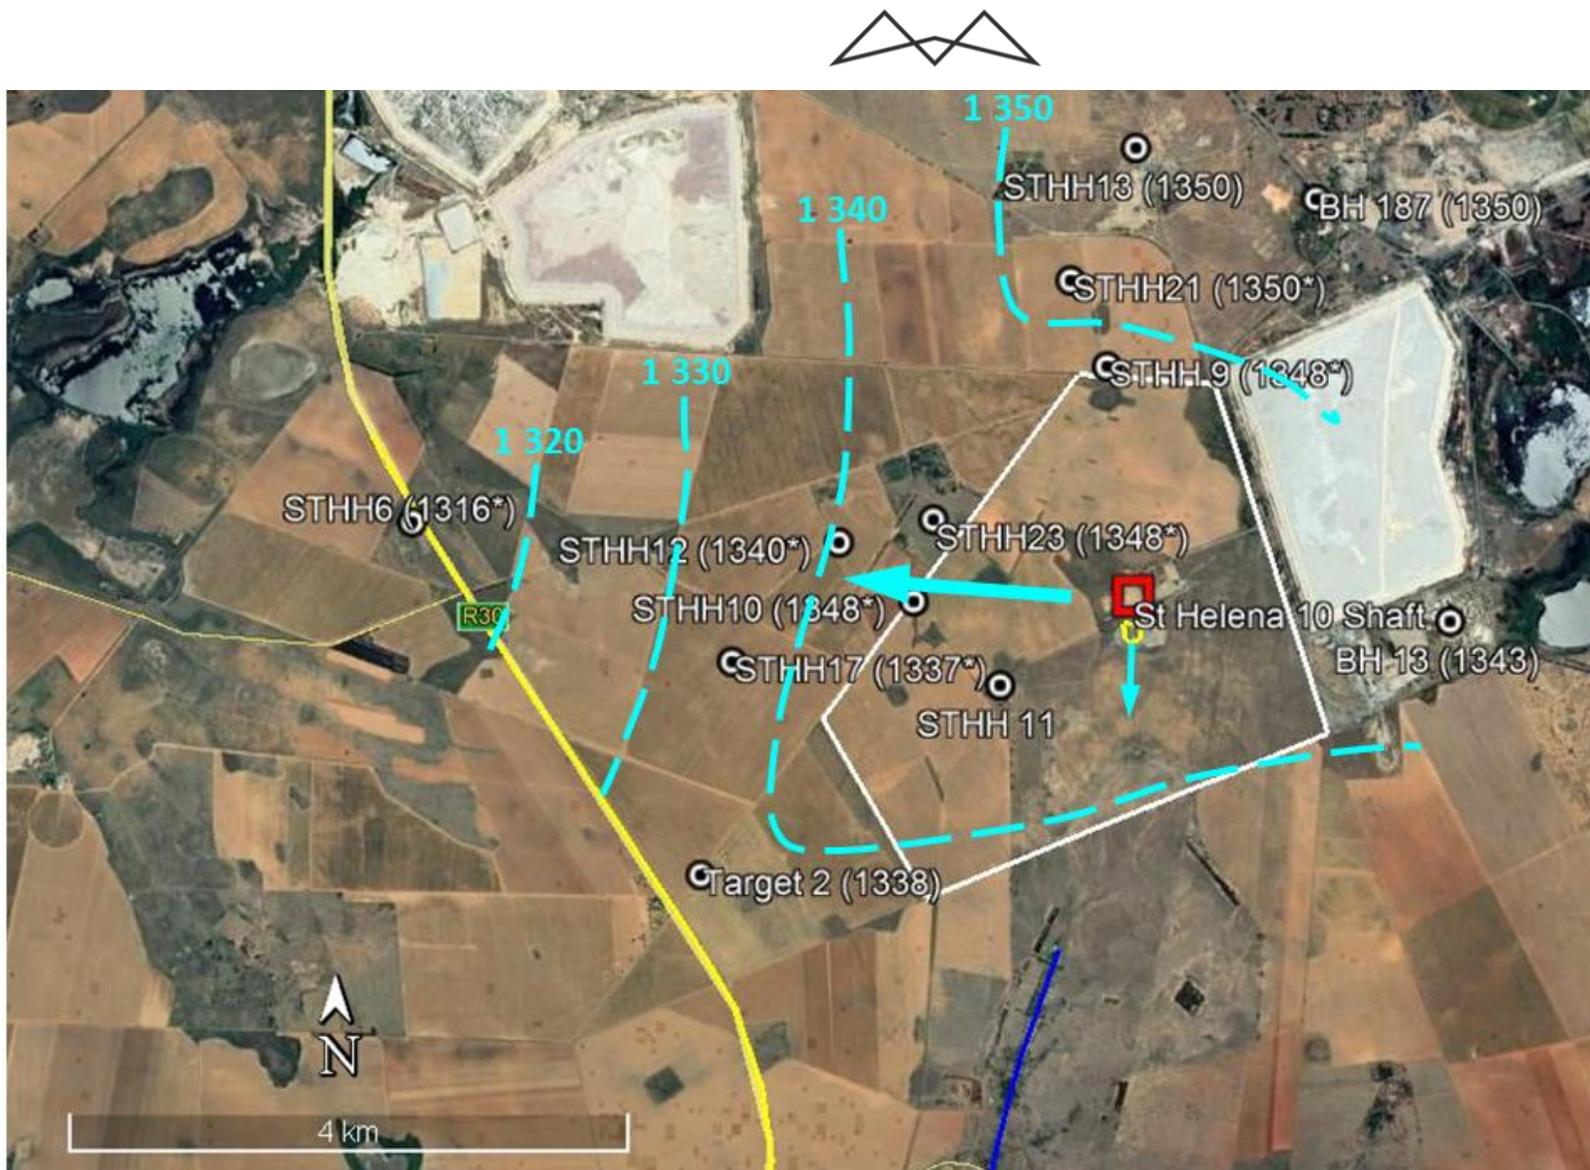
Figure 6 shows the distribution of measurements and inferred contours of groundwater elevations around the assessment area. No levels were obtained within the assessment area itself. Figure 6 also indicates the dominant groundwater flow direction is approximately west-northwest with a possible minor flow component to the south. The directions are consistent with the topography, although the inferred hydraulic gradients are generally flatter than the topographic gradients.

Figure 6: Inferred groundwater elevations at the St Helena 10 Shaft assessment area (turquoise arrows show inferred groundwater flow direction).
