**Integrated Wetland, Aquatic and  
Rehabilitation Assessment for the  
proposed Expansion of the Mooiplaats  
Colliery Underground Mining  
Operation**

**Ermelo, Mpumalanga, South Africa**

June 2019

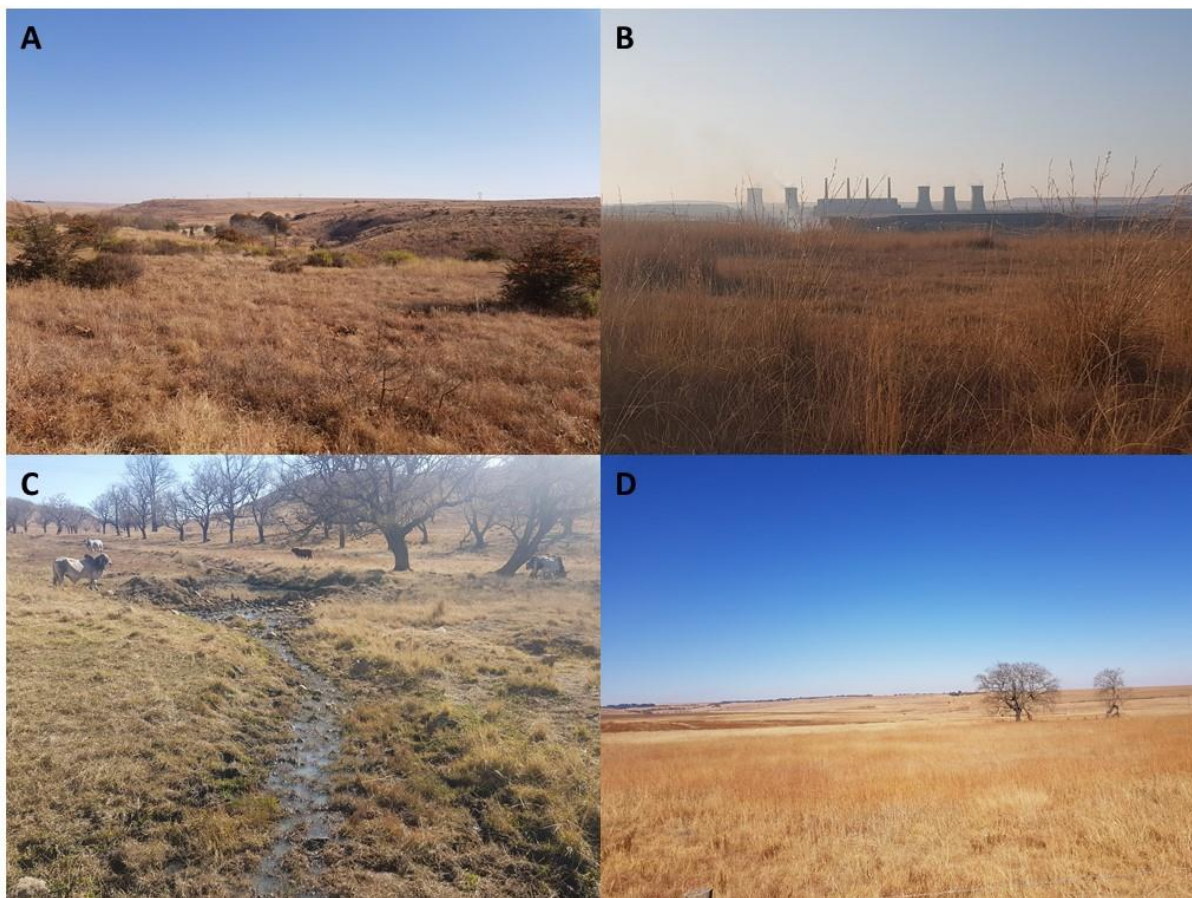
*Figure 3: Dominant land uses within the project area; A) largely natural areas, B) mines and power stations, C) livestock farming, D) past (fallow lands) and current crop agriculture*

The prevailing land uses within the project area centre on commercial crop cultivation, livestock grazing (predominantly cattle) and game farming. The majority of the landscape is in a natural state and is relatively devoid of alien and invasive species. Other land uses within the project area includes agricultural properties and cultivated fields; various secondary farm roads and minor tar roads; power lines – especially Eskom powerlines transecting multiple farm portions; telephone lines; and agricultural homesteads. Figure 3 provides examples of the dominant land uses.

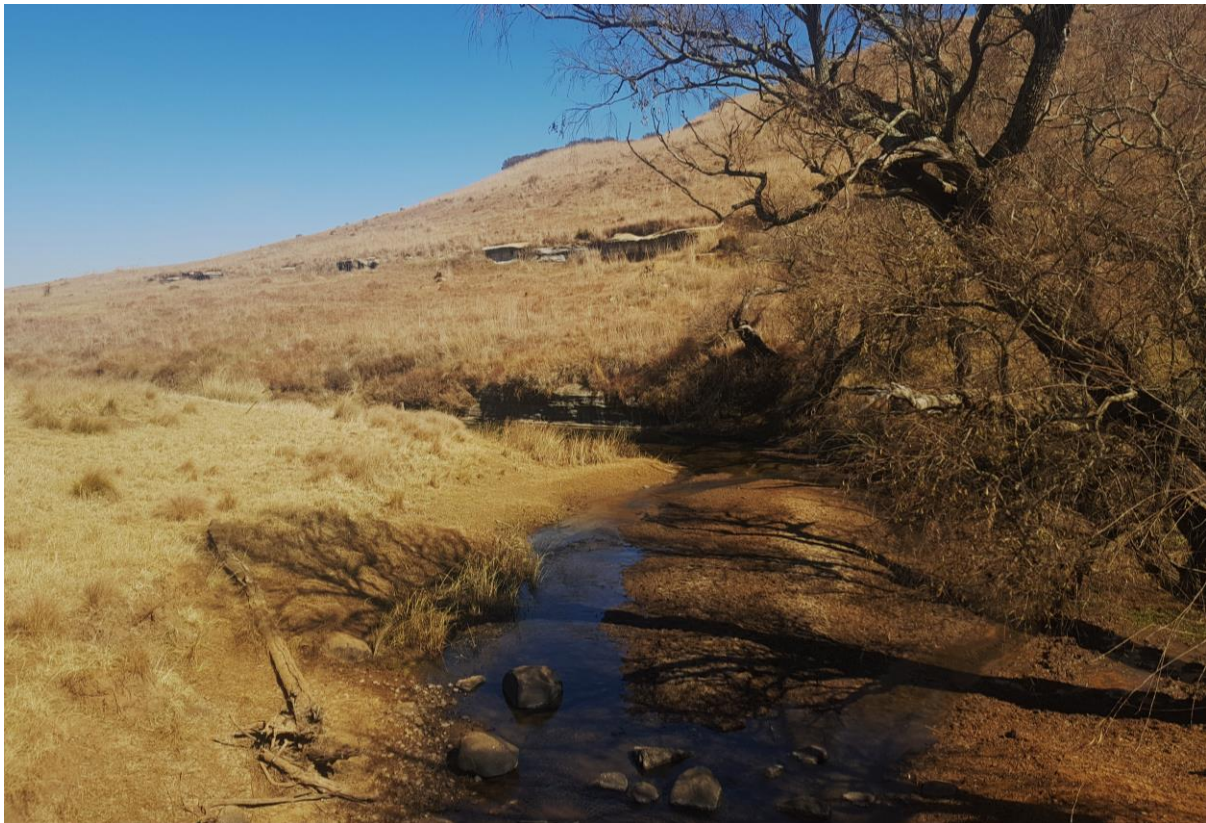
Figure 10: Reach of the Vaal River Floodplain (crossing along main access route)

The project area and associated wetlands are situated in the upper reaches of the Vaal River catchment. These systems form part of the Upper Vaal Water Management Area and are zoned under Quaternary catchment C11B. In the north (existing mining area) water drains in a north-easterly direction towards the Witpuntspruit. This river runs to the north of the project area before merging with the Vaal while in the south, a network of seeps and valley-bottom wetlands direct water towards the Vaal River Floodplain. This large, well developed floodplain flows in a south-westerly direction, effectively bisecting the expansion area. A further 6.5 km downstream it is joined by the Klein Vaal. The deeply incised topography of the expansion area has likely aided in the protection of its wetland systems which remain, for the most part, in a relatively intact state. Studies by Gradient Consulting, (2019) suggest that the overall ground and surface water quality is good with most analysed parameters falling below the SANS 241:2015 limits with exception of a few locations where fluoride, nitrate as well as heavy metals i.e. manganese and iron are elevated.

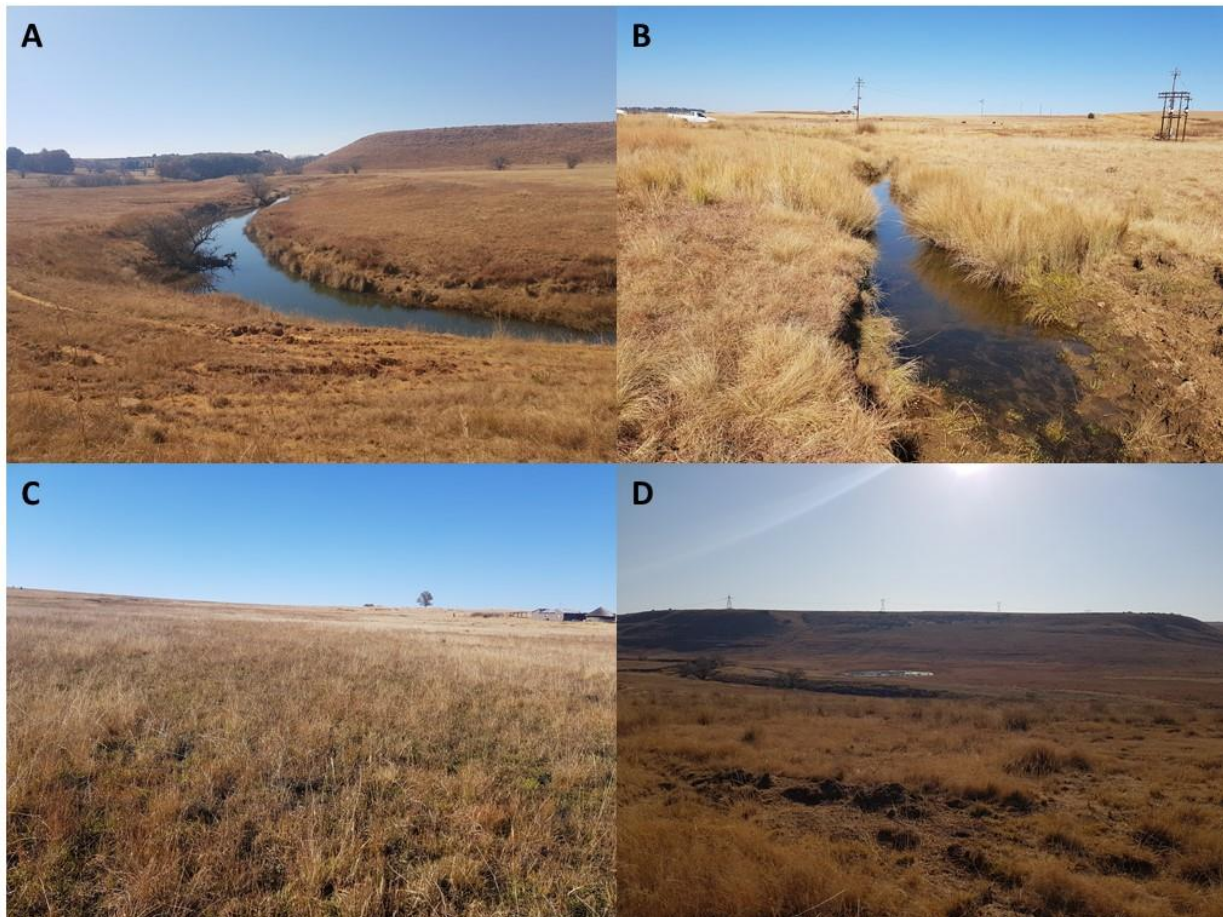
Figure 14: Examples of the main wetland HGM types identified within the project are; A) floodplain (Vaal), B) channelled valley-bottom, C) seep, D) toe of unchanneled valley-bottom with floodplain depression in the background

For the purposes of this assessment, the delineated and assessed wetland HGM units have been grouped per drainage areas or watersheds. This has allowed for the grouping of similar HGM units into three (3) separate groups. This grouping of HGM units is supported by the topography of the area, but also the similar land uses and project area characteristics across the larger project area. The three groups are associated with the main watercourses into which they drain, namely the Vaal (located centrally), Witpuntspruit (situated in the north) and Vaal Southern Tributary (located in the south-west). The largest grouping of HGM units is associated with the Vaal River Floodplain which effectively bisects the expansion area. Figure 11 presents a digital elevation model and the associated stream orders identified for the area, depicting the three key drainage areas. Figure 12 presents the spatial extent of the delineated wetland areas (or groups) delineated for this project. In total over 68 discrete wetland areas were delineated during the survey within the project area and surrounding 500 m regulated area. Results of the level 1-4 wetland classification for the wetland systems within the project area are presented in (Figure 13). Photographs of some of the soil forms and vegetation identified for the project are presented in Figure 14.

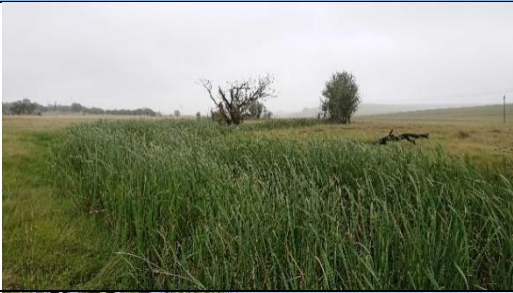
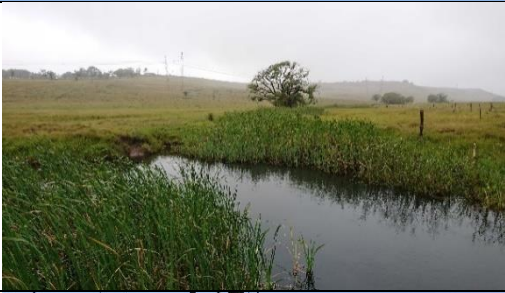
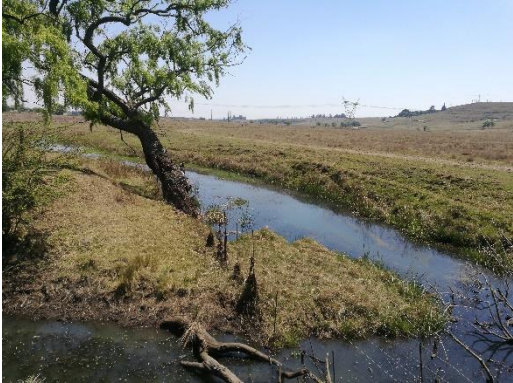
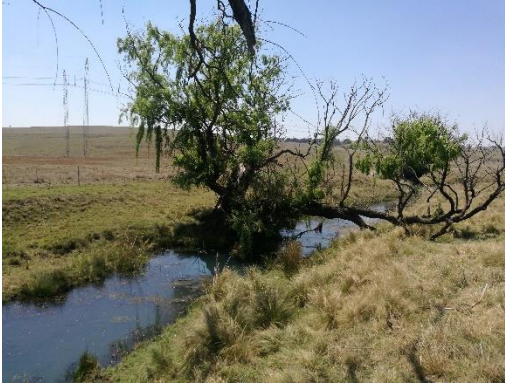
MPU	Upstream	Downstream
High flow

GPS	26°37'22.41"S 30° 6'51.69"E	
Site	Site MPU was located upstream of the Mooiplaats Colliery on the Witpuntspruit. The site is further located approximately 1 km downstream of Camden Power Station. The site was characterized by slow flowing waters over sand, mud and stone. Marginal vegetation was abundant in the form of reeds, with moderate amounts of aquatic vegetation present.	
Onsite impacts	A clearing in the channel presumably for vehicle navigation trough the stream was present. Erosion of the riparian and marginal zone by livestock trampling has caused extensive siltation of the system. Black residue was present in the sediment.	
MPD	Upstream	Downstream
High flow

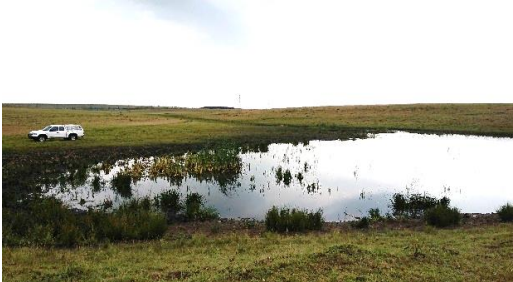
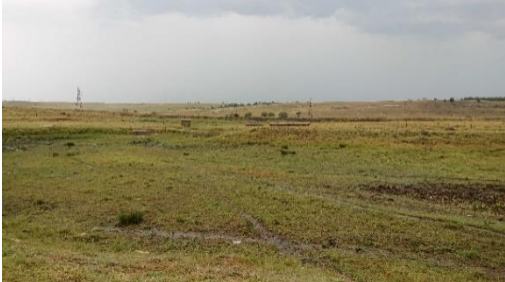
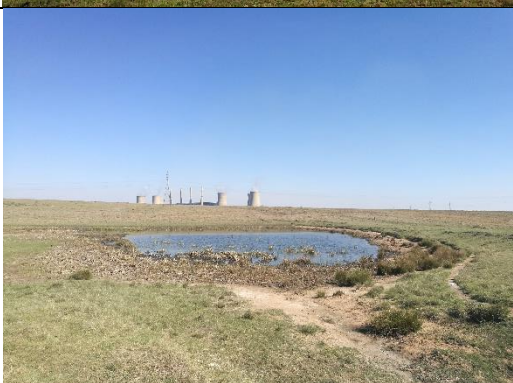
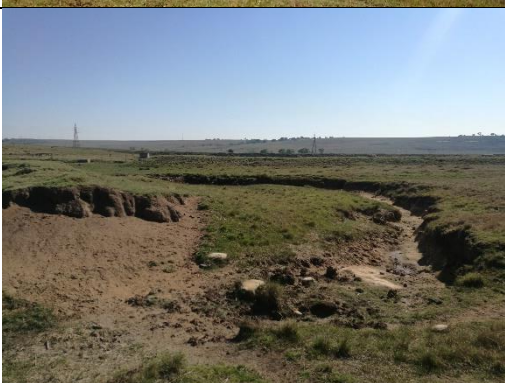
30° 6'41.62"E	
<b>Site</b>	Site MPD was situated in a dam, approximately 1.4 km downstream of the Mooiplaats Colliery on a tributary of the Witpuntspruit. The site was characterised by standing water.	
<b>Onsite impacts</b>	The dam was subject to trampling by livestock	
<b>MP2</b>	<b>Upstream</b>	<b>Downstream</b>
<b>High flow</b>

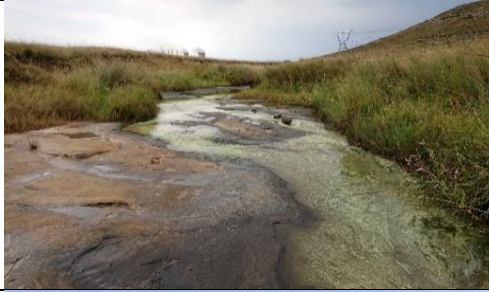
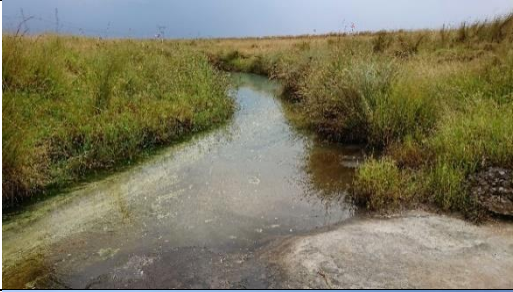
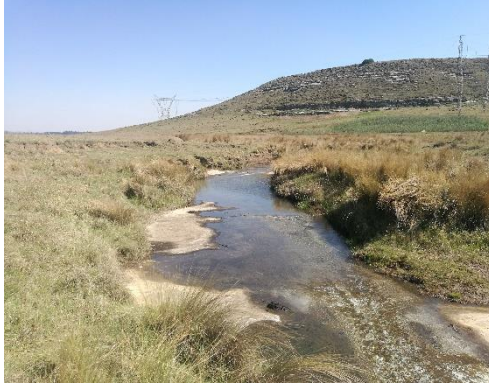
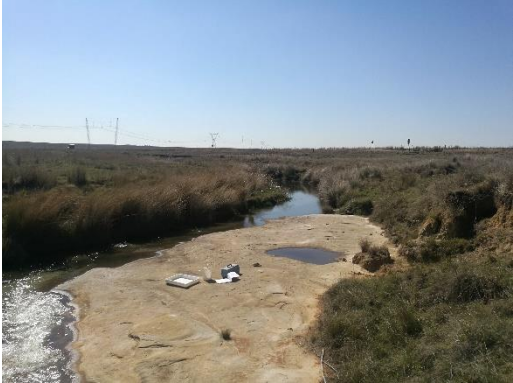
<b>GPS</b>	26°38'7.53"S 30° 7'46.81"E	
<b>Site</b>	Site MP2 was located on the Witpuntspruit downstream of the Mooiplaats Colliery and sites MPU and MPD. The site is further located approximately 1 km downstream of Camden Power Station. The site was characterised by slow flowing water over bedrock and sand. Marginal vegetation was abundant.	
<b>Onsite impacts</b>	Instream areas were heavily contaminated from an unknown source, resulting in excessive algae growth smothering all habitat. The water had a blue appearance stemming from the contamination.

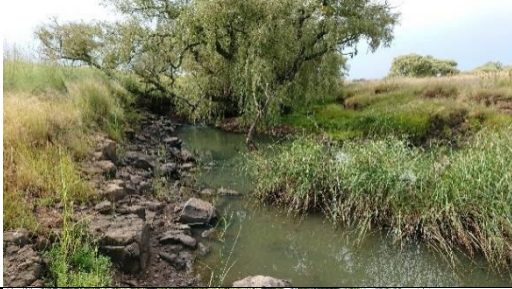
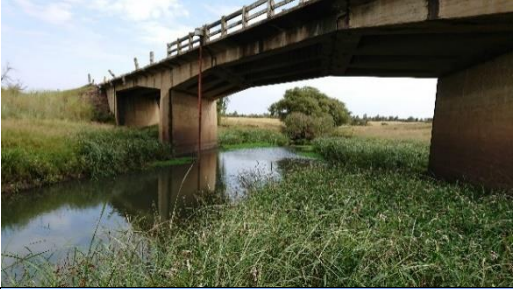
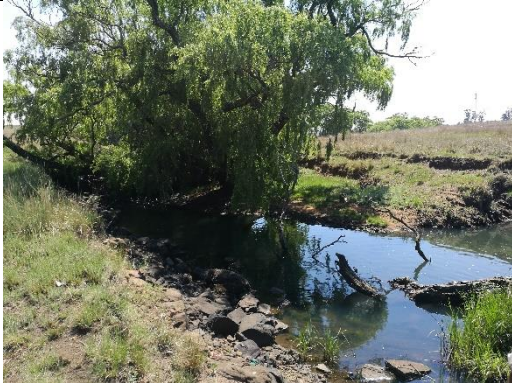
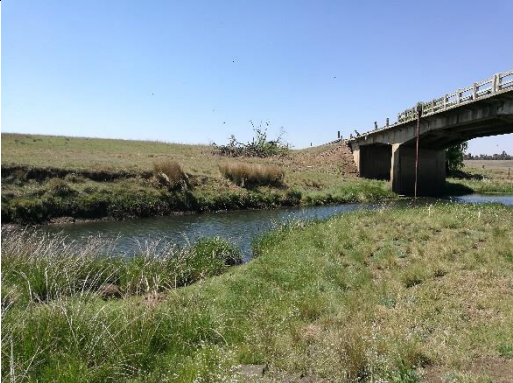
MV1	Upstream	Downstream
High flow

GPS	26°38'54.09"S 30° 9'4.09"E	
Site	Site MV1 was located on the Vaal River upstream of the Witpuntspruit and Mooiplaats Colliery. The site was characterised by slow to fast flowing water over stones, gravel, sand and mud substrate. Marginal and aquatic vegetation were abundant.	
Onsite impacts	Erosion of the riparian area, solid waste disposal, runoff from N2 road bridge, and sedimentation of instream areas.	
MPW	Upstream	Downstream
High flow

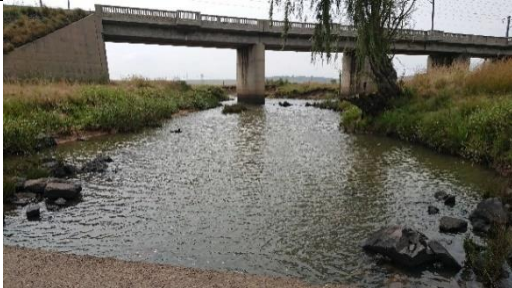
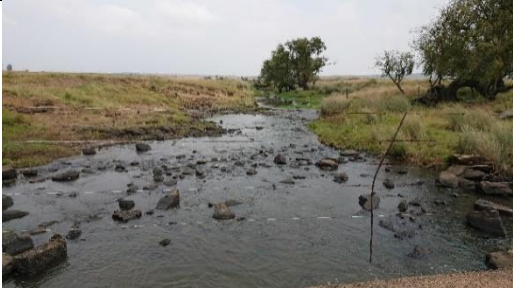
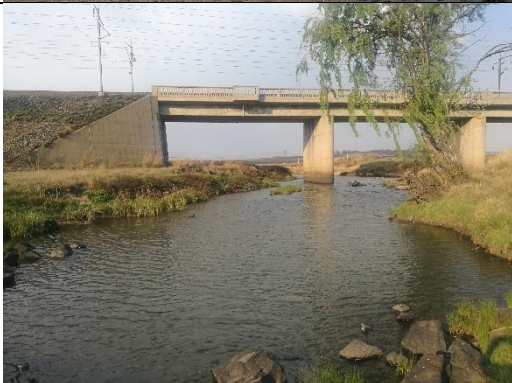
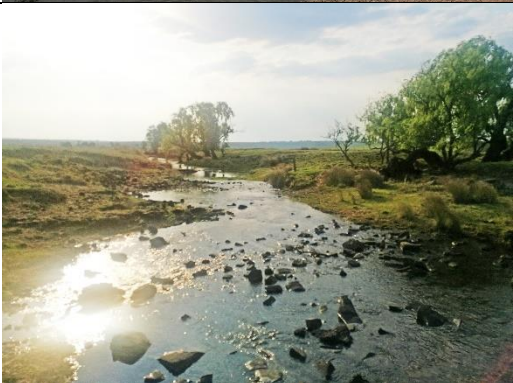
GPS	26°40'44.67"S 30° 7'25.61"E	
Site	Site MPW was located on the Vaal River downstream of the Witpuntspruit, site MV1 and Mooiplaats Colliery. The site was characterised by slow to fast flowing water over stones bedrock, gravel, sand and mud substrate. Marginal and aquatic vegetation were abundant.	
Onsite impacts	Small areas of erosion and bank incision. Livestock trampling of riparian areas

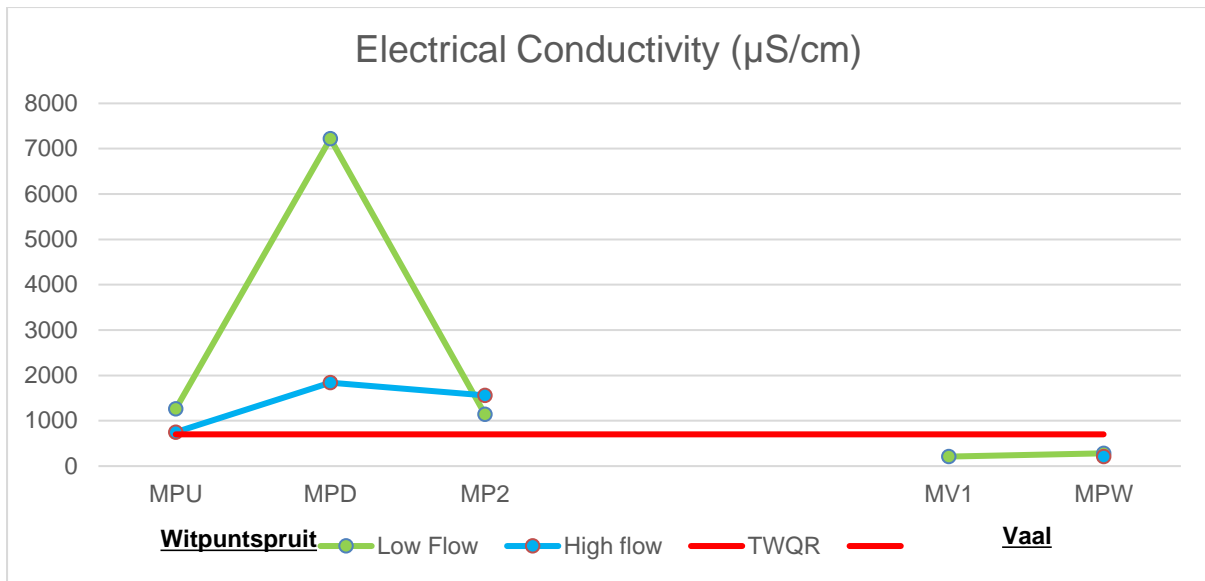
Electrical Conductivity (EC) levels ranged from 749  $\mu\text{S}/\text{cm}$  to 1840  $\mu\text{S}/\text{cm}$  on the Witpuntspruit at sites MPU and MPD respectively during the high flow survey. An increase in dissolved solids was observed during the low flow survey, with dissolved solids ranging from 1144  $\mu\text{S}/\text{cm}$  at site MP2 and 7220  $\mu\text{S}/\text{cm}$  at site MPD. The lack of connectivity between MPD and the Witpuntspruit reduced the influx of dissolved solids stemming from the Mooiplaats tributary. All sites on the Witpuntspruit during both high and low flow surveys exceeded TWQRs for the system. As illustrated by Figure 22, spatial trends of the Witpuntspruit indicate the Mooiplaats Colliery is contributing to increased EC levels of the Witpuntspruit. The dissolved solid levels within the Vaal River remained within TWQR during both surveys, however, the Witpuntspruit is contributing an increase of 25% as illustrated by Figure 23. The elevated EC levels within the Witpuntspruit would present adverse conditions to local aquatic biota, and limit diversity and abundances.

Figure 22: Spatial and temporal trends for Conductivity levels in the tributary (TWQR- Target Water Quality Range, WUL- Water Use License)

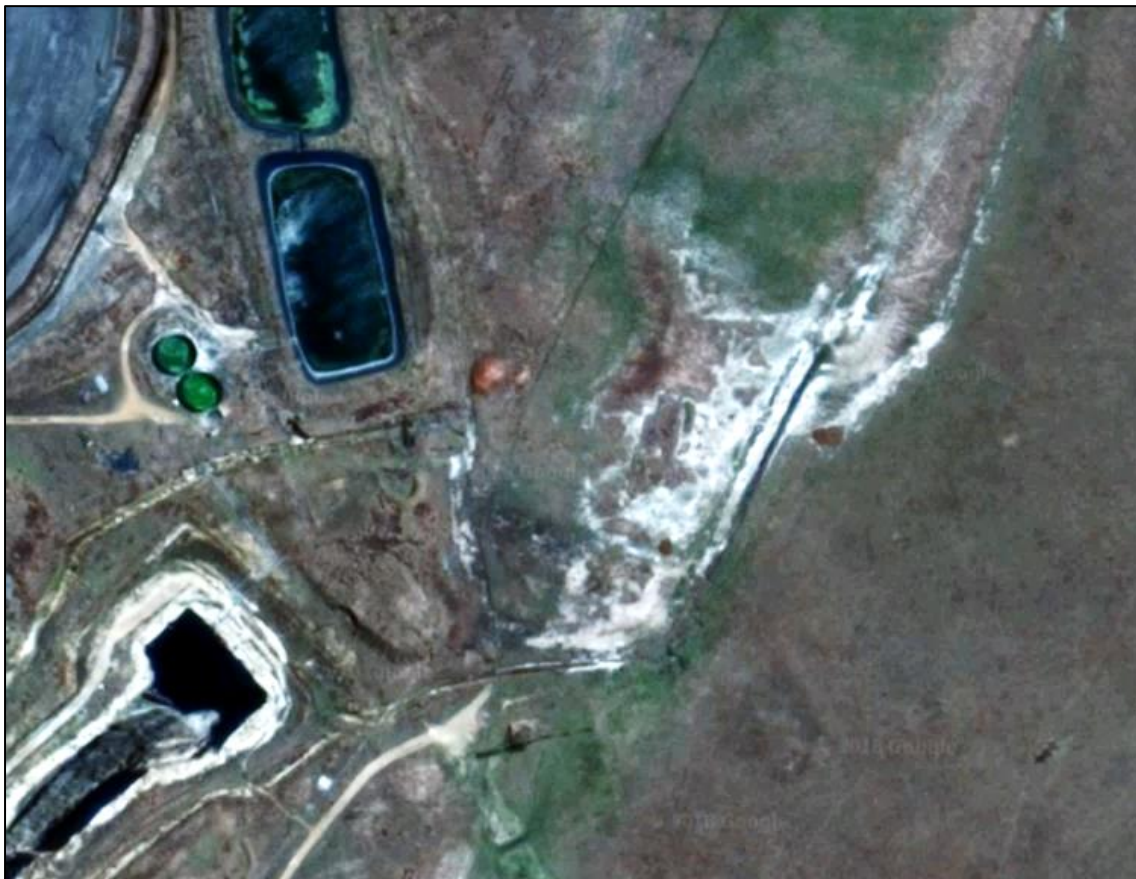
Figure 23: Illustration of likely salts below the Mooiplaats operation, upstream of site MPD (Google Earth Imagery, 2017; 26° 38.566'S 30° 6.115'E)

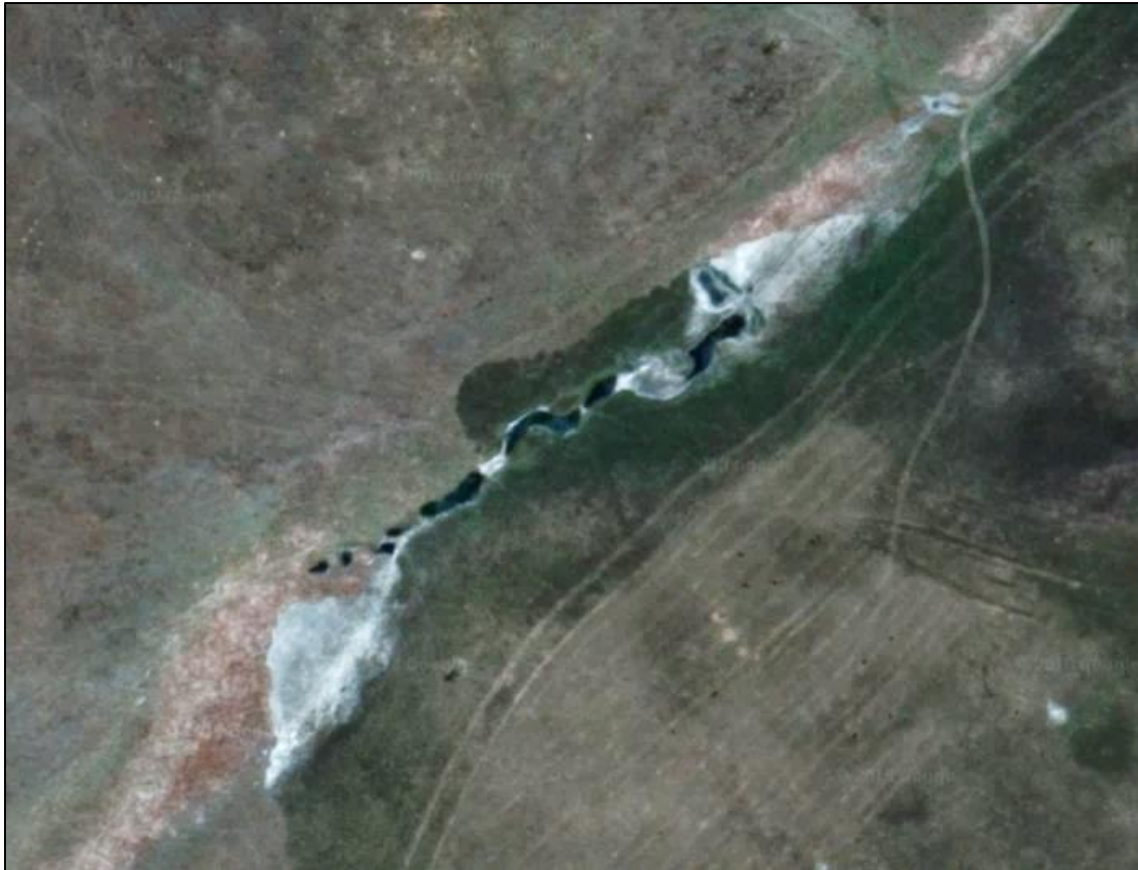
Figure 24: Illustration of salts below the Mooiplaats operation, upstream of site MPD (Google Earth Imagery, 2017; 26° 38.192'S 30° 6.419'E)

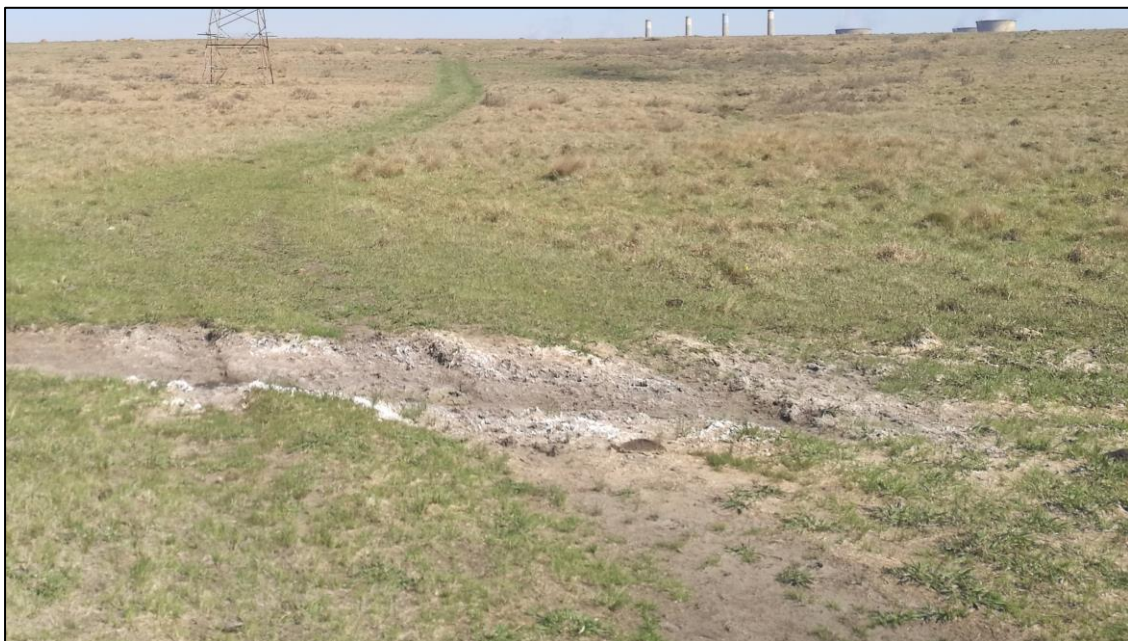
Figure 25: Illustration of salts below the Mooiplaats operation, upstream of site MPD (Photo taken, October 2018; 26° 38.192'S 30° 6.419'E)

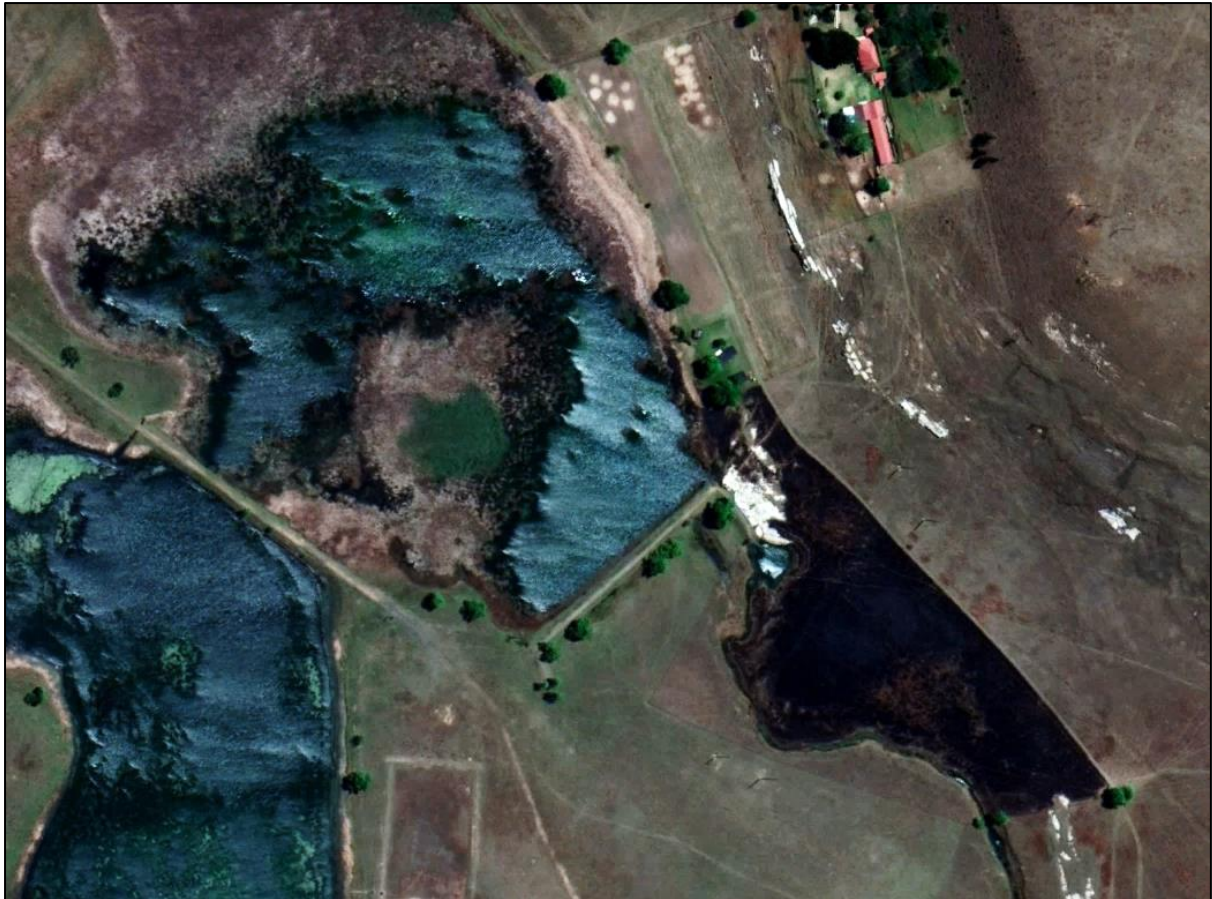
Figure 26: Aerial imagery illustrating impacts within the reach; artificial wetland upstream of site MPU (Google Earth 2018)

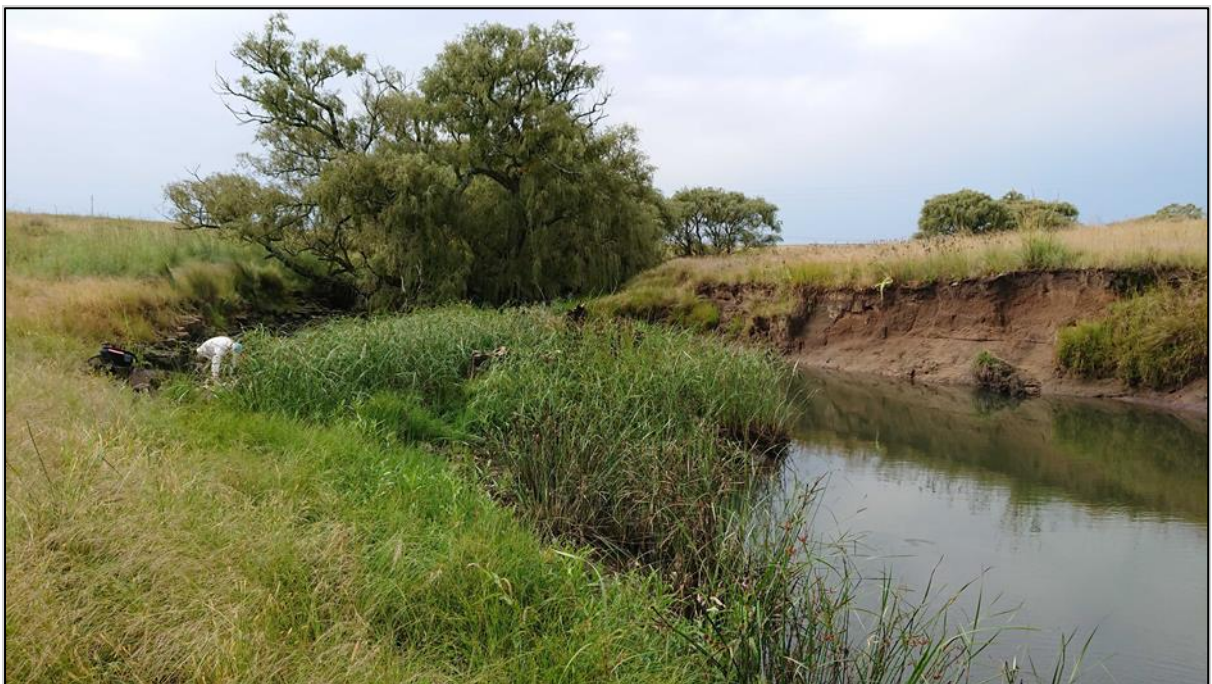
Figure 27: Illustration of bank erosion at site MV1 (Taken: March 2018)

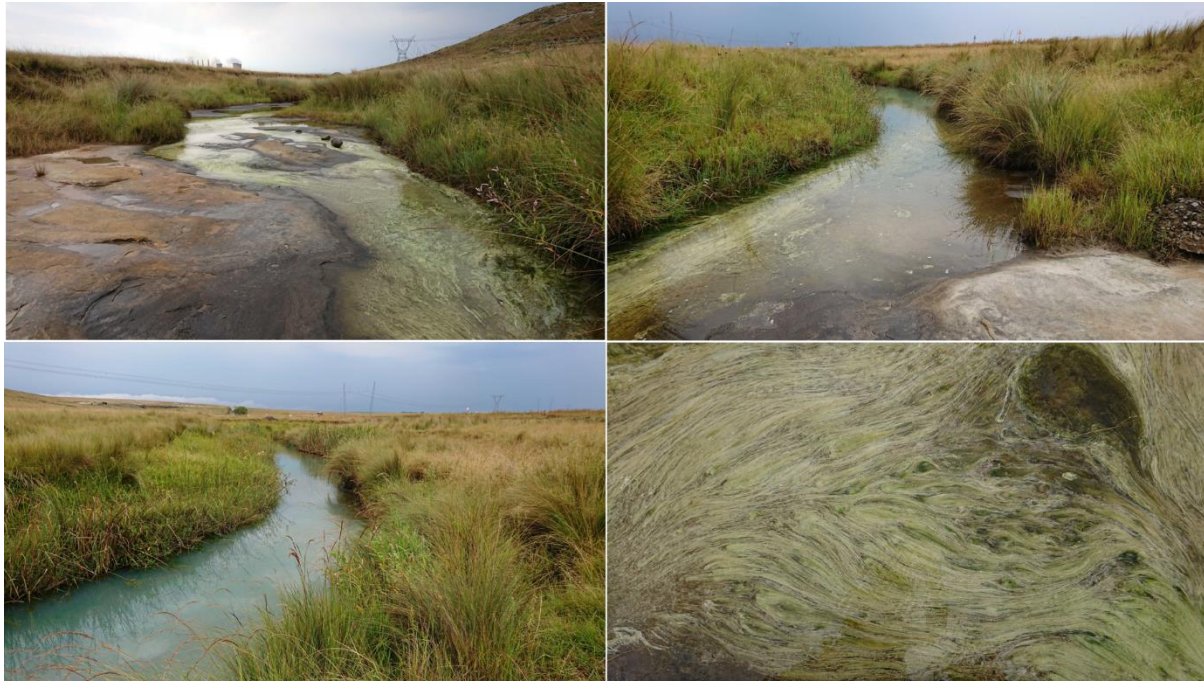
It was noted in the field that MP2 was particularly modified with extensive algal growth, limiting habitat availability (Figure 28). The site had a strong sulphur odour.

Figure 28: Excessive algal growth at site MP2. Photographed 16 March 2018

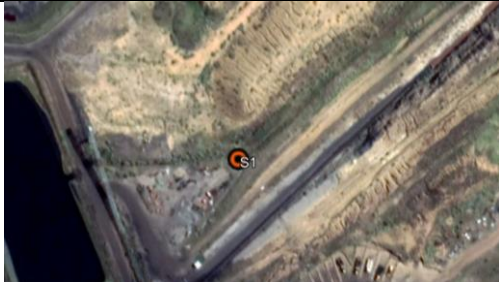
Point	Notes	GPS coordinates
S1	<p><b>Description:</b> Runoff from the current above ground mining operations that is channelled into a 520 m long trench that runs from the PCD nearest the mine buildings to a discharge point into the eastern valley bottom near the three north-eastern PCDS.</p> <p><b>Proposed action:</b> Requires engineered, hard interventions. Flows in trench should be re-diverted into dirty water stormwater system.</p>

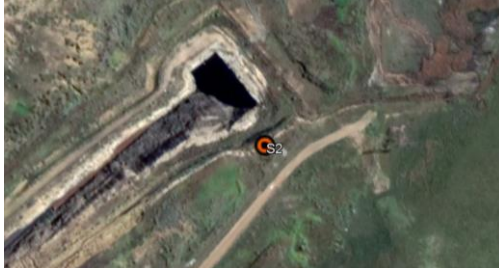
S2	<p><b>Description:</b> Trench that runs along the southern end of the boxcut. Runoff from cleared areas is channelled along this trench which discharges into the wetland.</p> <p><b>Proposed action:</b> Requires engineered, hard interventions. Flows in trench should be re-diverted into dirty water stormwater system.</p>

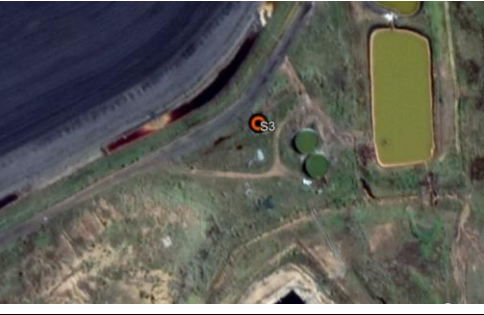
<p>S3</p>	<p><b>Description:</b> Subsurface seepage and periodic overland flows from the main coal stockpile. Overland flows during peak rainfall events have caused notable head cut erosion at the point where it merges with the S1 trench () on the south-western corner of the southern-most PCD.</p> <p><b>Proposed Action:</b> Check coal stockpile liner for leakage. Requires engineered, hard intervention. Trench around the coal stockpile needs to be deep enough to effectively intercept subsurface flows. Collected water needs to be pumped to PCDs to prevent overflows.</p>

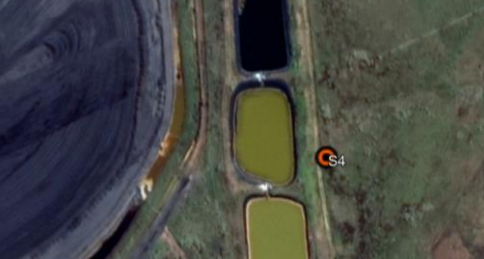
<p>S4</p>	<p><b>Description:</b> Subsurface seepage downstream of eastern-most PCDS.</p> <p><b>Proposed Action:</b> Check liners of PCDs and coal stockpile for leakage. Effectively trap contaminated water from these structures in appropriately engineered trench designed to return dirty water to PCDs.</p>

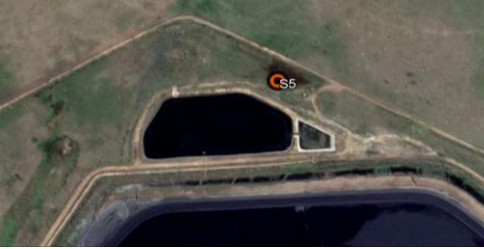
<p>S5</p>	<p><b>Description:</b> Subsurface seepage downstream of northern-most PCDS.</p> <p><b>Proposed Action:</b> Check liners of PCDs and coal stockpile for leakage. Effectively trap contaminated water from these structures in appropriately engineered trench designed to return dirty water to PCDs.</p>

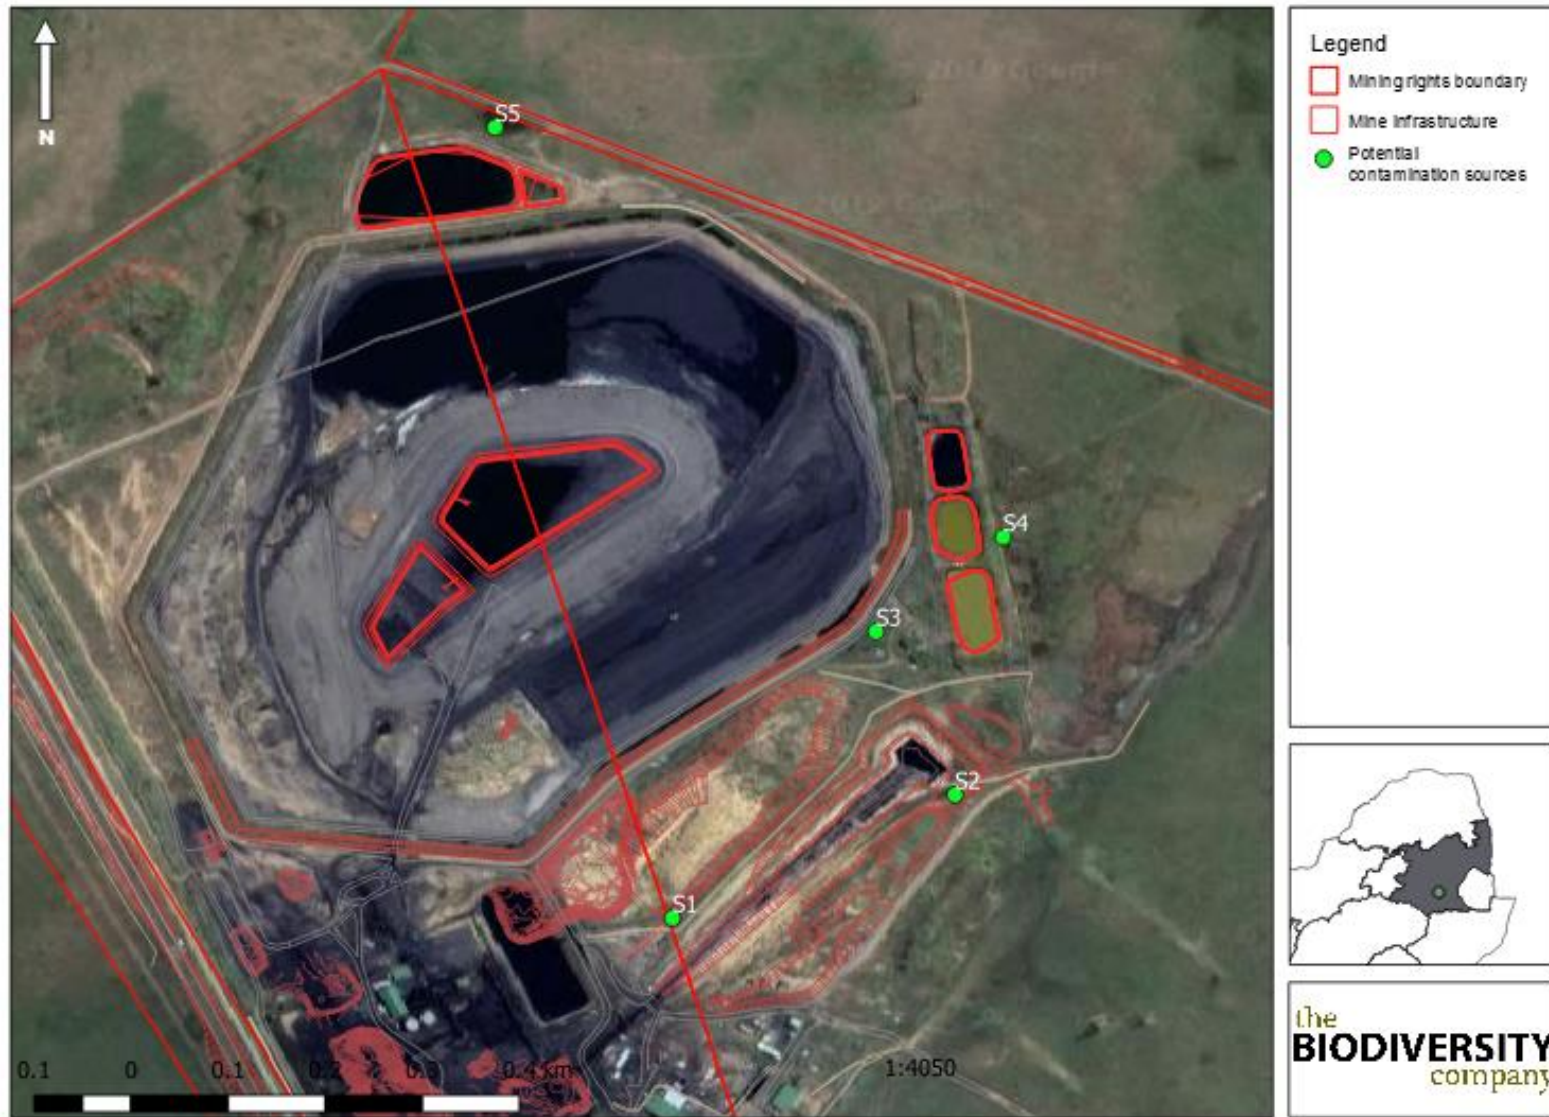
Figure 32: Locations of potential contamination sources

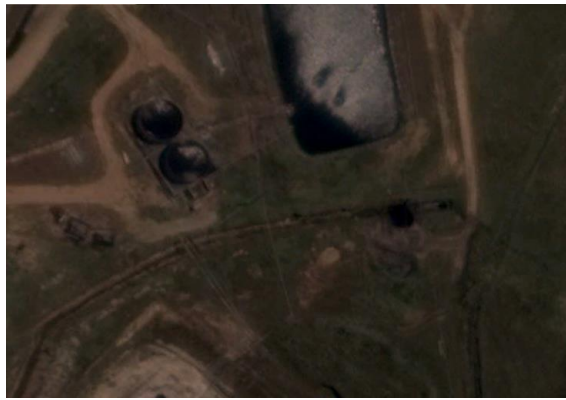
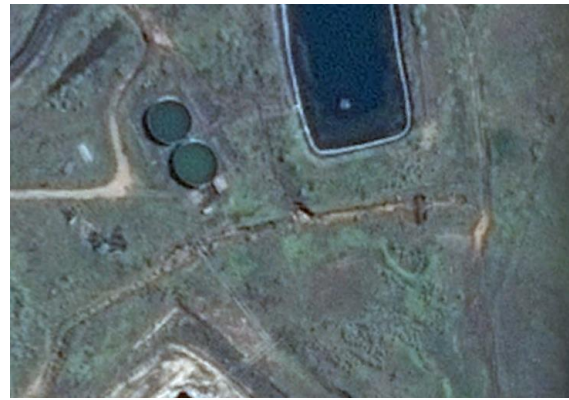
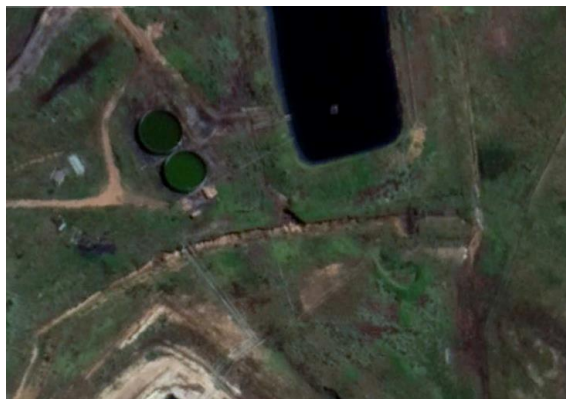
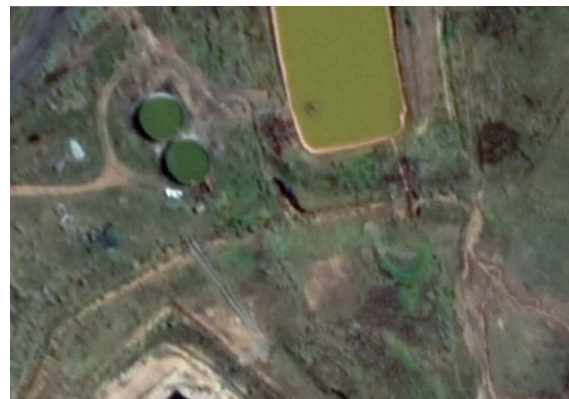
11 February 2013

19 May 2016

13 May 2017

04 June 2019

Figure 35: Progression of headcut erosion gully situated immediately south of the eastern PCDs ( $26^{\circ}38'32.59''S$ ;  $30^{\circ} 6'2.22''E$ )

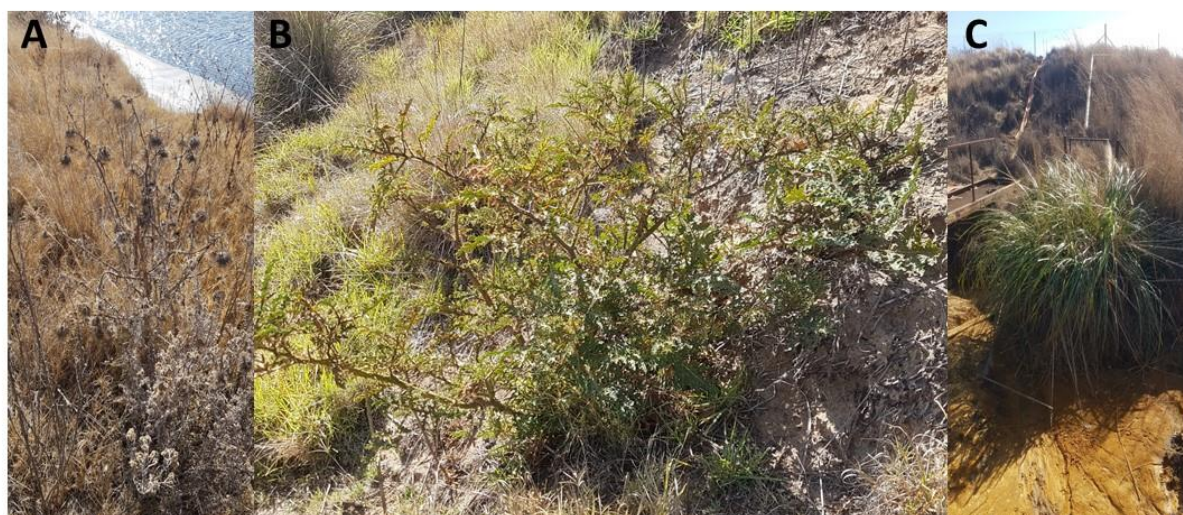
Figure 36: Category 1b listed alien and invasive species on site A) *Cirsium vulgare*, B) *Solanum sisymbriifolium* and C) *Cortaderia selloana*

**It is very important to note that no chemical or hormonal control of AIS must be employed within any wetland area or their associated buffers.** Although Table 45 includes chemical and hormonal control options these are intended for terrestrial areas only. In the wetlands themselves only mechanical control (i.e. removal of whole plant by hand) should be permitted. Although listed as a Category 1 b species the lowest clearing priority should be afforded to *Tamarix ramosissima* due to its role in slope stabilisation and phytoremediation.
