<p>Project</p> <p>MOOIPLAATS COLLIERY</p>
	<p>Plan Description</p> <p>SITE LAYOUT (AS-BUILT)</p>

MP1401 – MOOIPLAATS COLLIERY

CONSTRUCTION COMPLETION REPORT

PROJECT NO: 140171

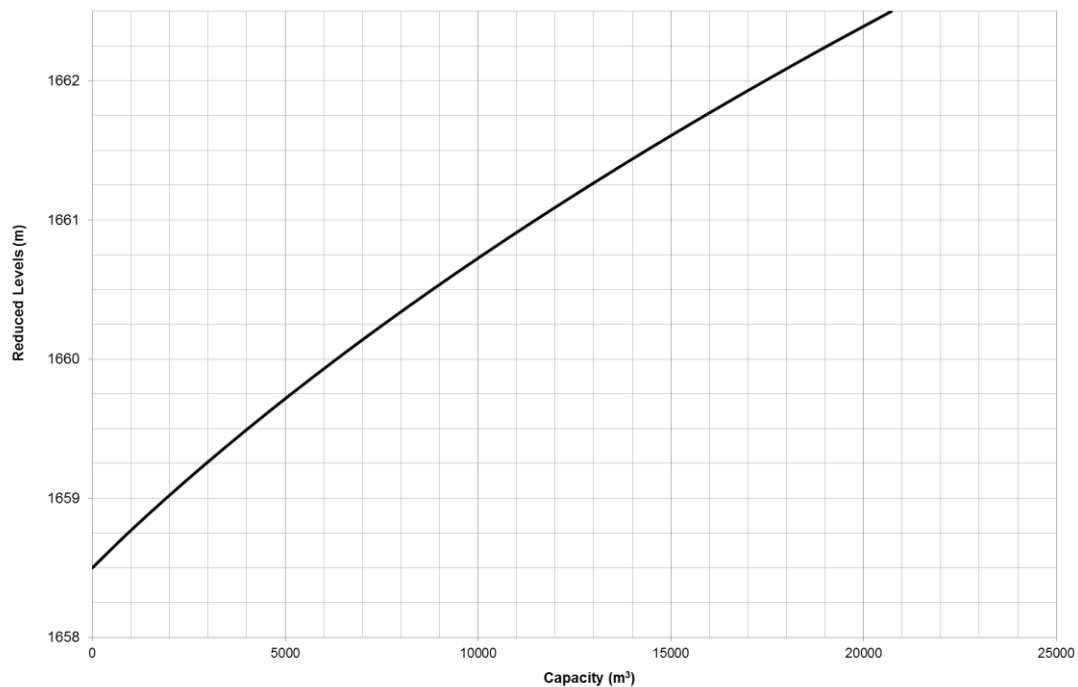
Figure 4.1: As-built stage/capacity curve of PCD

The existing excavation was re-sized such that the constructed, lined, PCD would have a capacity of approximately **22059 m³** at full supply level. The actual capacity at full supply level after construction was **20721m³** (see Figure 4.1).

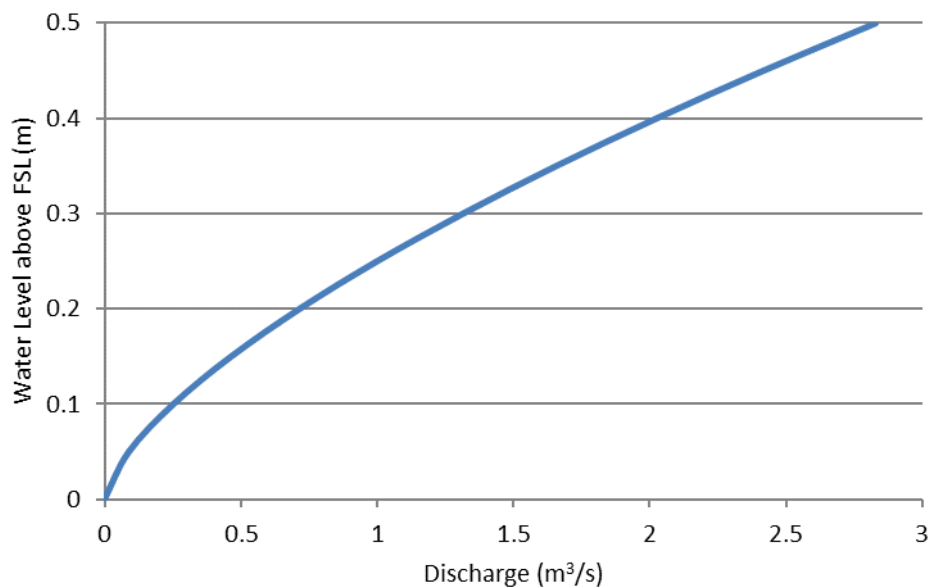
Figure 2: Spillway Discharge Curve

The spillway was constructed from grade 30/19 concrete. Only 500mm freeboard is required to pass the 1:100 year flood peak, although the available freeboard is higher as a result of raising the NOC levels for aesthetic reasons. The discharge capacity of the spillway was evaluated using the equation below:

$$Q = CLH^{3/2}$$

Using these values, the spillway discharge capacity is **2.83m³/s** which is greater than the 1 in 100-year flood peak. It should be noted that the discharge coefficient used is that of a broad-crested weir which was deemed to be a conservative estimate of the spillway capacity. **Figure 2** shows the relationship between discharge and water level above FSL for this spillway.
