City of Ekurhuleni Wetland and Watercourse Rehabilitation Planning within the Kaalspruit Catchment

Situation Assessment Report

Wetland Consulting Services (Pty.) Ltd. in association with GreenGab Consulting (Pty) Ltd.

May 2018

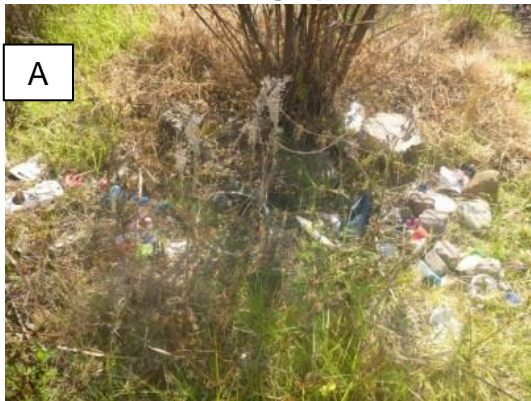
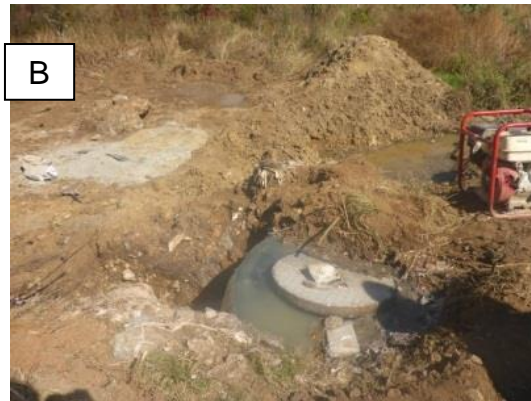
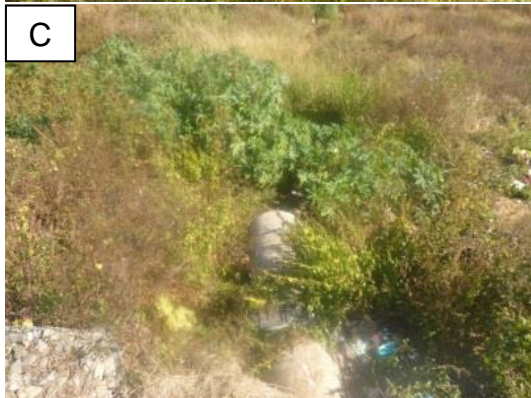
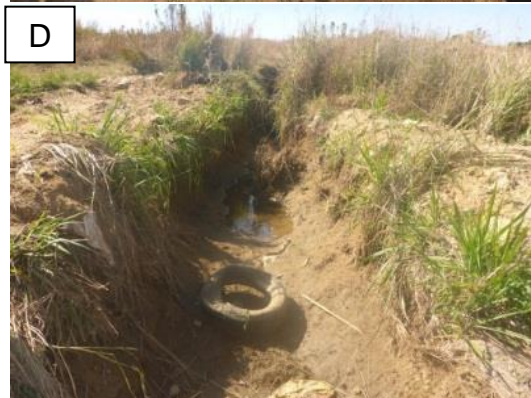
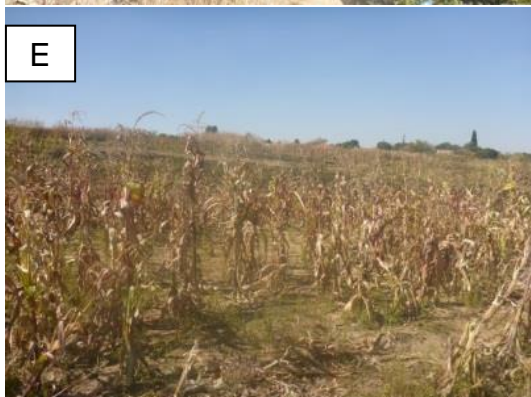
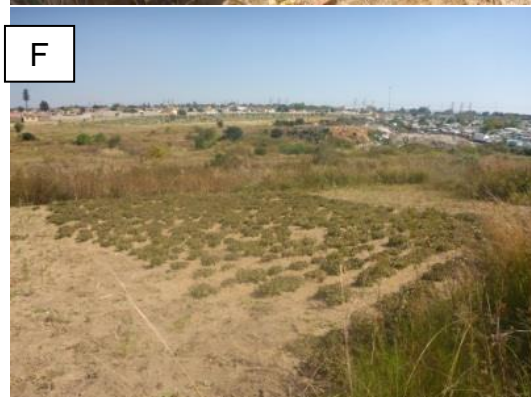
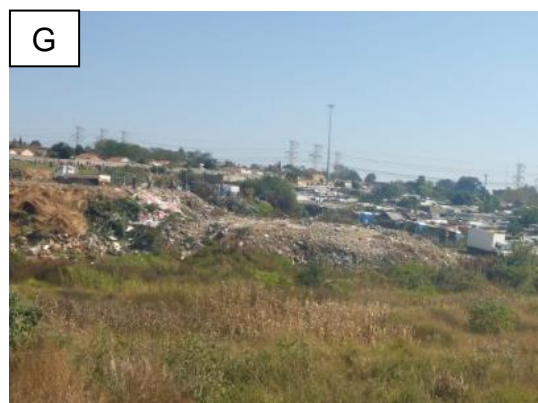
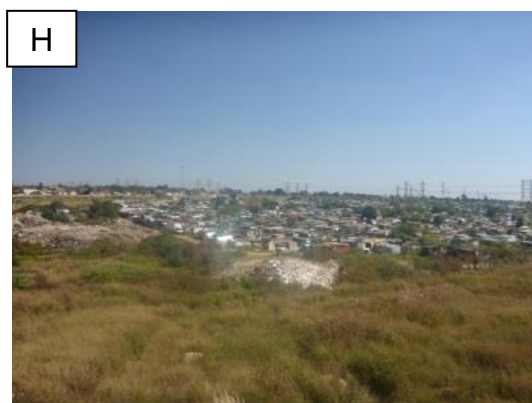
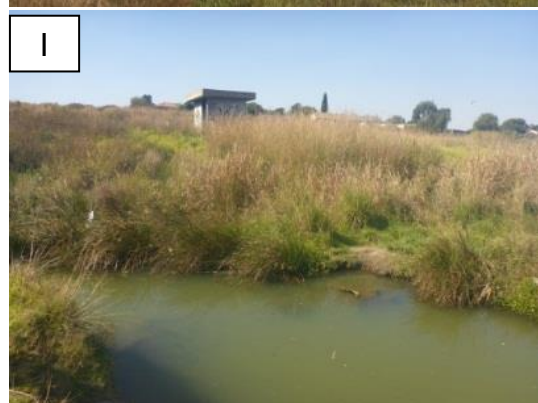
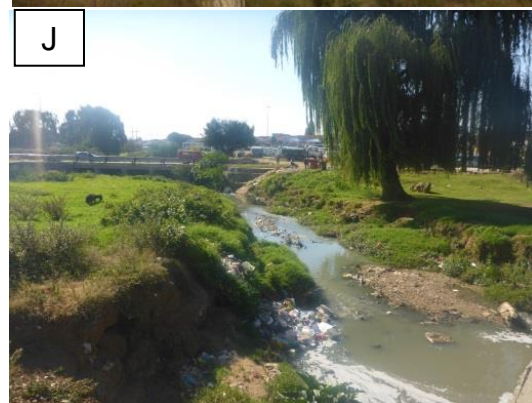
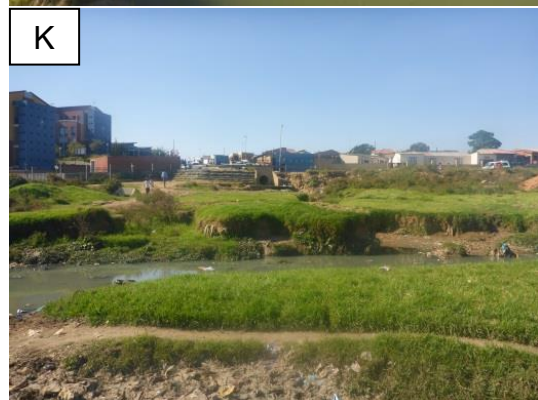
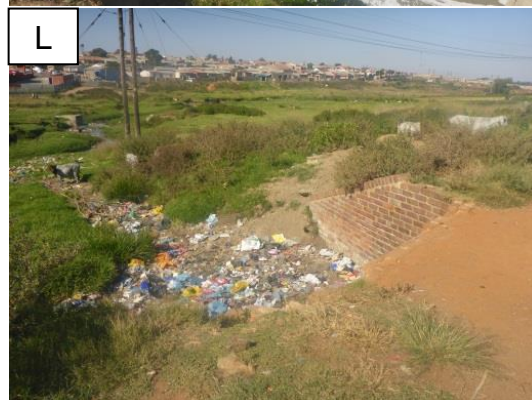
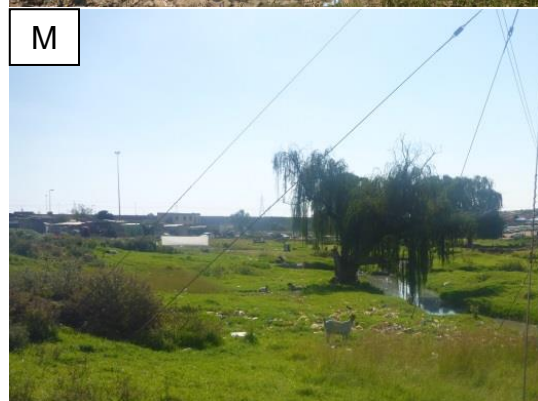
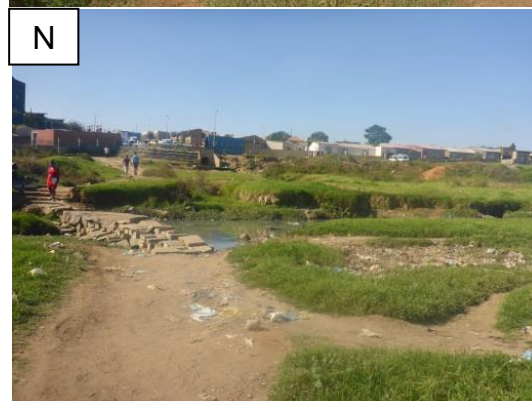
Figure 14: A. Litter dumping (26° 2' 19.18"S 28° 13' 13.16"E); B. Storm-water drainage from the houses (26° 2' 10.59"S 28° 13' 8.73"E); C. Storm-water drainage from the road (26° 2' 5.73"S 28° 13' 6.34"E); D. Erosion gully (26° 2' 14.47"S 28° 13' 13.05"E); E. Cultivation for subsistence farming (26° 2' 11.75"S 28° 13' 12.10"E); F. Cultivation for subsistence farming (26° 2' 11.75"S 28° 13' 12.10"E). . G. Area used as a landfill (26° 2' 14.38"S 28° 13' 9.78"E); H. Congestion of informal human settlements (squatter camps) (26° 2' 13.33"S 28° 13' 7.64"E); I. Concrete building within the wetland (26° 2' 15.51"S 28° 13' 12.50"E).

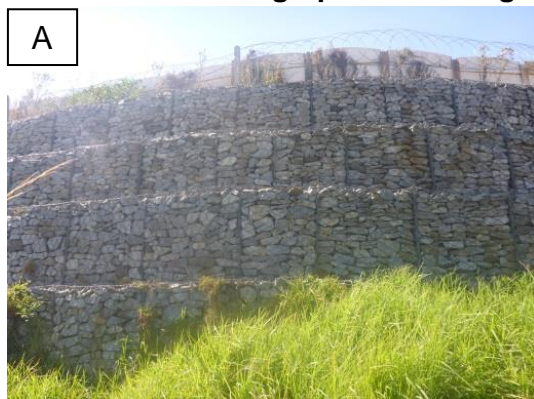
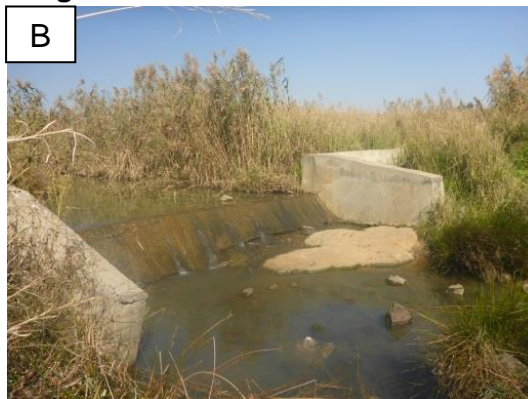
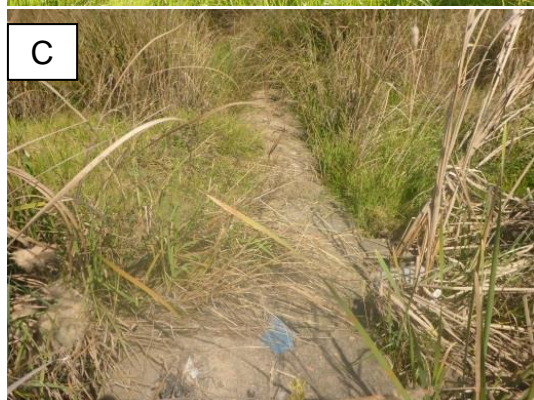
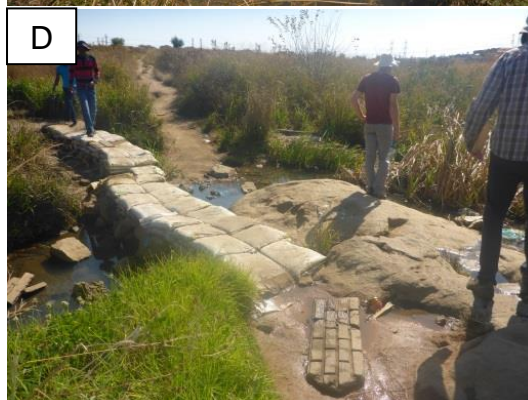
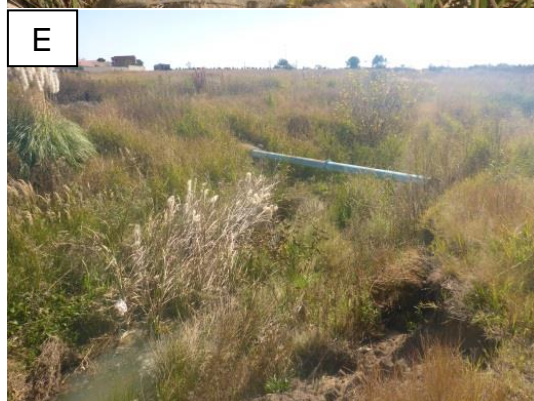
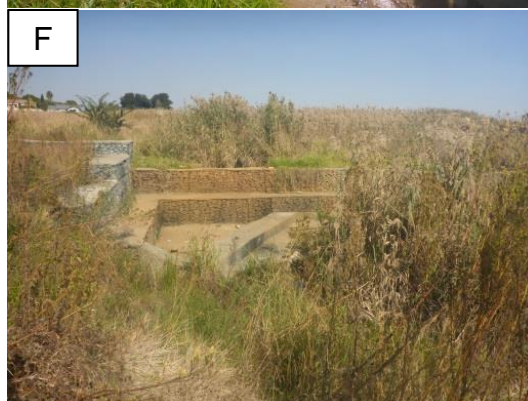
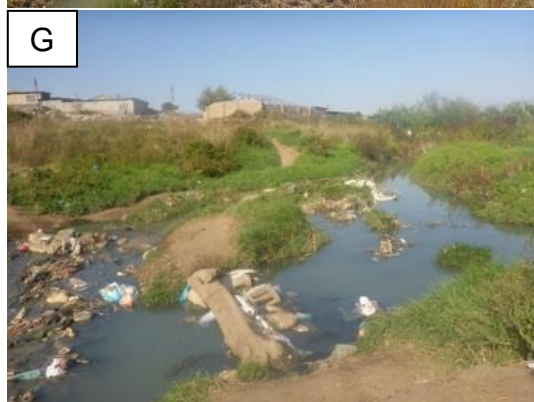
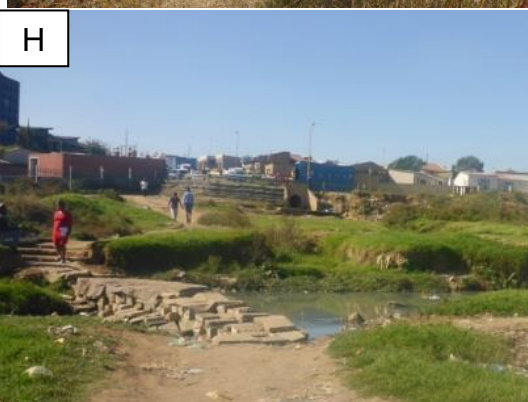
Figure 15: : A. Gabion weir (26° 2' 9.95"S 28° 13' 8.39"E); B. Mass gravity concrete weir A21B-21-004 (26° 2' 14.70"S 28° 13' 11.02"E); C. Concrete pipe crossing A21B-21-003 (26° 2' 16.14"S 28° 13' 12.74"E); D. Rock and sack informal channel crossing (26° 2' 18.87"S 28° 13' 12.48"E); E. Pipe cutting across channel (26° 2' 20.83"S 28° 13' 10.74"E); F. Gabion weir A21B-21-009 (26° 2' 22.52"S 28° 13' 11.51"E).

- *Erythrin spp.*
- *Hypoxis spp.*
- *Combretum erythrophyllum*
- Reinforce the rock and sack informal channel crossing;
- Install a structure to link the rock and sack informal channel crossing and structure A21B-21-009;
- Install a structure within the channel at 26°1'46.46"S; 28°12'37.05"E;
- Install a pedestrian crossing with rails across channel;
- Consider eviction of squatter camps;
- Remove alien vegetation;
- Create walkway along the flood lines of the valley bottom and revegetated open spaces; and
- Plant trees in selected areas to provide shades for bird viewers and picnics.

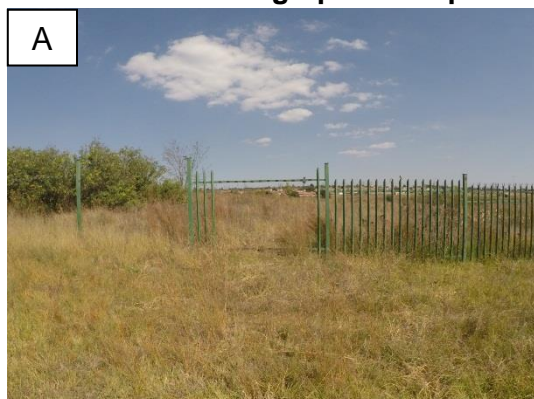
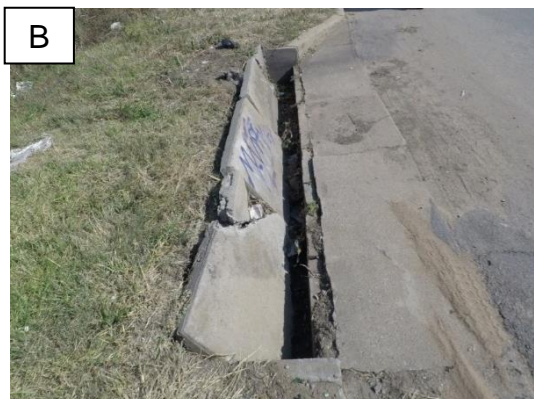
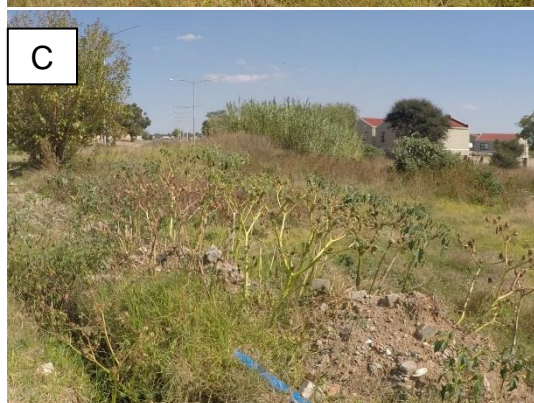
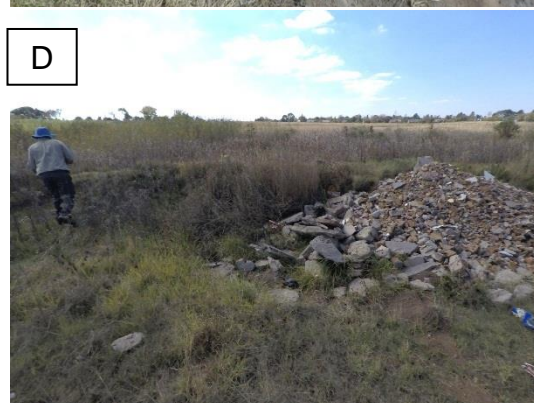
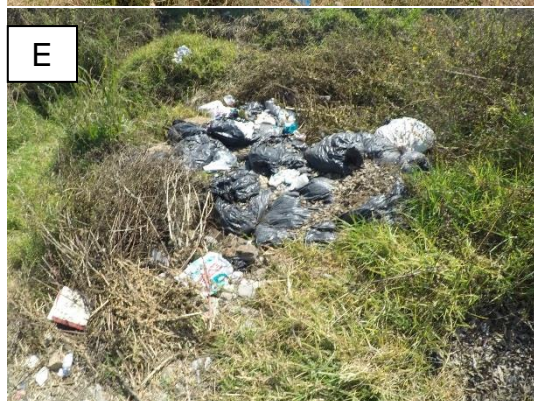
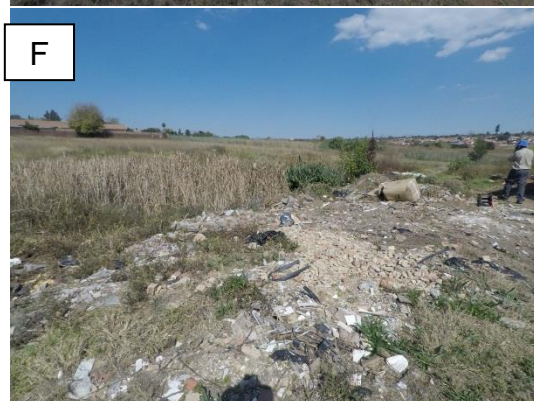
- Dumping of building rubble and litter;
- Sewage discharge into channel;
- Tracks and paths;
- Damaged fencing and damaged storm-water drain; and
- Alien invasive vegetation:
 - *Solanum delagoense*
 - *Bidens pilosa*
 - *Arundo donax*
 - *Morus alba*
 - *Salix babylonica*
 - *Cortaderia selloana*

Figure 16: Damaged fencing (26°2'18.15"S; 28°13'18.54"E); B. damaged storm-water drain (26°2'17.24"S; 28°13'20.12"E); C. Dumping of rubble and alien invasive vegetation (26°2'20.00"S; 28°13'30.14"E); D. Dumping of rubble (26°2'29.20"S; 28°14'17.79"E); E. Dumping of litter (26°2'17.48"S; 28°13'18.89"E); F. Dumping of rubble and litter (26°2'17.15"S; 28°13'19.66"E). G. Presence of alien invasive vegetation (26°2'17.25"S; 28°13'20.90"E); H. Dumping of sand and alien invasive vegetation (26°2'17.37"S; 28°13'22.84"E); I. Dumping of rubble (26°2'19.61"S; 28°13'29.39"E); J. Open area surrounding channel and possible recreational space for community (26°2'22.99"S; 28°13'46.21"E).

- Replace damaged fencing and fix damaged storm-water drain;
- Removal of rubble and litter around the channel and in the open surrounding area and supply an alternative official dumping site;
- Upgrade sewerage infrastructure to limit sewerage discharge into the streams;
- Revegetate the channel using indigenous flora:
- Typical Species:
 - *Typha capensis*
 - *Juncus effuses*
 - *Kyllinga erecta*
 - *Schoenoplectus decipiens*
- Revegetate the open area using indigenous flora:
- Typical Species:
 - *Erythrina lysistemon trees*
 - *Celtis Africana trees*
 - *Melinis repens*
 - *Eragrostis racemosa*
- Create designated paths in the open surrounding area and bridges across the channel; and
- Create a recreational area for the community in the open surrounding area by providing benches, park facilities and planting trees to provide shade.

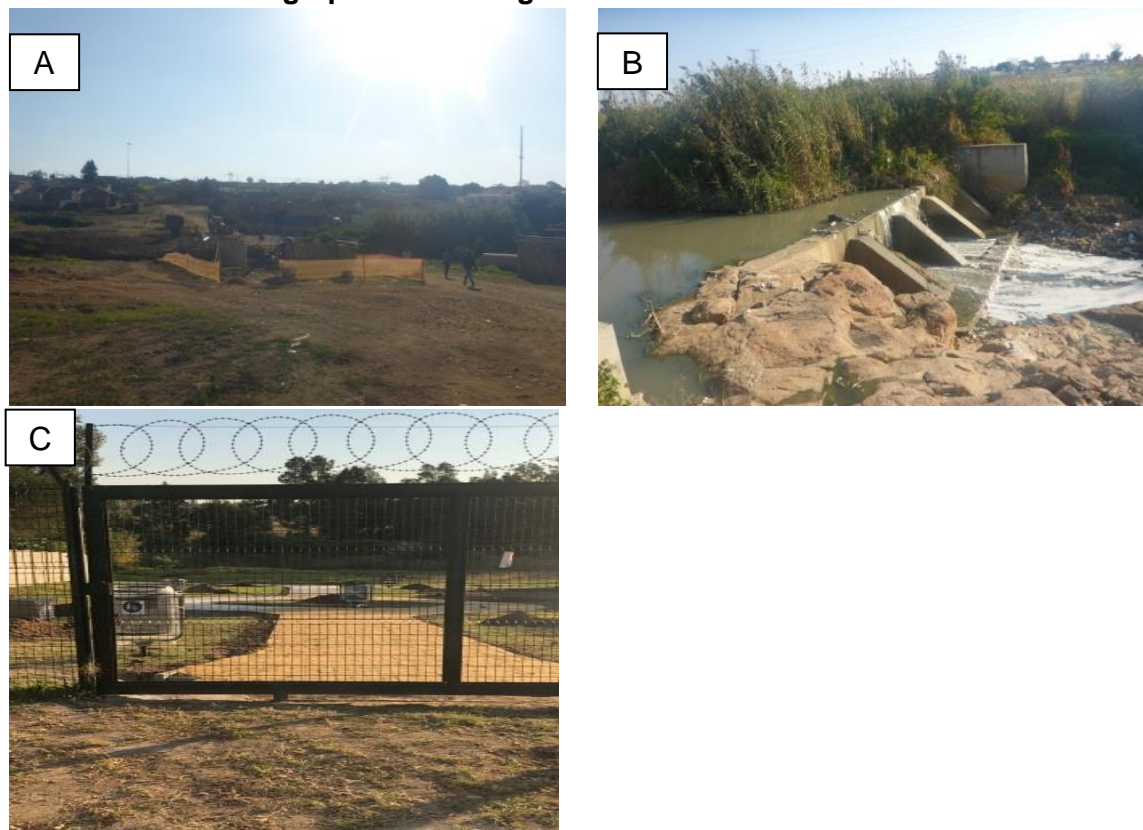
Figure 23: Photographs indicating some of the existing wetland rehabilitation interventions and activities onsite.

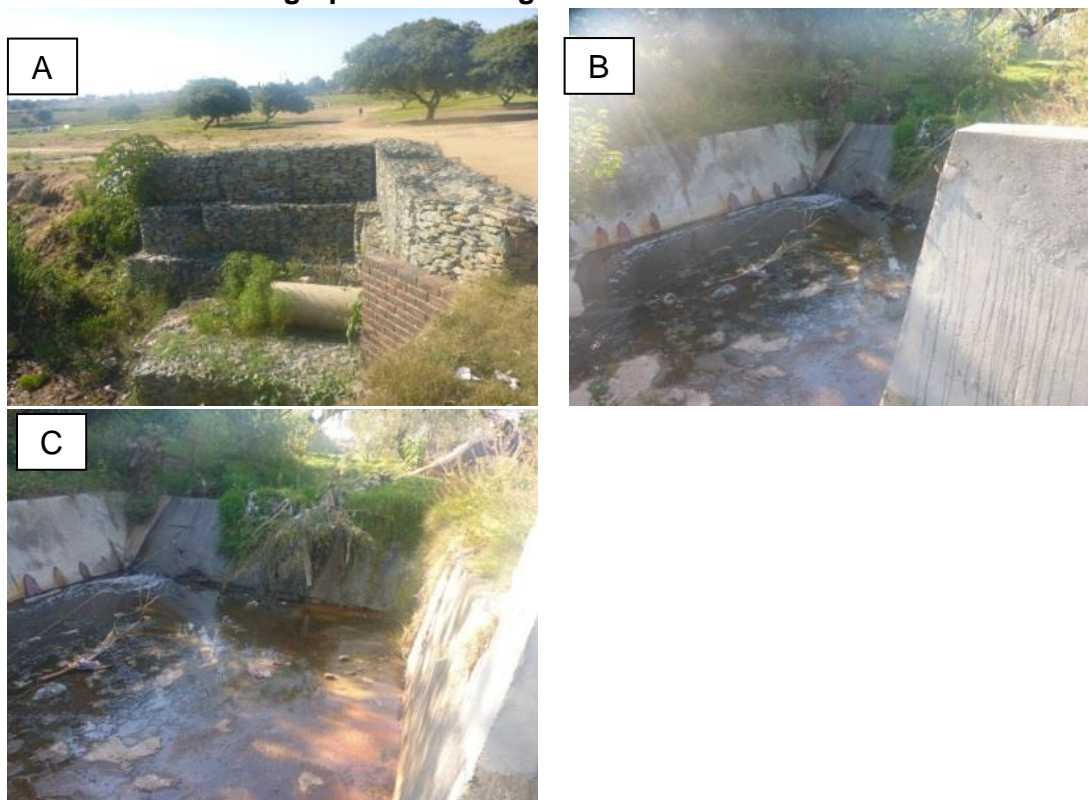
Figure 26: Photographs indicating some of the existing wetland rehabilitation interventions and activities onsite.

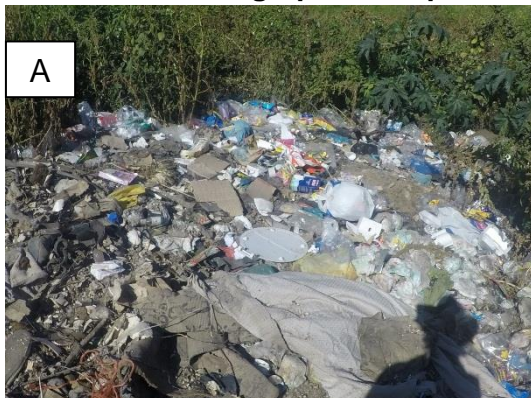
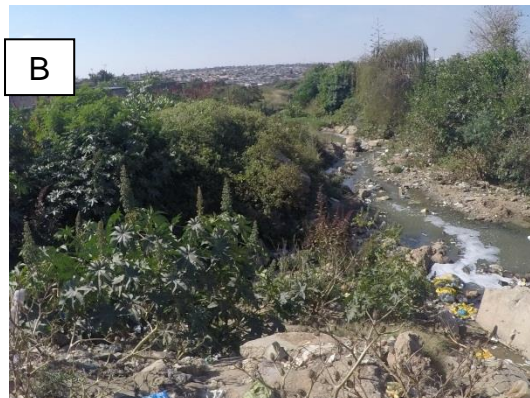
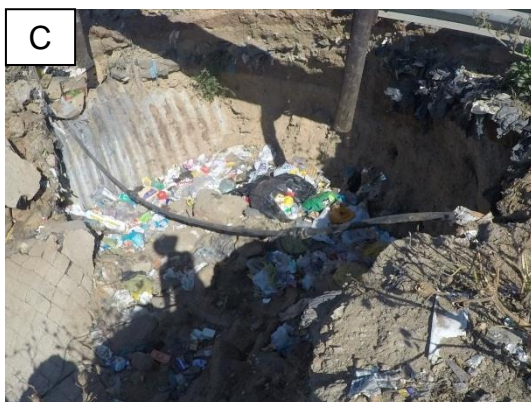
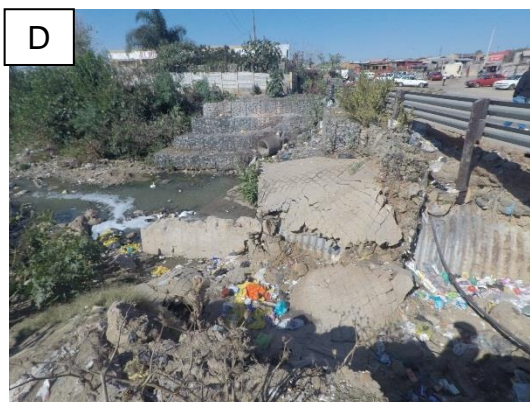
Figure 28: A. Litter (26°0'49.58"S; 28°11'27.15"E); B. Alien invasive vegetation (26°0'48.92"S; 28°11'28.72"E) C. Large active erosion beneath bridge (26°0'48.94"S; 28°11'28.77"E); D. Large active erosion and litter beneath bridge and gabion weir (26°0'48.94"S; 28°11'28.77"E); E. Large active erosion and litter (26°0'48.94"S; 28°11'28.77"E); F. Large active erosion and litter (26°0'48.94"S; 28°11'28.77"E); G. Alien invasive vegetation and polluted water (26°0'49.56"S; 28°11'28.48"E); H. Sedimentation and polluted water (26°0'50.15"S; 28°11'26.91"E).

- Formalize the water channel;
- Restore or replace bridge and crossing for cars and pedestrians to improve safety for community;
- Stabilisation of erosion by construction erosion control structures
- Removal of alien invasive vegetation and water pollutants; and
- Removal of rubble and litter around the channel and in the open surrounding area and supply an alternative official dumping site.
