EXTERNAL NEMA EA AUDIT REPORT 2018

MOOPLAATS COLLIERY

REFERENCE NUMBERS: 17/2/1/15 MP 29, 17/2/3 GS-58, 17/2/4/G
(GS)-36

EIMS REFERENCE: 1284
DOCUMENT TITLE: Mooiplaats Colliery External NEMA EA Audit Report- 2018

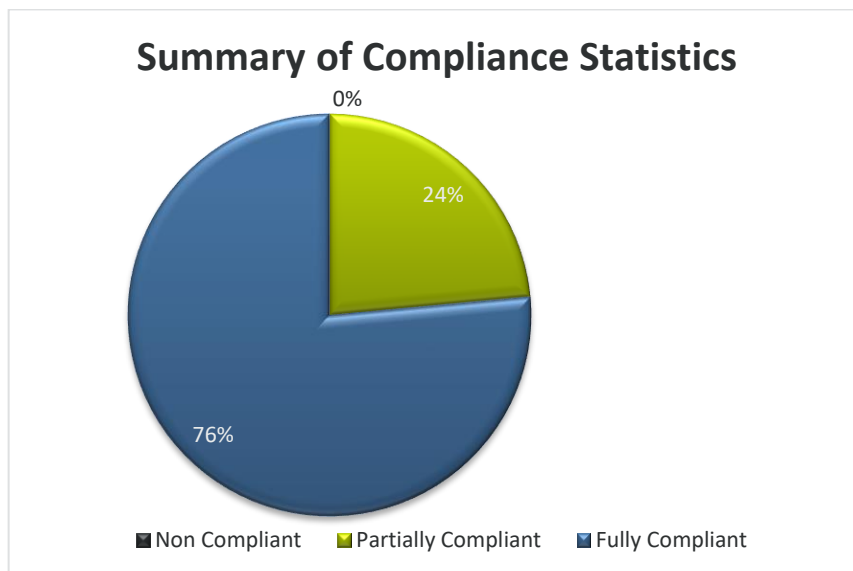
A total of 30 conditions were assessed, of which 13 were not applicable, 13 conditions were found to be fully compliant, 0 non-compliant and 4 partially compliant. A summary of compliance is presented in Figure 1 and the full compliance evaluation for the applicable conditions is presented in Table 7 of Section 5.2. The percentages in the figure indicate the percentage of applicable conditions that were rated as fully compliant, partially compliant and non-compliant. Based on the audit and according to the scoring criteria defined in Section 4.2, an overall compliance score of **88.24%** was obtained for EA (17/2/3 GS-58).

Figure 1: Summary of compliance with the EA (17/2/3 GS-58) conditions.

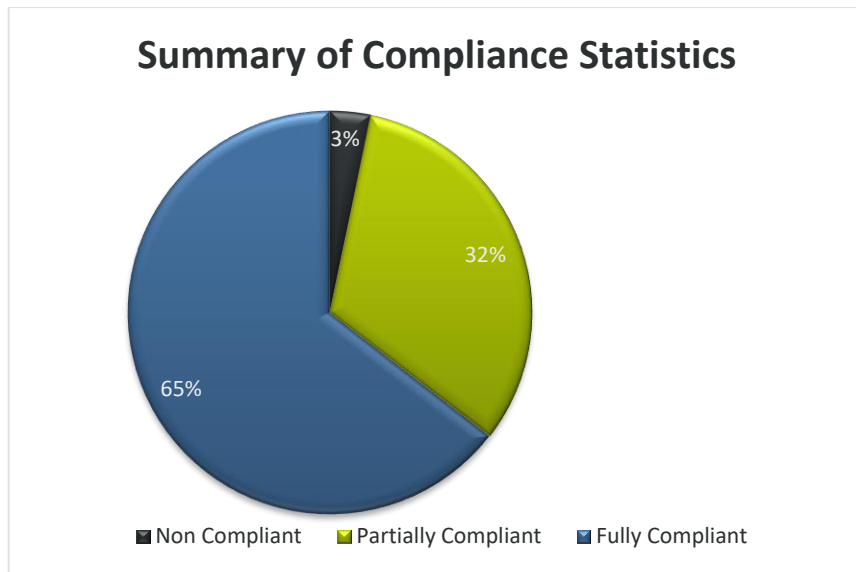
A total of 46 conditions were assessed, of which 15 were not applicable, 20 conditions were found to be fully compliant, 1 non-compliant and 10 partially compliant. A summary of compliance is presented in Figure 2 and the full compliance evaluation for the applicable conditions is presented in Table 10 of Section 5.2. The percentages in the figure indicate the percentage of applicable conditions that were rated as fully compliant, partially compliant and non-compliant. Based on the audit, and according to the scoring criteria as defined in Section 4.2, an overall compliance score of **80.65%** was obtained for EA (17/2/4/G (GS) - 36).

Figure 2: Summary of compliance with the EA (17/2/4/G (GS) - 36) conditions.
