KAALSPRUIT CATCHMENT CONCEPTUAL ENGINEERING DRAWINGS CITY OF EKURHULENI

Cover Page

General Arrangement

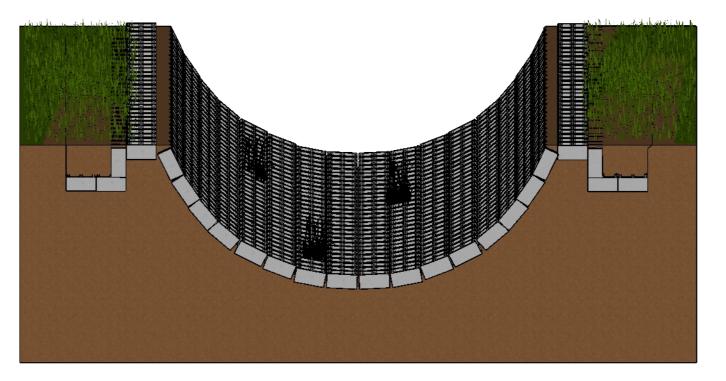
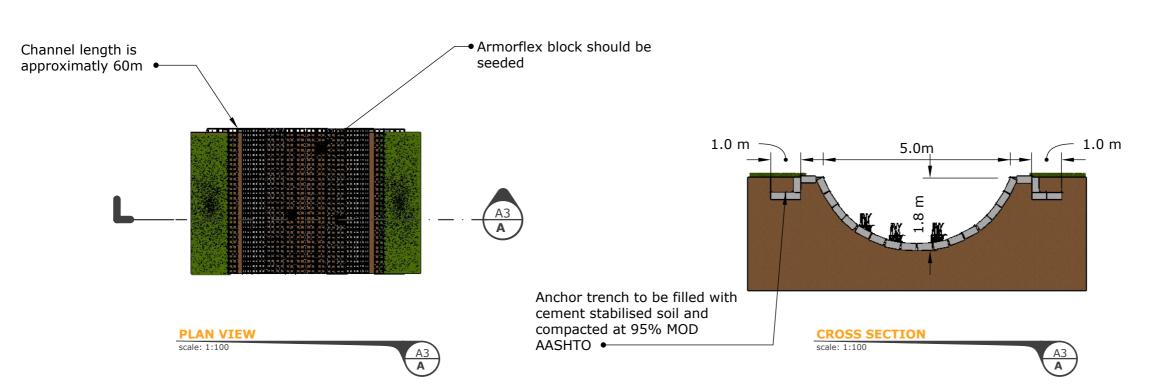
ARMORFLEX AND OR MACMAT CHANNEL

All the stormwater channels entering the main wetland systems should be formalise to Armorflex channels. Sufficient energy dissipation measure should be constructed before stormwater enters the wetland system. Design connecting the current stormwater outlet and the Armorflex channel should be carefully considered.

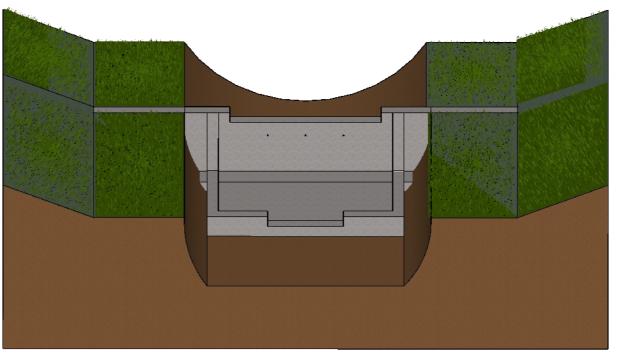
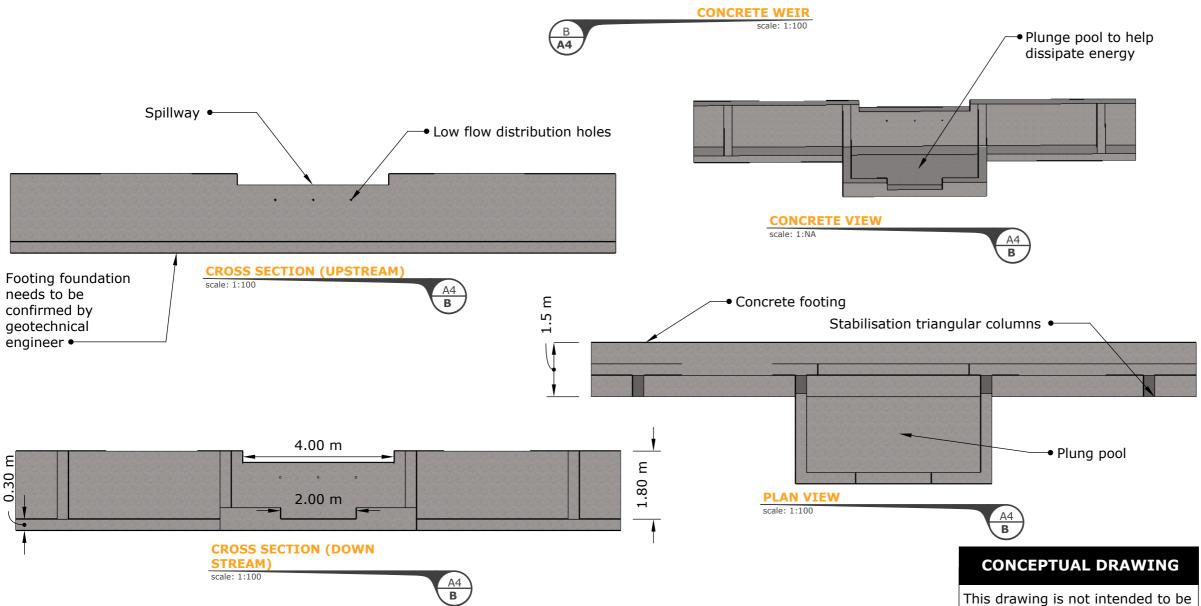
CONCRETE WEIR

These weirs are not designed for low water pedestrian walkway. Please note that in high flows the water is designed to move over the entire structure and at such time the walkways will not be safe to use. Clear signage should be installed to highight this. Structure can be optimised during the detailed engineering design phase of the project.

Concrete weirs will need to be scaled for each individual point. These sizes should be confirmed in the detailed design.

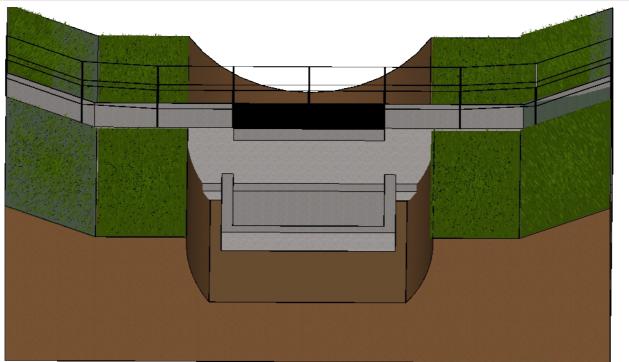
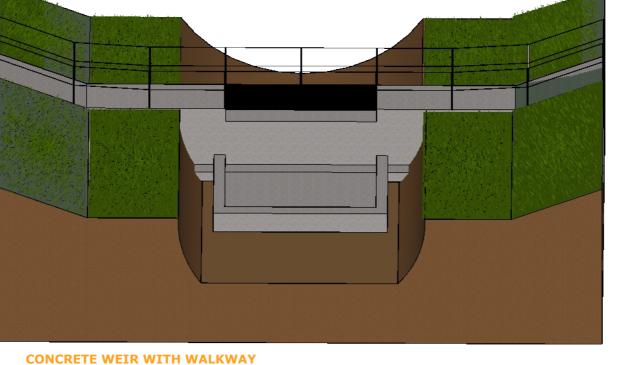
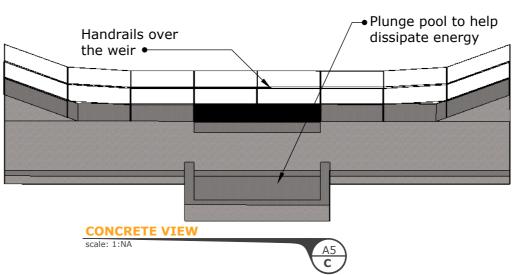
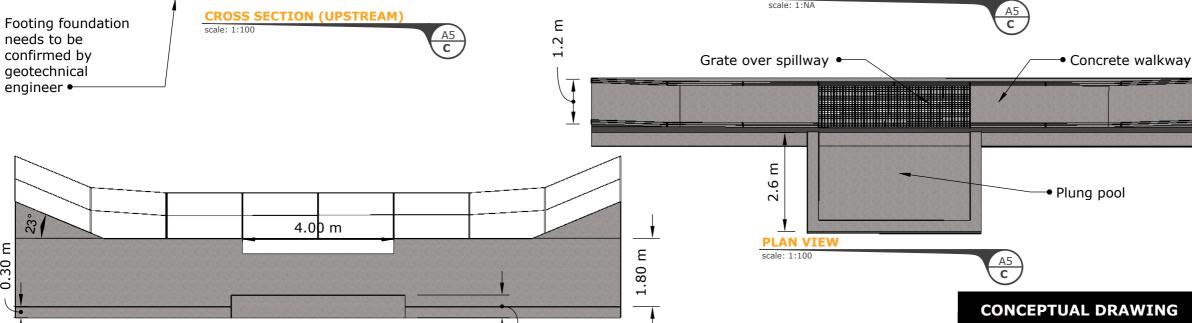
CONCRETE WEIR WITH WALKWAY

Spillway •

All Concrete weir doubles up as a low water pedestrian walkway. Please note that in high flows the water is designed to move over the entire structure and at such time the walkways will not be safe to use. Clear signage should be installed to highight this. Structure can be optimised during the detailed engineering design phase of the project.

Concrete weirs will need to be scaled for each individual point. These sizes should be confirmed in the detailed design.

CROSS SECTION (DOWN STREAM)

0.60 m

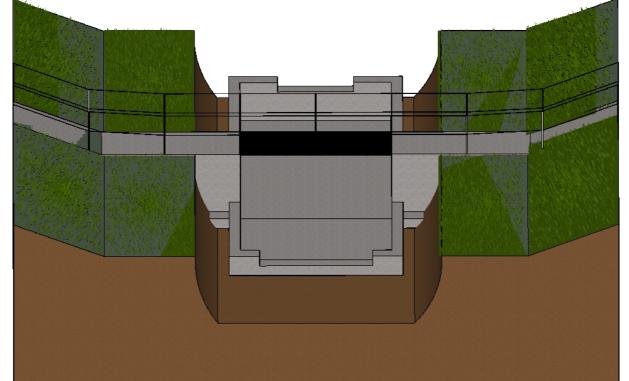
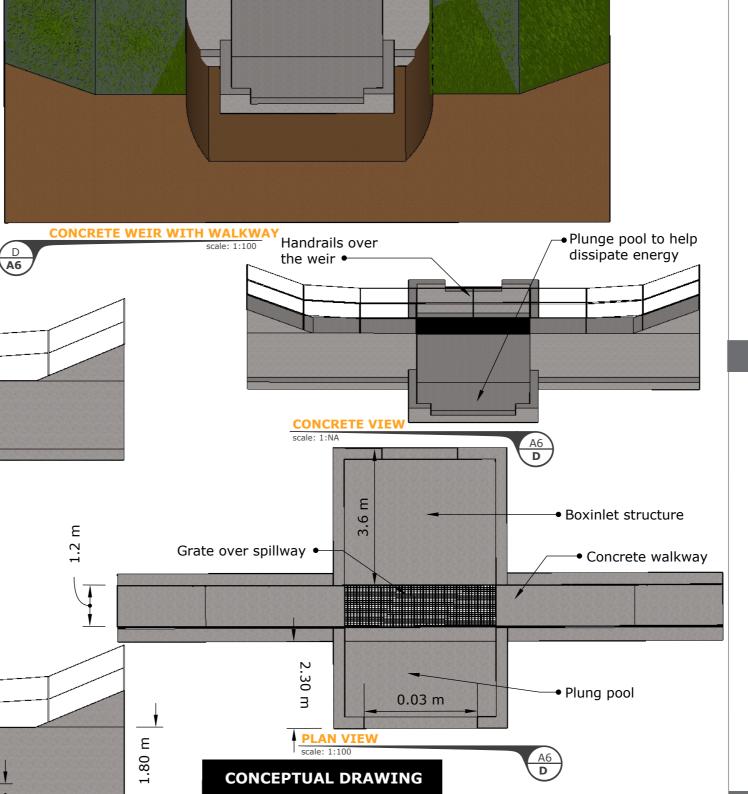
CONCRETE WEIR WITH WALKWAY AND DROP INLET

Footing foundation

needs to be

confirmed by

geotechnical

engineer •

All Concrete weir doubles up as a low water pedestrian walkway. Please note that in high flows the water is designed to move over the entire structure and at such time the walkways will not be safe to use. Clear signage should be installed to highlight this. Structure can be optimised during the detailed engineering design phase of the project.

CROSS SECTION (UPSTREAM)

CROSS SECTION (DOWN STREAM)

Boxinlet spillway to allow

for larger flows •

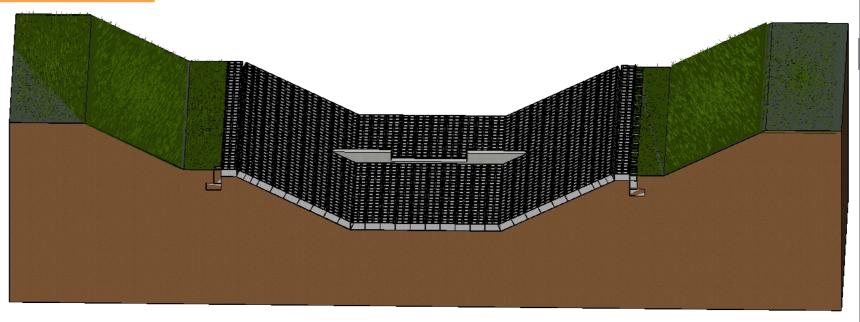
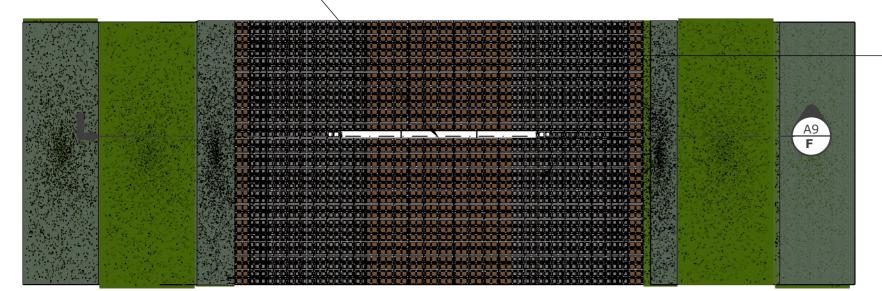
ARMORFLEX CHANNEL

Small weirs to reduce flow

velocity •

Armorflex block should be seeded

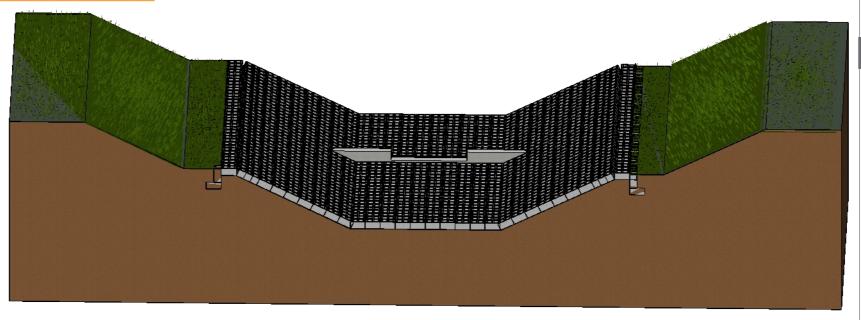
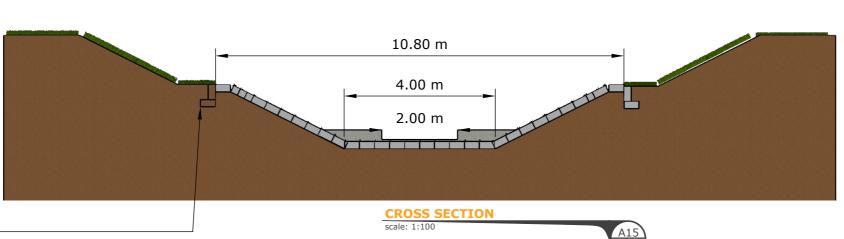
ARMORFLEX CHANNEL

Small weirs to reduce flow

velocity •

Armorflex block should be seeded

soil and compacted at 95% MOD

AASHTO ◆

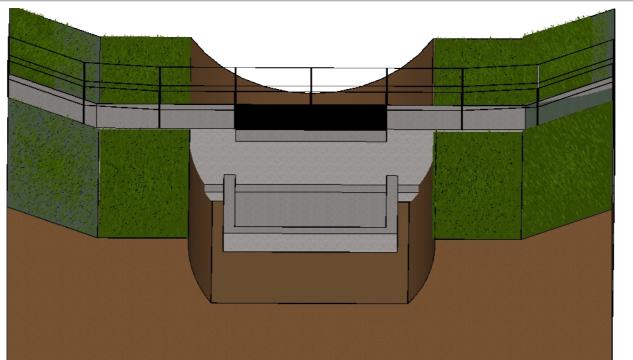
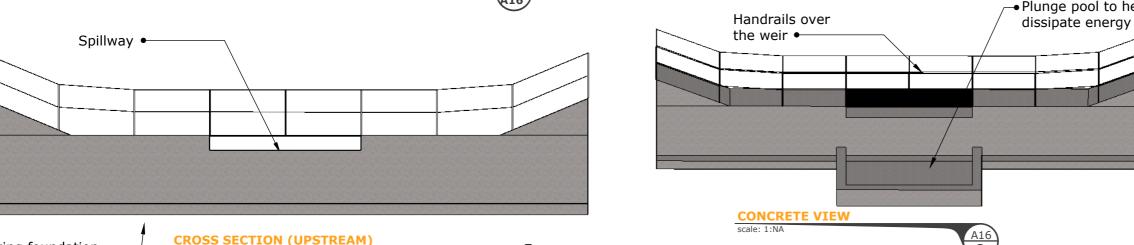
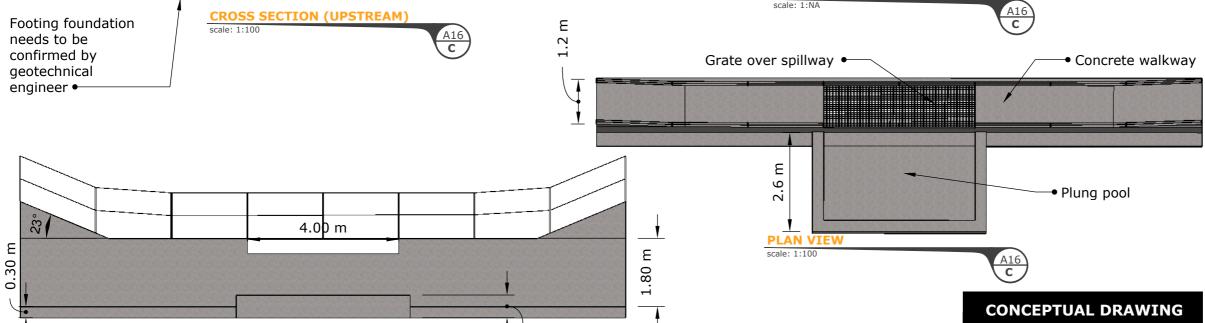
CONCRETE WEIR WITH WALKWAY Plunge pool to help

Concrete weirs will need to be scaled for each individual point. These sizes should be confirmed in the detailed design.

CROSS SECTION (DOWN STREAM)

0.60 m
