# **City of Ekurhuleni Wetland and Watercourse Rehabilitation Planning within the Kaalspruit Catchment**

## **Wetlands and Watercourses Assessment and Management Report**

**June 2018**

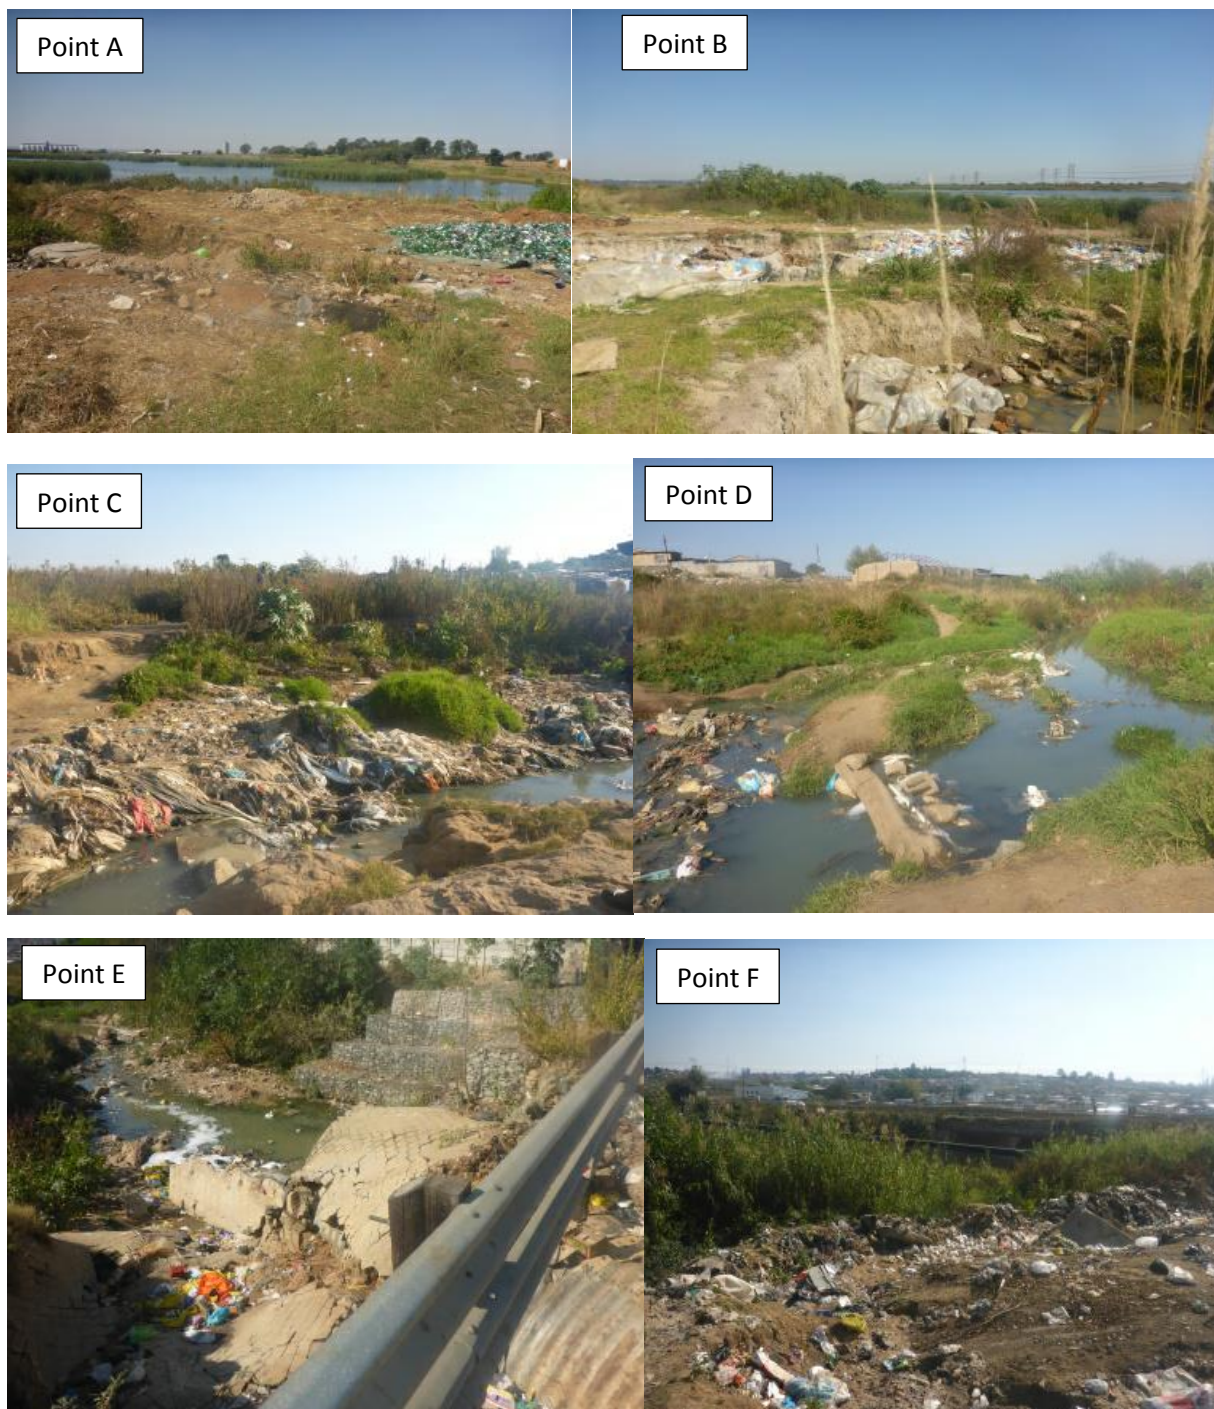
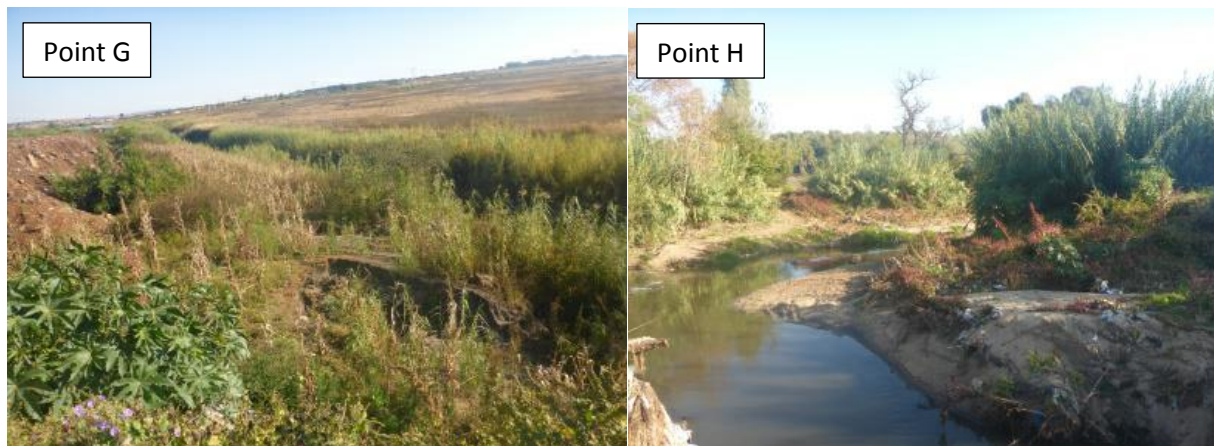
**Figure 4: Fixed point photographs for monitoring.**

FIXED POINT	DISCRIPTION	LOCATION
POINT A	Dumping and infilling within the pan basin	26° 1'37.32"S 28°14'21.38"E
POINT B	Digging and sand dumping within the pan basin	26° 1'43.27"S 28°14'0.53"E
POINT C	Dumping, infilling and channel incision	26° 2'0.94"S 28°11'25.25"E
POINT D	Informal road crossing, channel incision and dumping	26° 1'47.64"S 28°12'37.58"E
POINT E	Eroding lined channel, channel incision and erosion and dumping	26° 0'49.10"S 28°11'28.78"E
POINT F	Dumping and infilling, erosion and channel incision	26° 0'0.18"S 28°11'44.14"E
POINT G	Dumping and infilling, erosion and channel incision	25°57'36.22"S 28°12'22.69"E
POINT H	Dumping, erosion and channel incision and alien invasive vegetation	25°55'20.48"S 28°13'38.50"E

Fixed point photos were used to document the appearance of wetland habitat and vegetation prior to wetland rehabilitation activities being implemented. Photos were taken at points where significant changes are anticipated (linked to the Wet-Health assessments) and should be taken at the same time of the year for consecutive monitoring periods. Photographs taken are included below (Figure 4) while the locations of fixed photo points are indicated in Table 26 and Figure 5.
